**Report: TAB Report**  
**Function: Test, Adjust, & Balance**  
**Date: 01/21/2026**  
**Completed By: National TAB**

**PROJECT**  
**01-19-26 SEPHORA #672 GLENDALE, CA**

Project: 01-19-26 SEPHORA #672 GLENDALE, CA

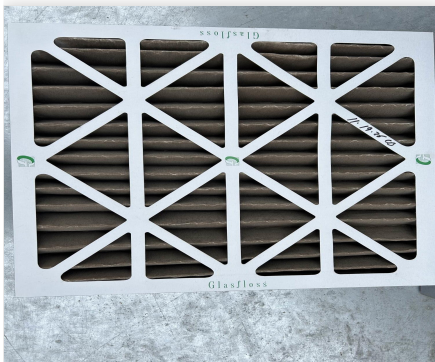
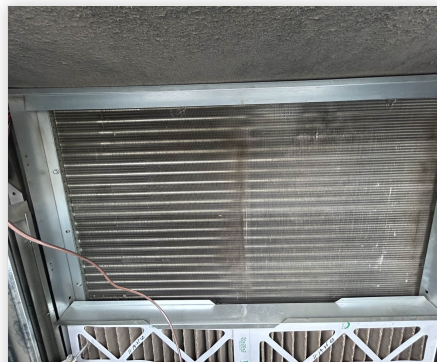
**Issue Name :** RTU-1 FAN COIL DIRTY  
**Description :** RTU-1 fan coil appears to be dirty. Static pressure drop -0.82" from mixed air compartment to fan blower. Recommend cleaning fan coils and replacing final filters.  
**Created By :** National TAB      **Assigned To :** National TAB - Dan Hertenstein  
**Status :** Open  
**Priority :** Medium      **Asset Tag :**  
**Originated Date :** 01/27/2026 - David Nicolas Sanchez - National TAB

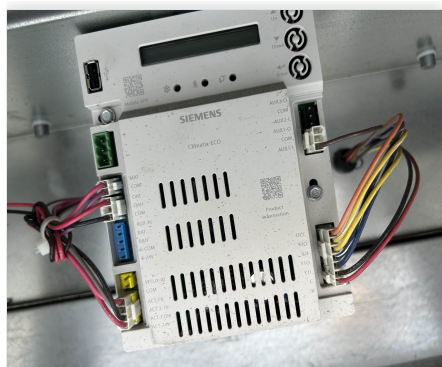
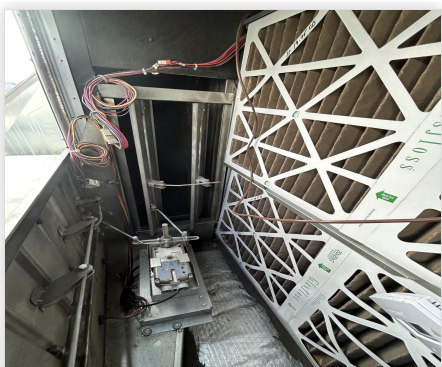
**Issue Name :** RTU’S ECONOMIZER NOT FUNCTIONAL  
**Description :** RTU Economizers are not functional. Economizers have been assembled but not operational. OA dampers have been manually adjusted to design airflow. Recommend getting Economizers operational.  
**Created By :** National TAB                      **Assigned To :** National TAB - Dan Hertenstein  
**Status :** Open  
**Priority :** Medium                      **Asset Tag :**  
**Originated Date :** 01/26/2026 - David Nicolas Sanchez - National TAB

Economizers assemble but not functional.

No

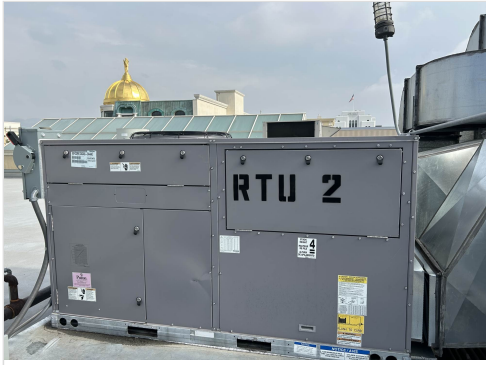
## Unit Data - PHOTO LOG

Asset: RTU2
