Report: Test and Balance
Date: 4/3/2018

PROJECT
CHIPOTLE - EAST GREENBUSH #31-3240
(RENSSELAER, NY)

Project: CHIPOTLE - EAST GREENBUSH #31-3240 (RENSSELAER, NY)

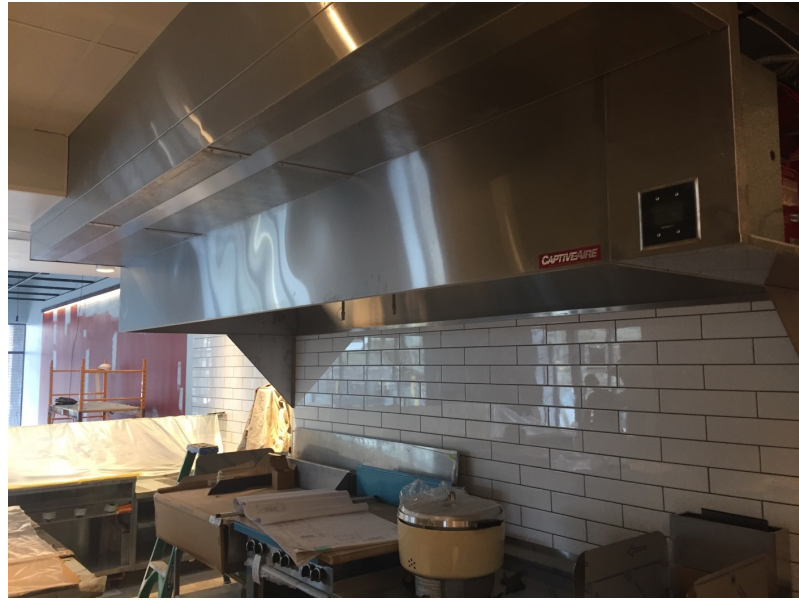
HD-1

The hood capture was tested at the perimeter of the hood and the cook top level with the equipment heat "off" and 100% capture was observed.

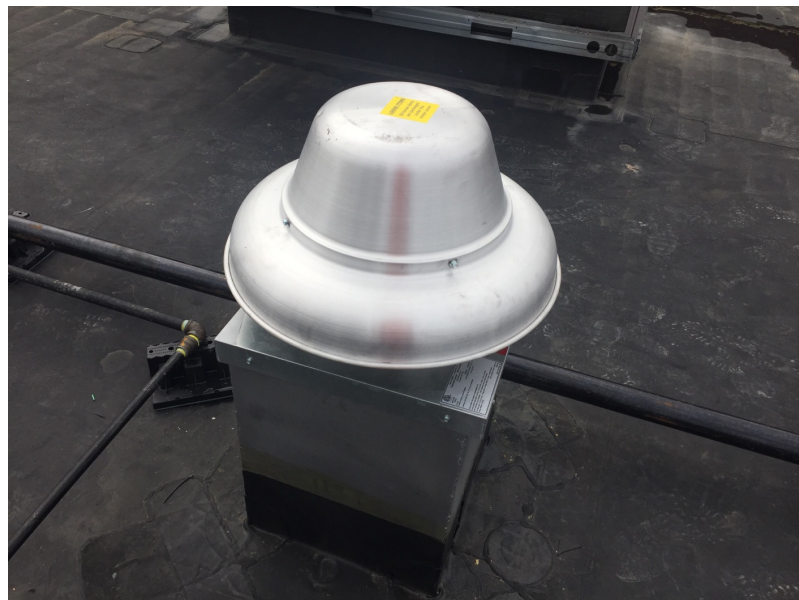
EF-2 was measured by reading each air device with a Flow Hood. The total airflow for each fan is equivalent to the sum of these readings. Fan speed was then adjusted so that the airflow was within +/-10% of design. Each terminal device was balanced to within +/-10% of the design volume using the installed volume dampers.

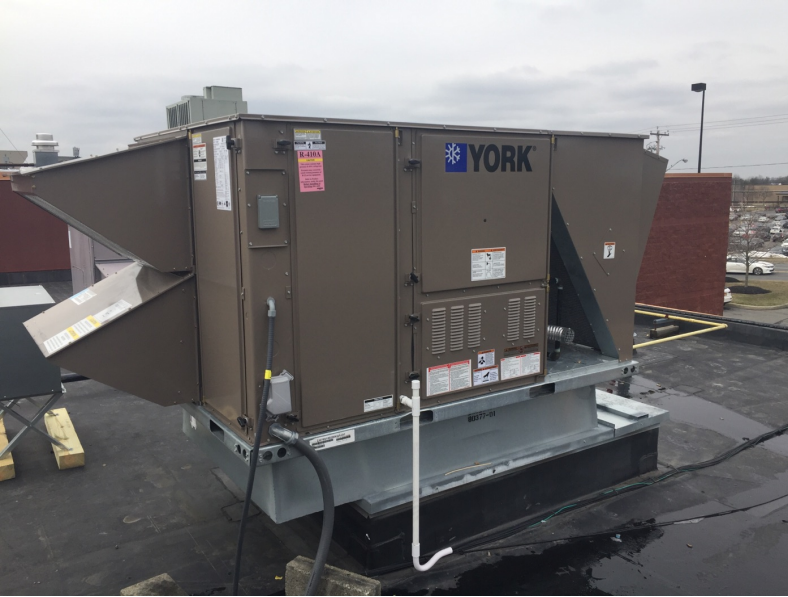
NOTE: ON RTU-1 THE DAMPERS FOR THE ACPSP WERE INACCESSIBLE. THERE WAS DUCTWORK AND LIGHTING IN THE WAY, INCLUDING THE DAMPERS BEING UNDERNEATH THE FLEX STRAP.
