**Report: TAB Report**  
**Function: Test, Adjust, & Balance**  
**Date: 12/17/2025**  
**Completed By: National TAB**

## 12-08-25 WAWA #8695 WOODFORD, VA

5230 MUDD TAVERN ROAD

WOODFORD, VA 22551

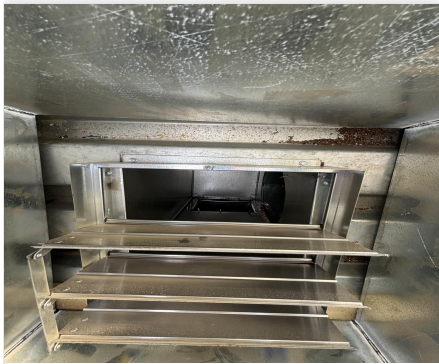
**Issue Name :** EF-2: Improper riser installation  
**Description :** Riser for EF2 is set on top of the roof. 12x12" duct needs to be extended to the top of the curb. Flange needs to be sealed with the top of the curb.  
**Created By :** National TAB                      **Assigned To :** National TAB - Brianna Biggs  
**Status :** Open  
**Priority :** Urgent                                      **Asset Tag :**  
**Originated Date :** 02/16/2026 - Cody Mauro - National TAB

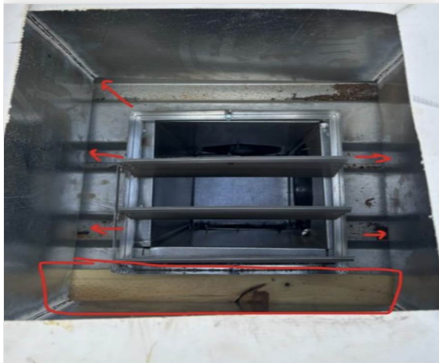
**Issue Name :** EF-2: Low total exhaust  
**Description :** Total exhaust ~80% of design due to improper riser seating on rooftop.  
**Created By :** National TAB                      **Assigned To :** National TAB - Brianna Biggs  
**Status :** Open  
**Priority :** High                                      **Asset Tag :**  
**Originated Date :** 02/16/2026 - Cody Mauro - National TAB

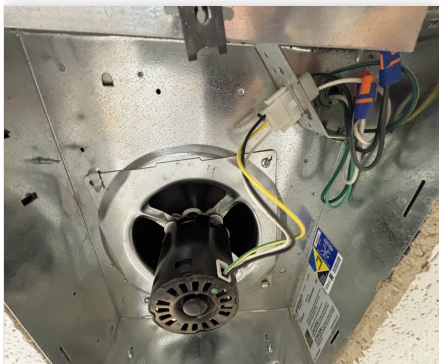
**Issue Name :** EF-3: High total exhaust  
**Description :** EF3 total exhaust ~15% high of design. Single phase motor, wired at high speed.  
**Created By :** National TAB                      **Assigned To :** National TAB - Brianna Biggs  
**Status :** Open  
**Priority :** Low                                      **Asset Tag :**  
**Originated Date :** 02/16/2026 - Cody Mauro - National TAB

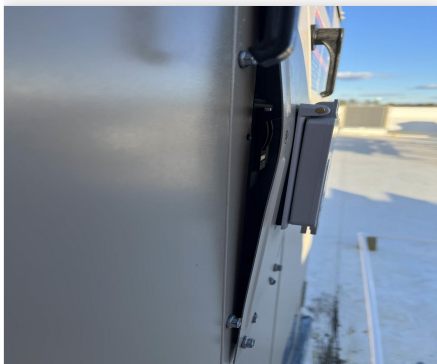
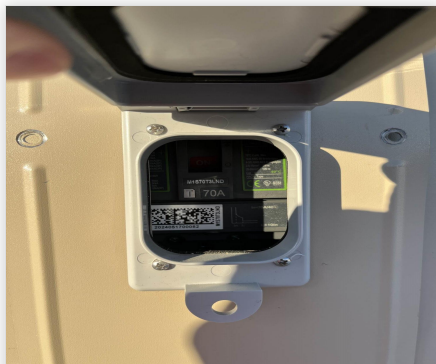
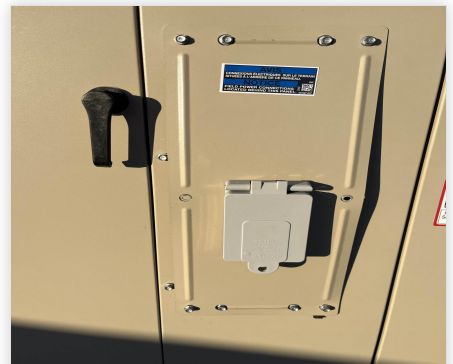
**Issue Name :** RTU-3 Unit Disconnect  
**Description :** Unit disconnect switch cover is misaligned, unable to access/use switch unless cover is taken off.  
**Created By :** National TAB                      **Assigned To :** National TAB - Brianna Biggs  
**Status :** Open  
**Priority :** Low                                      **Asset Tag :**  
**Originated Date :** 12/12/2025 - John Barresi - National TAB

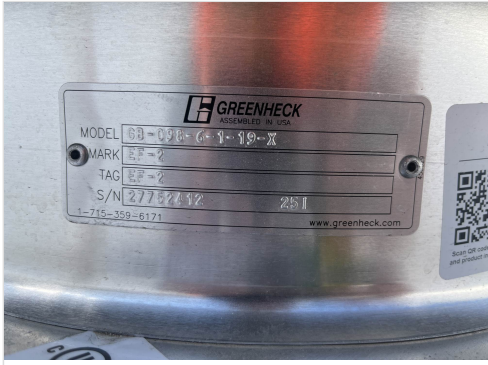
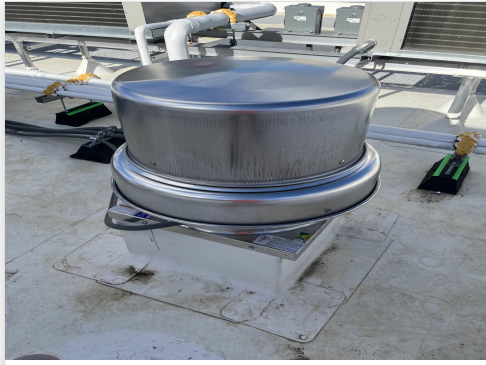
## Unit Data - PHOTO LOG

Unit Data		
	Design	Actual
MFG	GREENHECK	GREENHECK
Model Num	GB-098-6	GB-098-6
Serial Num	-	27752412 25I
Type	DOWNBLAST	DOWNBLAST
Configuration	VERTICAL	VERTICAL

Motor Data		
	Design	Actual
Motor MFG	-	LEESON
Frame	-	48Y
Horsepower	0.167	0.167
Motor Rpm	-	1725
Phase	1	1
Voltage (rated)	120	115
Amperage (rated)	-	3.6
Service Factor	-	1.15

Test Data		
	Design	Actual
CFM	375	391
Fan RPM	-	1126
Fan Rotation	-	CW
Motor RPM	-	1763
System SetPt	-	3.5 TURNS OUT
RL Voltage	-	N/A
RL Amperage	-	N/A
Total ESP	0.38"	0.11"
Fan Inlet SP	-	-0.11"
Fan Discharge SP	-	ATM

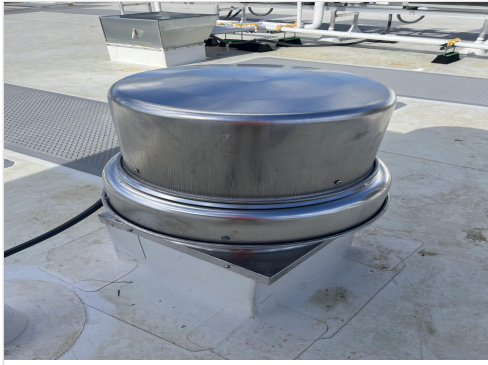
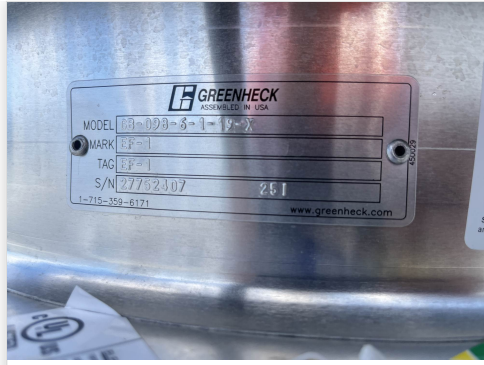
## Unit Data - PHOTO LOG

Unit Data		
	Design	Actual
MFG	GREENHECK	GREENHECK
Model Num	GB-098-6	G-120-4-VG-1-19-X
Serial Num	-	28377281 25L
Type	DOWNBLAST	DOWNBLAST
Configuration	VERTICAL	VERTICAL

Motor Data		
	Design	Actual
Motor MFG	-	VARIGREEN
Frame	-	NL
Horsepower	0.167	0.25
Motor Rpm	-	1750
Phase	1	1
Voltage (rated)	120	277
Amperage (rated)	-	2.85
Service Factor	-	1.25

Test Data		
	Design	Actual
CFM	1100	883
Fan RPM	-	NL
Fan Rotation	-	CW
Motor RPM	-	NL
System SetPt	-	100%
RL Voltage	-	N/A
RL Amperage	-	N/A
Total ESP	0.38"	0.34"
Fan Inlet SP	-	-0.34"
Fan Discharge SP	-	ATM

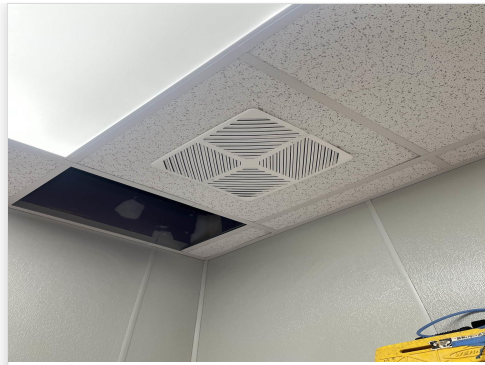
# Unit Data - PHOTO LOG

Unit Data		
	Design	Actual
MFG	GREENHECK	GREENHECK
Model Num	SP-B200	SP-B200-QD
Serial Num	-	203254082-0062
Type	CEILING	CEILING
Configuration	HORIZONTAL	HORIZONTAL

Motor Data		
	Design	Actual
Motor MFG	-	GREENHECK
Frame	-	N/L
Horsepower	0.167	0.03
Motor Rpm	-	1000
Phase	1	1
Voltage (rated)	120	115
Amperage (rated)	-	2.7
Service Factor	-	N/L

Test Data		
	Design	Actual
CFM	200	230
Fan RPM	-	1000
Fan Rotation	-	CCW
Motor RPM	-	1000
System SetPt	-	100
RL Voltage	-	N/A
RL Amperage	-	N/A
Total ESP	0.50"	0.05"
Fan Inlet SP	-	-0.05"
Fan Discharge SP	-	ATM
