Report: TAB REPORT
Function: Test, Adjust, & Balance
Date: 03/08/2025
Completed By: National TAB

03-03-25 CHIPOTLE #5147 HOPE MILLS, NC

Project: 03-03-25 CHIPOTLE #5147 HOPE MILLS, NC

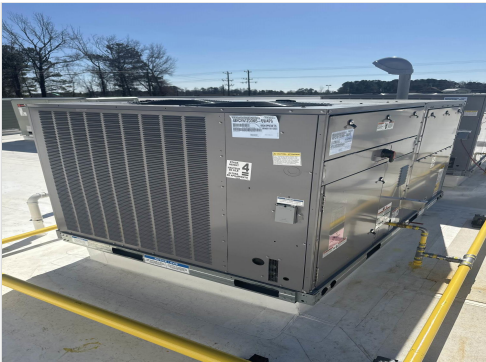
Unit Data - PHOTO LOG

Asset: RTU1

AREA: KITCHEN

Unit Data		
	Design	Actual
MFG	CARRIER	CARRIER
Serial Num	-	0424P63015
Model Num	48FCFN12	48FCFN12
Type	RTU	RTU
Configuration	VERTICAL	VERTICAL
Num OA Filters 1	-	1
OA Filter Size 1	-	34.5X19
Num Final Filter 1	-	4
Final Filter Size 1	-	20X20X2

Test Data		
	Design	Actual
SF CFM	4000	4090
SF RPM	-	2004
RA CFM	3500	3558
OA CFM	500	532
RL Voltage	-	210 / 208 / 208
RL Amperage	-	6.6 / 6.7 / 7.0
SF Rotation	-	CCW
SF System SetPt	-	C 50
RA Damper Position	-	7.10 V
Min OA Damper Position	-	2.90 V
Min OA Damper Type	-	ECON
OA Enthalpy Setpt	-	ES5

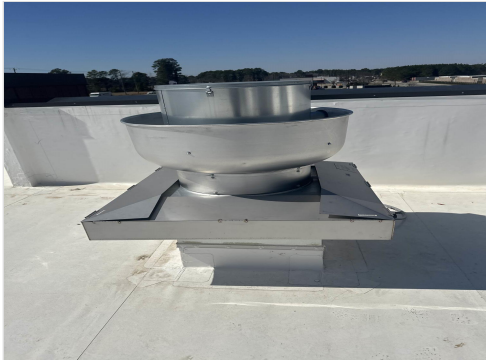
Unit Data - PHOTO LOG

Asset: EF1

AREA: KITCHEN HOOD

Unit Data		
	Design	Actual
MFG	CAPTIVEAIRE	CAPTIVEAIRE
Model Num	DU180HFA	DU180HFA
Serial Num	-	6941851
Type	UPBLAST	UPBLAST
Configuration	VERTICAL	VERTICAL

Test Data		
	Design	Actual
CFM	2550	2595
Fan RPM	1222	1186
Fan Rotation	-	CCW
Motor RPM	-	1186
System SetPt	-	60.8 HZ
RL Voltage	-	209 / 209 / 208
RL Amperage	-	5.4 VFD
Total ESP	1.450"	0.87"
Fan Inlet SP	-	-0.87"
Fan Discharge SP	-	ATM

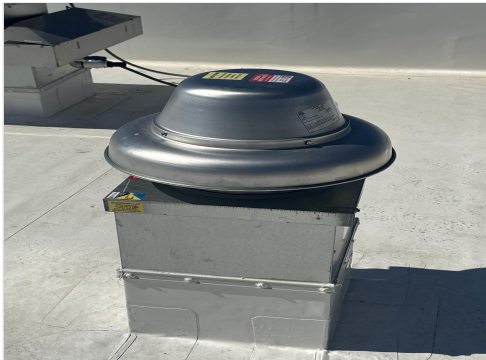
Unit Data - PHOTO LOG

Asset: EF2

AREA:RESTROOMS

Unit Data		
	Design	Actual
MFG	CAPTIVEAIRE	CAPTIVEAIRE
Model Num	DR12HFA	DR12HFA
Serial Num	-	6941851
Type	DOWBLAST	DOWNBLAST
Configuration	VERTICAL	VERTICAL

Test Data		
	Design	Actual
CFM	150	149
Fan RPM	1282	930
Fan Rotation	-	CCW
Motor RPM	-	930
System SetPt	-	50P
RL Voltage	-	[1]
RL Amperage	-	[1]
Total ESP	0.600"	0.12"
Fan Inlet SP	-	-0.12"
Fan Discharge SP	-	ATM

[1] LIGHTSWITCH STYLE CONTROLLER - UNABLE TO READ VOLTS AND AMPS

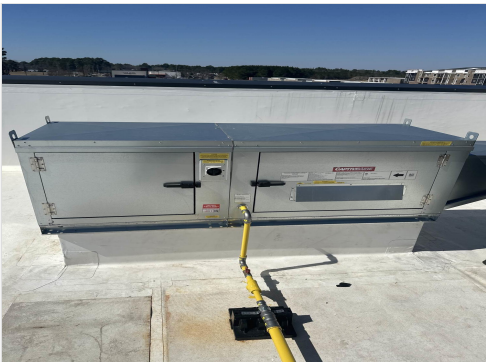
Unit Data - PHOTO LOG

Asset: MUA1

AREA: KITCHEN HOOD

Unit Data		
	Design	Actual
MFG	CAPTIVEAIRE	CAPTIVEAIRE
Model Num	A1-D.250-15D	A1-D.250-15D
Serial Num	-	6941851
Type	MUA	MUA
Configuration	VERTICAL	VERTICAL

Test Data		
	Design	Actual
CFM	1300	1369
SF RPM	1548	1395
Motor RPM	-	1395
SF System SetPt	-	40.1 HZ
RL Voltage	-	209 / 208 / 209
RL Amperage	-	2.3 VFD
Total ESP	-	0.33"
Fan Discharge SP	-	0.33"
