Project Summary

09-26 CULVERS - ROCKFORD, MI

Name : TECH - SITE PICTURES **Status :** NotSubmitted
Assigned Organization : National TAB **Asset :**
Requesting Organization : National TAB

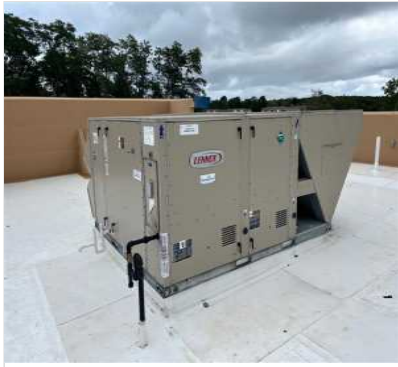
[1] RTU-2 (Kitchen) gas valve was turned off on the roof during the balance. A gas smell was detected at the connection to the RTU. Owner made aware.
