**Report: TAB Report**  
**Function: Test, Adjust, & Balance**  
**Date: 03/03/2025**  
**Completed By: National TAB**

**PROJECT**  
**02-24-25 SEPHORA 730 NORTHRIDGE, LA**

9301 Tampa Avenue

Northridge , CA 91324

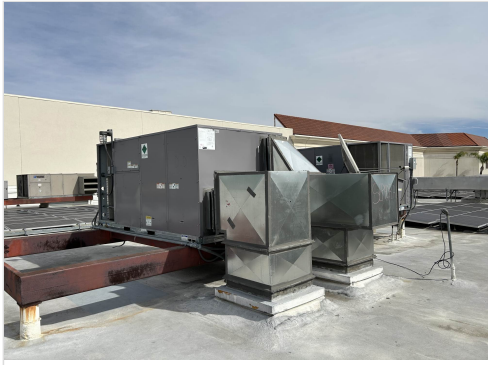
## Unit Data - PHOTO LOG

Asset: RTU1

| Test Data | | |
|---|---|---|
| SF CFM | 3500 | 3818 |
| RA CFM | 2975 | 3286 |
| OA CFM | 525 | 532 |

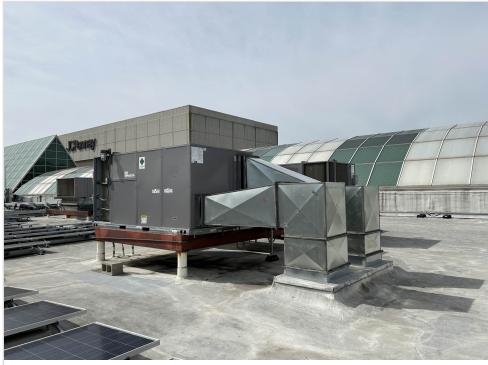
## Unit Data - PHOTO LOG

Asset: RTU2

| Test Data | | |
|---|---|---|
| SF CFM | 3500 | 3540 |
| RA CFM | 2975 | 2988 |
| OA CFM | 525 | 552 |

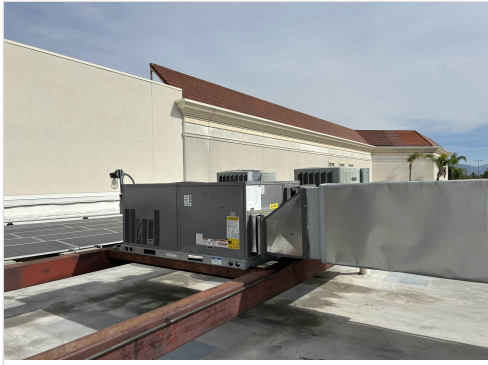
## Unit Data - PHOTO LOG

Asset: RTU3

| Test Data | | |
|---|---|---|
| SF CFM | 1400 | 1334 |
| RA CFM | 1190 | 1141 |
| OA CFM | 210 | 193 |
