**Report: TAB REPORT**  
**Function: Test, Adjust, & Balance**  
**Date: 02/20/2025**  
**Completed By: National TAB**

**PROJECT**  
**02-17-25 CULVERS BONAIRE, GA**

780 SR 96

BONAIRE, GA 31005

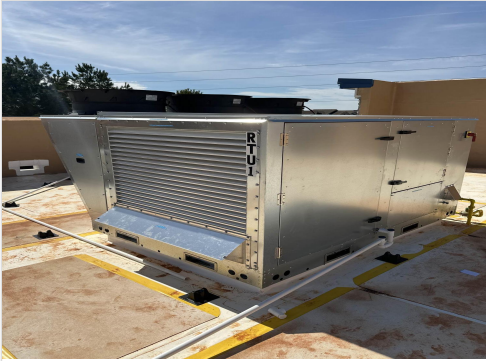
Asset: RTU1

Unit Data		
	Design	Actual
MFG	LENNOX	CAPTIVAIRE
Serial Num	-	6785651
Model Num	ENLIGHT LGT	CAS-HVAC C3-1.250-24-20T
Type	RTU	RTU
Configuration	VERTICAL	VERTICAL
Num OA Filters 1	-	4
OA Filter Size 1	-	16X25X2
Num Final Filter 1	-	8
Final Filter Size 1	-	20X25X2

Test Data		
	Design	Actual
SF CFM	6150	6126
SF RPM	-	1580
RA CFM	4400	4300
OA CFM	1750	1826
RL Voltage	-	229 / 228 / 229
RL Amperage	-	23.8 VFD
SF Rotation	-	CCW
SF System SetPt	-	56 HZ
RA Damper Position	-	5.3 V
Min OA Damper Position	-	4.7 V
Min OA Damper Type	-	ECON

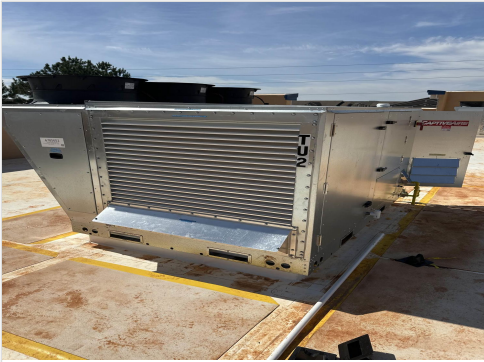
Asset: RTU2

Unit Data		
	Design	Actual
MFG	LENNOX	CAPTIVAIRE
Serial Num	-	6785651
Model Num	ENLIGHT LGT	CAS-HVAC C3-1.250-24-20T
Type	RTU	RTU
Configuration	VERTICAL	VERTICAL
Num OA Filters 1	-	4
OA Filter Size 1	-	16X25X2
Num Final Filter 1	-	8
Final Filter Size 1	-	20X25X2

Test Data		
	Design	Actual
SF CFM	6225	5755
SF RPM	-	1609
RA CFM	4525	4002
OA CFM	1700	1753
RL Voltage	-	229 / 229 / 229
RL Amperage	-	24.2
SF Rotation	-	CCW
SF System SetPt	-	55 HZ
RA Damper Position	-	5.3 V
Min OA Damper Position	-	4.7 V
Min OA Damper Type	-	ECON

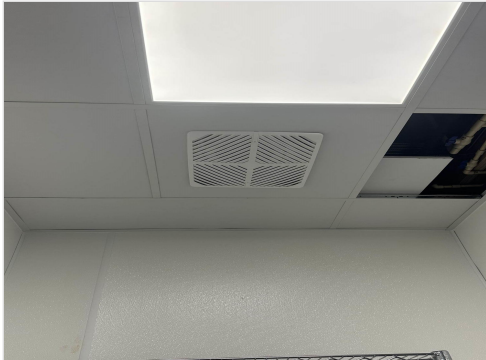
Asset: EF-A1

Unit Data		
	Design	Actual
MFG	ACCUREX	ACCUREX
Model Num	XCR-B80	XCR-B80
Serial Num	-	25683900
Type	-	CEILING
Configuration	-	UPBLAST

Test Data		
	Design	Actual
CFM	75	73
Fan Rotation	-	CCW
System SetPt	-	HIGH

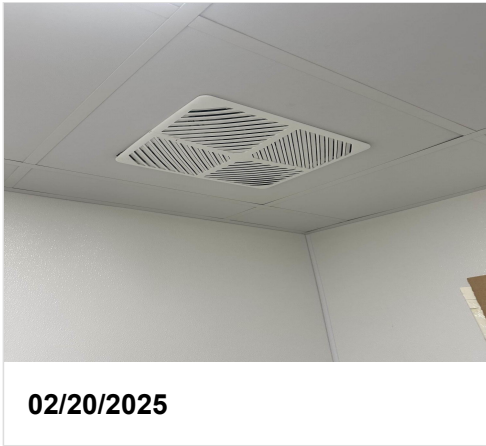
Asset: EF-B1

Unit Data		
	Design	Actual
<b>MFG</b>	ACCUREX	ACCUREX
<b>Model Num</b>	XCR-B80	XCR-B80
<b>Serial Num</b>	-	25683901
<b>Type</b>	-	CEILING
<b>Configuration</b>	-	UPBLAST

Test Data		
	Design	Actual
<b>CFM</b>	75	69
<b>Fan Rotation</b>	-	CCW
<b>System SetPt</b>	-	HIGH

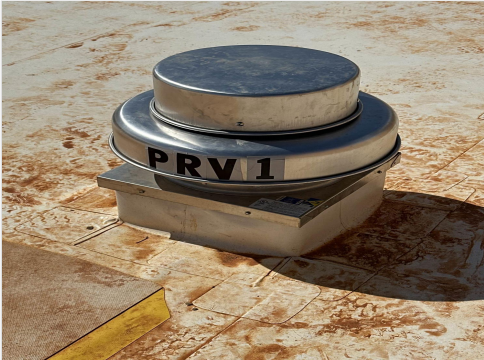
Asset: PRV1

Unit Data		
	Design	Actual
MFG	ACCUREX	ACCUREX
Model Num	XRED-090-VG	XRED-090-VG
Serial Num	-	25689165
Type	DOWNBLAST	DOWNBLAST
Configuration	VERTICAL	VERTICAL

Test Data		
	Design	Actual
CFM	300	312
Fan Rotation	-	CCW
System SetPt	-	5.25 DIAL
RL Voltage	-	[1]
RL Amperage	-	[1]
Total ESP	0.5"	0.11"
Fan Inlet SP	-	-0.11"
Fan Discharge SP	-	ATM

[1] LIGHTSWITCH-STYLE CONTROLLER - UNABLE TO TAKE VOLTS AND AMPS

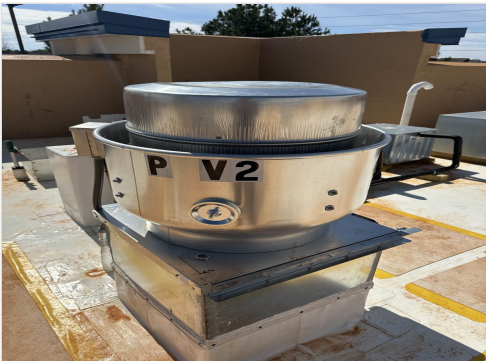
Asset: PRV2

Unit Data		
	Design	Actual
MFG	ACCUREX	ACCUREX
Model Num	XCUE-140-VG	XCUE-140-VG
Serial Num	-	25699714
Type	UPBLAST	UPBLAST
Configuration	VERTICAL	VERTICAL

Test Data		
	Design	Actual
CFM	1500	1555
Fan RPM	1725	1138
Fan Rotation	-	CCW
Motor RPM	-	1138
System SetPt	-	6.5 VDC
RL Voltage	-	121
RL Amperage	-	4.2
Total ESP	1.801"	0.54"
Fan Inlet SP	-	-0.54"
Fan Discharge SP	-	ATM

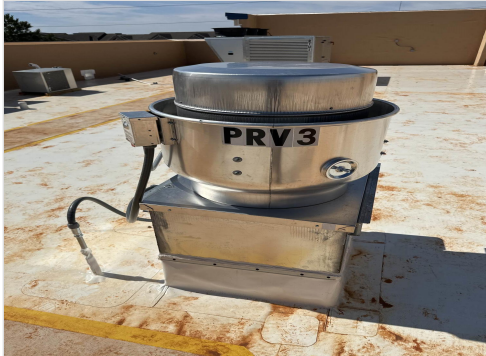
Asset: PRV3

Unit Data		
	Design	Actual
MFG	ACCUREX	ACCUREX
Model Num	XCUE-140-VG	XCUE-140-VG
Serial Num	-	25699765
Type	UPBLAST	UPBLAST
Configuration	VERTICAL	VERTICAL

Test Data		
	Design	Actual
CFM	1500	1507
Fan RPM	1365	1138
Fan Rotation	-	CCW
Motor RPM	-	1138
System SetPt	-	6.5 VDC
RL Voltage	-	120
RL Amperage	-	3.4
Total ESP	1.0"	0.47"
Fan Inlet SP	-	-0.47"
Fan Discharge SP	-	ATM

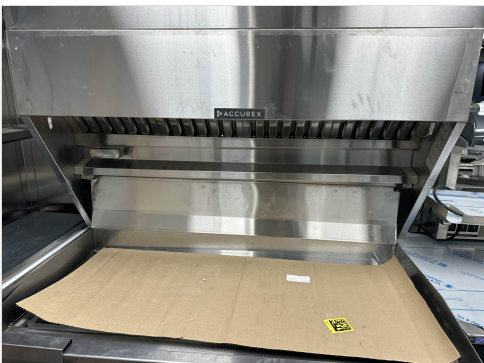
Asset: HD1

Unit Data		
	Design	Actual
MFG	ACCUREX	ACCUREX
Model Num	XGEP-64-S	XGEP-64-S
Job / Serial Num	-	25725035
Type	TYPE I LOW PROXIMITY	TYPE I LOW PROXIMITY
Hood length	64"	64"
Hood Width	23"	26"

Test Data Exhaust		
	Design	Actual
Filter Type	GREASE GRABBER	X TRACTOR
Filter Size 1	16X16	16X16
Filter Qty 1	4	4
Filter AK factor size 1	1.53	1.53
Filter Total AK Area	6.12	6.12
Filter1 FPM	-	250
Filter2 FPM	-	252
Filter3 FPM	-	235
Filter4 FPM	-	280
Filter Ave FPM(corr)	-	254
CFM	1500	1555

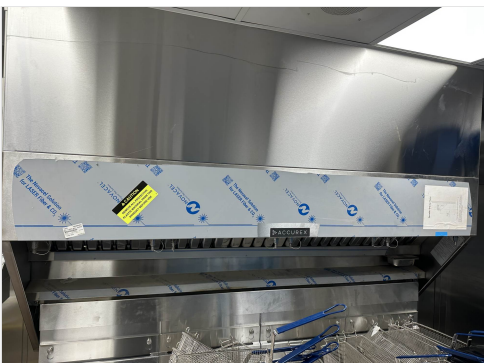
Asset: HD2

Unit Data		
	Design	Actual
MFG	ACCUREX	ACCUREX
Model Num	XXEP-83-S	XXEP-83-S
Job / Serial Num	-	25725027
Type	TYPE I LOW PROXIMITY	TYPE I LOW PROXIMITY
Hood length	83"	83"
Hood Width	23"	26"

Test Data Exhaust		
	Design	Actual
Filter Type	X TRACTOR	X TRACTOR
Filter Size 1	16X16	16X16
Filter Qty 1	5	5
Filter AK factor size 1	1.53	1.53
Filter Total AK Area	7.65	7.65
Filter1 FPM	-	226
Filter2 FPM	-	178
Filter3 FPM	-	170
Filter4 FPM	-	198
Filter5 FPM	-	215
Filter Ave FPM(corr)	-	197
CFM	1500	1507
