Report: TAB Report
Function: Test, Adjust, & Balance
Date: 01/20/2026
Completed By: National TAB

PROJECT
01-19-25 WAWA #5463 BUSHNELL, FL

Project: 01-19-25 WAWA #5463 BUSHNELL, FL

Table Of Contents

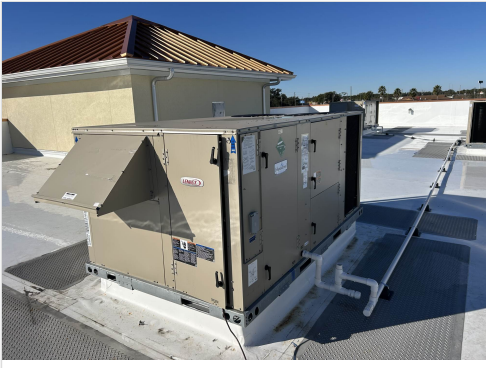
Unit Data - PHOTO LOG

Asset: RTU-1

AREA:RETAIL

Unit Data		
	Design	Actual
MFG	LENNOX	LENNOX
Serial Num	-	5624K00724
Model Num	LCT102H4E	LCT102H4EG1Y
Type	RTU	RTU
Configuration	VERTICAL	VERTICAL
Num OA Filters 1	-	1
OA Filter Size 1	-	23x14
Num Final Filter 1	-	4
Final Filter Size 1	-	20x25x2

Test Data		
	Design	Actual
SF CFM	3400	3458
SF RPM	-	1386
MOTOR RPM	-	1386
RA CFM	2900	2950
OA CFM	500	508
RL Voltage	-	216/215/216
RL Amperage	-	2.7/2.7/2.7
SF System SetPt	-	63%
OA Damper Position	-	36%
OA Damper Type	-	SINGLE BLADE

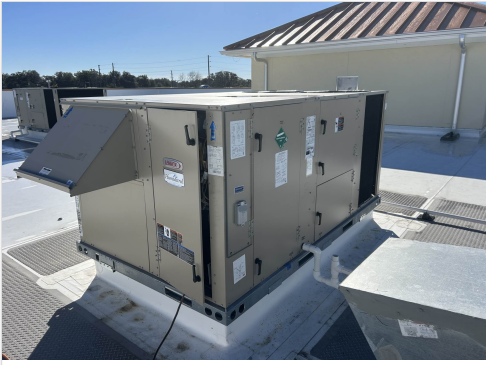
Unit Data - PHOTO LOG

Asset: RTU-2

AREA:DELI

Unit Data		
	Design	Actual
MFG	LENNOX	LENNOX
Serial Num	-	5624L02313
Model Num	LCT150H4E	LCT150H4EN2Y
Type	RTU	RTU
Configuration	VERTICAL	VERTICAL
Num OA Filters 1	-	1
OA Filter Size 1	-	23x14
Num Final Filter 1	-	4
Final Filter Size 1	-	20x25x2

Test Data		
	Design	Actual
SF CFM	5000	4801
SF RPM	-	1459
MOTOR RPM	-	1459
RA CFM	4500	4276
OA CFM	500	525
RL Voltage	-	216/215/216
RL Amperage	-	5.0/4.9/4.9
SF System SetPt	-	82%
OA Damper Position	-	35%
OA Damper Type	-	SINGLE DRIVE

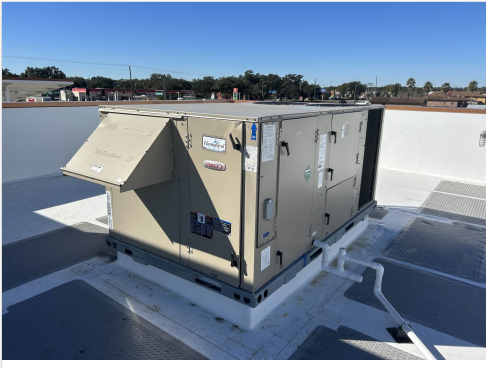
Unit Data - PHOTO LOG

Asset: RTU-3

AREA:RETAIL

Unit Data		
	Design	Actual
MFG	LENNOX	LENNOX
Serial Num	-	5624L01927
Model Num	LCT092H4E	LCT092H4EG2Y
Type	RTU	RTU
Configuration	VERTICAL	VERTICAL
Num OA Filters 1	-	1
OA Filter Size 1	-	23x14
Num Final Filter 1	-	4
Final Filter Size 1	-	20x25x2

Test Data		
	Design	Actual
SF CFM	3000	3009
SF RPM	-	1050
MOTOR RPM	-	1050
RA CFM	2700	2694
OA CFM	300	315
RL Voltage	-	215/215/215
RL Amperage	-	2.2/2.2/2.2
SF System SetPt	-	59%
OA Damper Position	-	29%
OA Damper Type	-	SINGLE BLADE

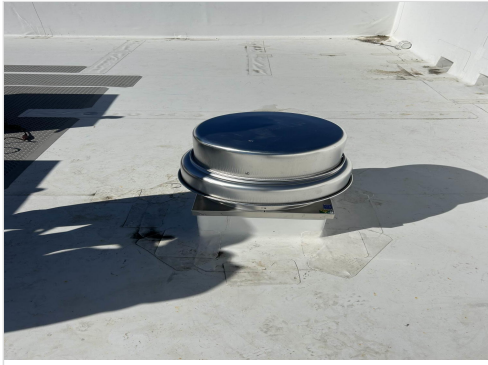
Unit Data - PHOTO LOG

Asset: EF-1

AREA:RESTROOMS/DELI

Unit Data		
	Design	Actual
MFG	GREENHECK	GREENHECK
Model Num	G-120	G-120-B-4-1-19-X
Serial Num	-	28179444
Type	DOWNBLAST	DOWNBLAST
Configuration	VERTICAL	VERTICAL

Test Data		
	Design	Actual
CFM	800	814
Fan RPM	-	DD
Fan Rotation	-	CW
Motor RPM	-	DD
System SetPt	-	SPEED CONTROLLER
Total ESP	0.25"	0.34"
Fan Inlet SP	-	-0.34"
Fan Discharge SP	-	ATM

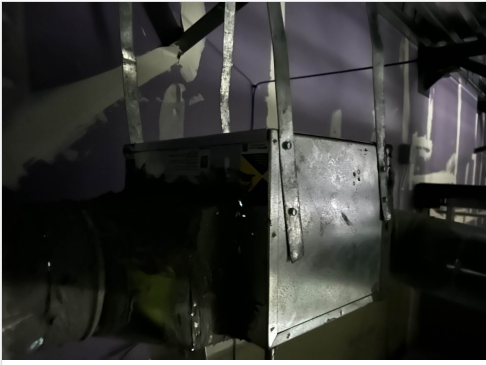
Unit Data - PHOTO LOG

Asset: EF-2

AREA: WATER SERVICE RM

Unit Data		
	Design	Actual
MFG	GREENHECK	GREENHECK
Model Num	CSP-B110	CSP-A110-QD
Serial Num	-	27995190
Type	INLINE	INLINE
Configuration	HORIZONTAL	HORIZONTAL

Test Data		
	Design	Actual
CFM	60	57
Fan RPM	584	DD
Fan Rotation	-	CORRECT
Motor RPM	-	DD
Suction ESP	-	-0.08"
Discharge ESP	-	0.04"
Total ESP	0.125"	0.12"
