Report: TAB REPORT
Function: Test, Adjust, & Balance
Date: 11/28/2022

11-28 FREDDY'S BETHLEHEM, GA (WINDER)

Project: 11-28 FREDDY'S BETHLEHEM, GA (WINDER)

Project Summary

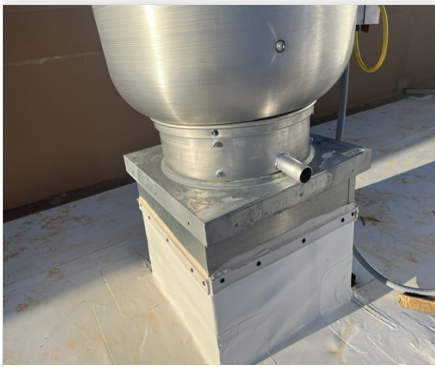
KEF-3.jpeg

Issue Name : 1. KEF-1, 2, and 3 not secured to curbs on roof.

Description : Kitchen Exhaust Fans are not secured to their curbs. Recommend fans are secured with screws.

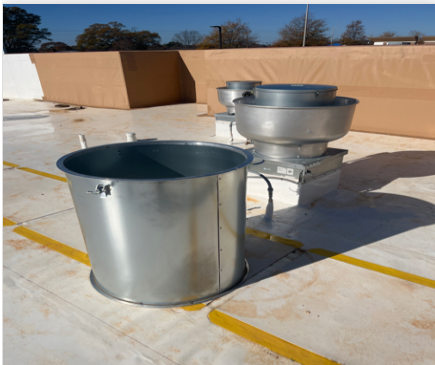
Windband.jpeg

Issue Name : 2. KEF-1 Wind Band Extension not installed.

Description : Wind band extension is not Mounted on KEF-1. Hardware to secure extension not found. Recommend extension is installed to preserve and keep the DOAS coil clean.

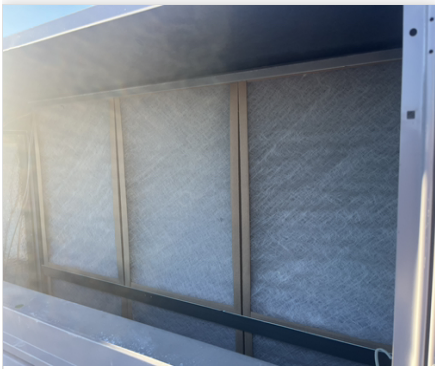
FinalFilters.jpeg

Issue Name : 3. RTU-1 Throwaway Final Filters Installed

Description : Throwaway construction final filters are installed. Recommend pleated final filters are installed.

General		
	Design	Actual
Fan Rotation Correct	-	YES
Unit Filters Clean	-	THROWAWAY FILTERS INSTALLED
Condensate Drain Installed	-	YES

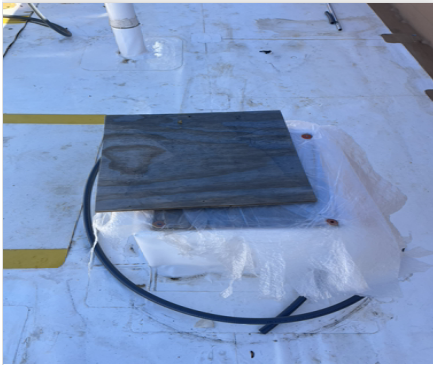
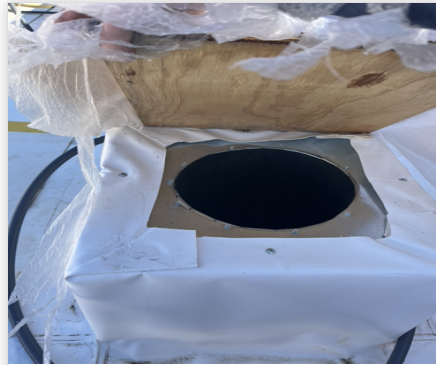
Curb.jpeg

Issue Name : 4. Exhaust curb not sealed.

Description : Original plans called for a roof mounted restroom exhaust fan. Curb and ductwork were installed, but fan was not. Ceiling fans installed in restrooms instead. Unsure if roof mounted fan will still be installed. Curb is not sealed. Plywood is unsecured, laying over roof opening. Recommend opening is sealed.

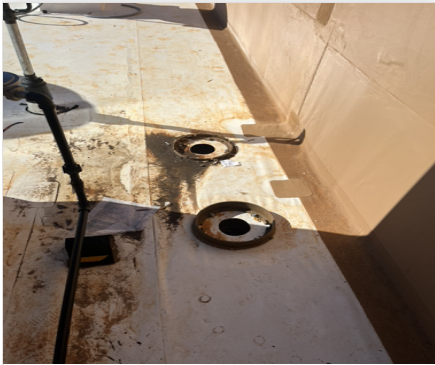
Drainguards.jpeg

Issue Name : 5. Roof drain guards not installed.

Description : Roof drain guards are not installed. Recommend they are installed to prevent drains from clogging with debris.

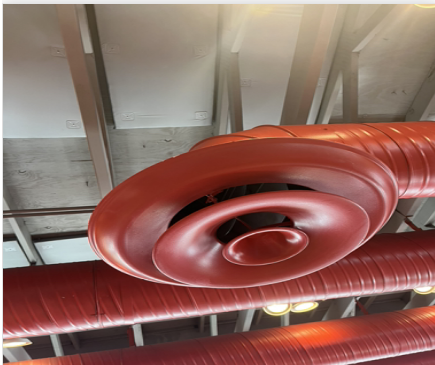
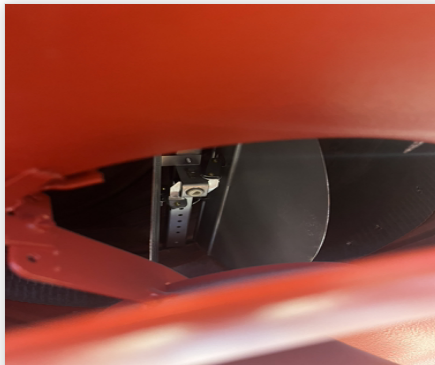
Diffuser.jpeg

Issue Name : 6. RTU-1 (Dining) Damper locations.

Description : RTU-1 dampers are installed in face of diffusers. Plans indicate dampers should be installed at the take-off from the main supply duct. As installed, dampers will create additional, unnecessary ventilation noise.
