**Report: TAB Report**  
**Function: Test, Adjust, & Balance**  
**Date: 12/10/2025**  
**Completed By: National TAB**

**PROJECT**  
**12-08-25 CHIPOTLE #5187 CAMAS, WA**

19530 SE BRADY RD

CAMAS, WA 98607

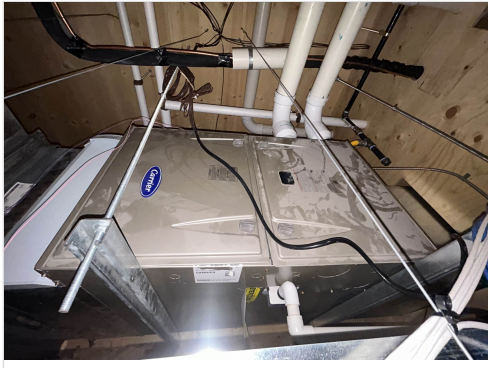
## Unit Data - PHOTO LOG

[1] FUR-1 & FUR-2 SERVE SAME DIFFUSER LINES. SUPPLY SHARE SAME DUCTS.

[2] FUR-1 & FUR-2 SHARE THE SAME RETURNS.

[3] FUR-1 & FUR-2 SHARE THE SAME OA DUCT
