Report: TAB Report
Function: Test, Adjust, & Balance
Date: 12/10/2025
Completed By: National TAB

PROJECT
12-08-25 CHIPOTLE #5187 CAMAS, WA

Project: 12-08-25 CHIPOTLE #5187 CAMAS, WA

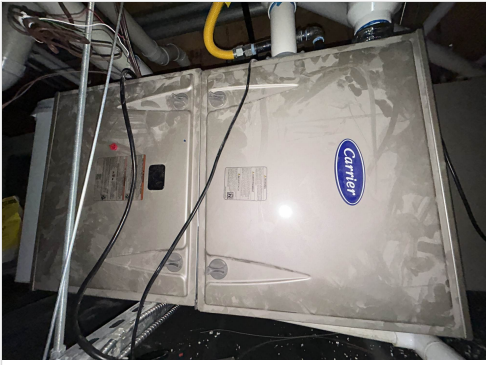
Unit Data - PHOTO LOG

Asset: FUR2

Test Data		
	Design	Actual
SF CFM	1450	3043
SF RPM	-	DD
RA CFM	950	2008
OA CFM	500	1035
RL Voltage	-	116
RL Amperage	-	10.2
SF Rotation	-	CCW
SF System SetPt	-	17
RA Damper Position	-	100%
Min OA Damper Position	-	20%
Min OA Damper Type	-	N/A
OA Enthalpy Setpt	-	N/A

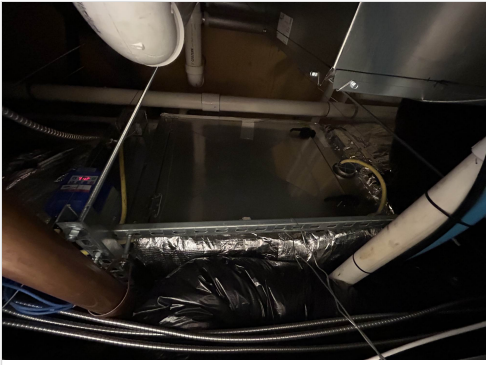
Unit Data - PHOTO LOG

Asset: EF1

Test Data		
	Design	Actual
CFM	2550	2609
Fan RPM	1805	45.2HZ
Fan Rotation	-	CCW
Motor RPM	-	45.2HZ
System SetPt	-	45.2HZ
RL Voltage	-	88@VFD
RL Amperage	-	9.3@VFD
Total ESP	1.20"	N/A
Fan Inlet SP	-	N/A
Fan Discharge SP	-	N/A
