**Report: TAB Report**  
**Function: Test, Adjust, & Balance**  
**Date: 12/10/2025**  
**Completed By: National TAB**

**PROJECT**  
**12-08-25 CHIPOTLE #5187 CAMAS, WA**

Project: 12-08-25 CHIPOTLE #5187 CAMAS, WA

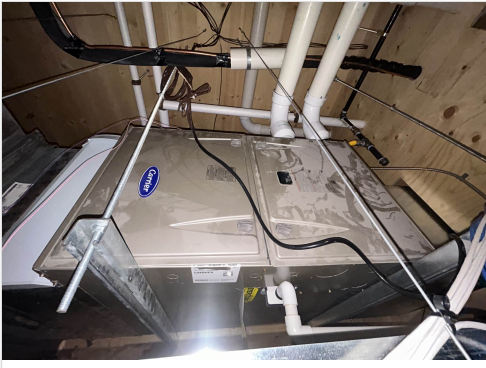
Asset: FUR1

Unit Data		
	Design	Actual
MFG	CARRIER	CARRIER
Serial Num	-	3625A45121
Model Num	59SC6A080M21-20	59SC6A080M21-20
Type	FUR	FUR
Configuration	VERTICAL	VERTICAL
Num Final Filter 1	-	1
Final Filter Size 1	-	25X21.25

Test Data		
	Design	Actual
SF CFM	1450	1521 [1]
SF RPM	-	DD
RA CFM	950	1004 [2]
OA CFM	500	517 [3]
RL Voltage	-	116
RL Amperage	-	10.3
SF Rotation	-	CCW
SF System SetPt	-	17
RA Damper Position	-	100%
Min OA Damper Position	-	25%
Min OA Damper Type	-	MANUAL
OA Enthalpy Setpt	-	N/A

- [1] FUR-1 & FUR-2 SERVE SAME DIFFUSER LINES. SUPPLY SHARE SAME DUCTS.
- [2] FUR-1 & FUR-2 SHARE THE SAME RETURNS.
- [3] FUR-1 & FUR-2 SHARE THE SAME OA DUCT

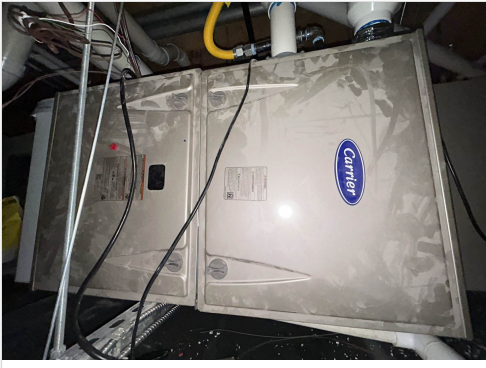
Asset: FUR2

Unit Data		
	Design	Actual
MFG	CARRIER	CARRIER
Serial Num	-	3625A45109
Model Num	59SC6A080M21-20	59SC6A080M21-20
Type	FUR	FUR
Configuration	VERTICAL	VERTICAL
Num Final Filter 1	-	1
Final Filter Size 1	-	25X21.25

Test Data		
	Design	Actual
SF CFM	1450	1521
SF RPM	-	DD
RA CFM	950	1004
OA CFM	500	517
RL Voltage	-	116
RL Amperage	-	10.2
SF Rotation	-	CCW
SF System SetPt	-	17
RA Damper Position	-	100%
Min OA Damper Position	-	20%
Min OA Damper Type	-	N/A
OA Enthalpy Setpt	-	N/A

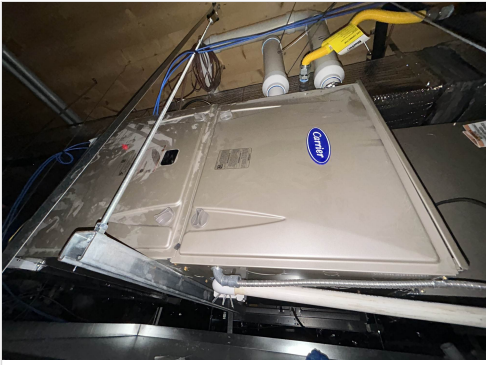
Asset: FUR3

Unit Data		
	Design	Actual
MFG	CARRIER	CARRIER
Serial Num	-	NL
Model Num	59SC6A080M21-20	59SC6A080M21-20
Type	FUR	FUR
Configuration	VERTICAL	VERTICAL
Num Final Filter 1	-	1
Final Filter Size 1	-	25X21.25

Test Data		
	Design	Actual
SF CFM	1600	1604
SF RPM	-	DD
RA CFM	1350	1366
OA CFM	250	238
RL Voltage	-	116
RL Amperage	-	10.7
SF Rotation	-	CCW
SF System SetPt	-	17
RA Damper Position	-	100%
Min OA Damper Position	-	20%
Min OA Damper Type	-	MANUAL

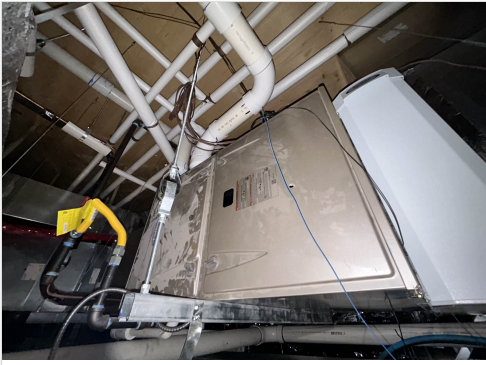
Asset: FUR4

Unit Data		
	Design	Actual
MFG	CARRIER	CARRIER
Serial Num	-	3625A45101
Model Num	59SC6A080M21-20	59SC6A080M21-20
Type	FUR	FUR
Configuration	VERTICAL	VERTICAL
Num Final Filter 1	-	1
Final Filter Size 1	-	25X21.25

Test Data		
	Design	Actual
SF CFM	1600	1515
SF RPM	-	DD
RA CFM	1350	1275
OA CFM	250	240
RL Voltage	-	116
RL Amperage	-	10.7
SF Rotation	-	CCW
SF System SetPt	-	17
RA Damper Position	-	100%
Min OA Damper Position	-	20%
Min OA Damper Type	-	MANUAL
OA Enthalpy Setpt	-	N/A

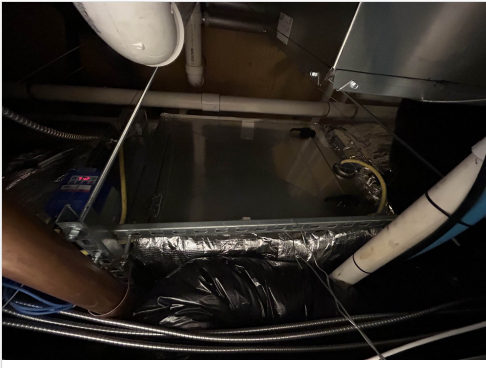
Asset: EF1

Unit Data		
	Design	Actual
MFG	CAPTIVEAIRE	CAPTIVEAIRE
Model Num	SIF15DD	SIF15DD
Serial Num	-	6887814
Type	UPBLAST	INLINE
Configuration	VERTICAL	VERTICAL

Test Data		
	Design	Actual
CFM	2550	2609
Fan RPM	1805	45.2HZ
Fan Rotation	-	CCW
Motor RPM	-	45.2HZ
System SetPt	-	45.2HZ
RL Voltage	-	88@VFD
RL Amperage	-	9.3@VFD
Total ESP	1.20"	N/A
Fan Inlet SP	-	N/A
Fan Discharge SP	-	N/A

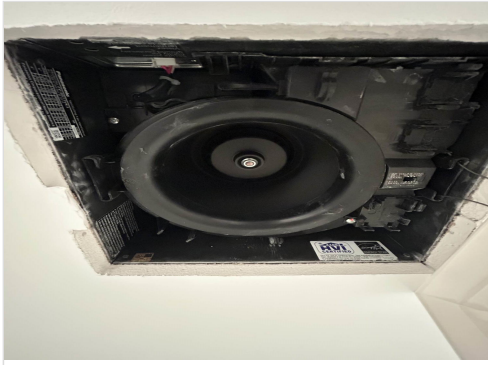
Asset: EF2

Unit Data		
	Design	Actual
MFG	WHISPERGREEN	PANASONIC
Model Num	FV-0511VK2	FV-0511VK3
Serial Num	-	50219
Type	INLINE	CEILING
Configuration	VERTICAL	VERTICAL

Test Data		
	Design	Actual
CFM	80	82
Fan RPM	-	DD
Fan Rotation	-	CCW
Motor RPM	-	DD
System SetPt	-	100CFM

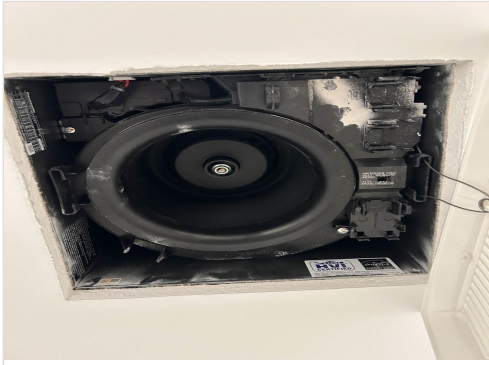
Asset: EF3

Unit Data		
	Design	Actual
MFG	WHISPERGREEN	PANASONIC
Model Num	FV-0511VK2	FV-0511VK3
Serial Num	-	50219
Type	INLINE	CEILING
Configuration	VERTICAL	VERTICAL

Test Data		
	Design	Actual
CFM	80	88
Fan RPM	-	DD
Fan Rotation	-	CCW
Motor RPM	-	DD
System SetPt	-	100CFM

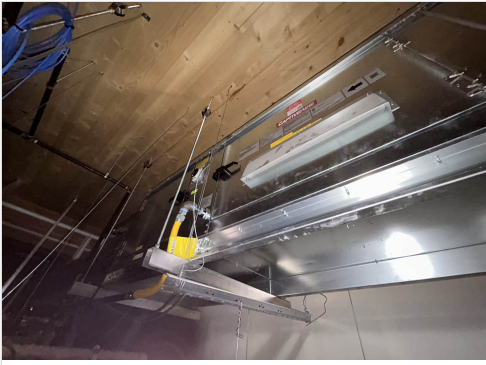
Asset: MAU1

Unit Data		
	Design	Actual
MFG	CAPTIVEAIRE	CAPTIVEAIRE
Model Num	A1-D.250-15D	A1-D.250-15D
Serial Num	-	6887814
Type	MAU	MAU
Configuration	VERTICAL	VERTICAL

Test Data		
	Design	Actual
CFM	1300	1402
SF RPM	1574	1711
Motor RPM	-	1711
SF System SetPt	-	59HZ
RL Voltage	-	174@VFD
RL Amperage	-	2.4@VFD
Total ESP	-	N/A
Fan Discharge SP	-	N/A

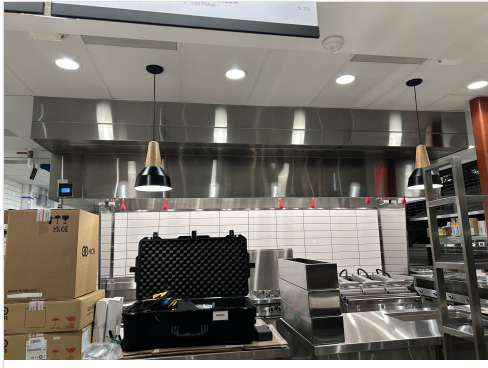
Asset: HD1

Unit Data		
	Design	Actual
MFG	CAPTIVEAIRE	CAPTIVEAIRE
Model Num	5424 ND-2-ACPSP-F	5424 ND-2-ACPSP-F
Job / Serial Num	-	6887814
Type	TYPE I CANOPY	TYPE I CANOPY
Hood length	153"	153"
Hood Width	54"	54"
Supply Plenum Type	-	ACPSP
Supply Plenum Width	9"	9"
Supply Plenum Length	165"	165"

Test Data Exhaust		
	Design	Actual
Filter Type	CAPTRATE SOLO FILTER	CAPTRATE SOLO FILTER
Filter Size 1	16X16	16X16
Filter Qty 1	9	9
Filter AK factor size 1	1.62	1.62
Filter Total AK Area	14.58	14.58
Filter1 FPM	-	160
Filter2 FPM	-	168
Filter3 FPM	-	185
Filter4 FPM	-	203
Filter5 FPM	-	206
Filter6 FPM	-	191
Filter7 FPM	-	170
Filter8 FPM	-	169
Filter9 FPM	-	164
Filter Ave FPM(corr)	-	179
CFM	2550	2609
