**Report: Renew
Date: 8/21/2021**

FREDDY'S - NORTH OAK TRAFFICWAY - RENEW 2FB (4)

5150 N. Oak Trafficway
Kansas City, MO 64118

Project Summary

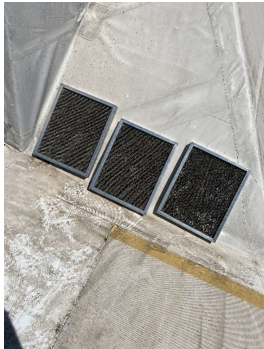
MAU
DIRTY OUTSIDE AIR FILTERS

MAU: The intake filters had slight dirt accumulation. They were washed.

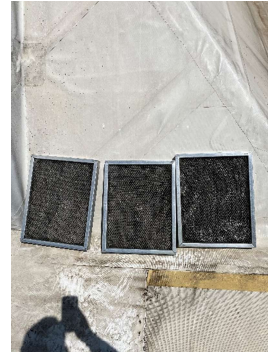
MAU
CLEAN OUTSIDE AIR FILTERS

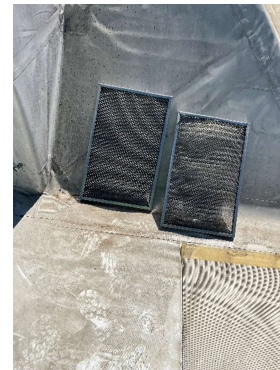
RTU-1 (DINING)
CLEAN OUTSIDE AIR FILTERS

RTUs: There evaporator coil was rinsed off and cleaned. During warmer months a self-cleaning chemical is sprayed on the evaporator. The outside air filters were rinsed off to remove any dirty, so the unit stays at the designated outside air set point. Based on static pressures, amps, and fan rpm it shows that the total supply has not changed since the last test and balance.

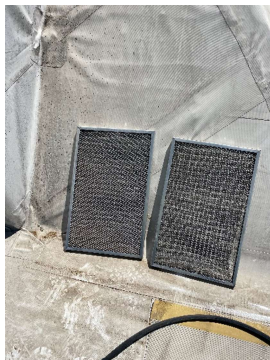
RTU-2 (DINING)
DIRTY OUTSIDE AIR FILTERS

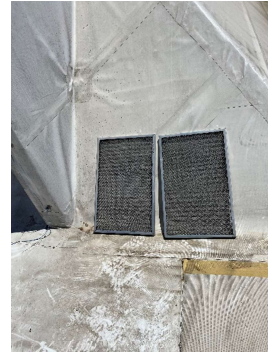
RTU-3 (KITCHEN)
CLEAN OUTSIDE AIR FILTERS

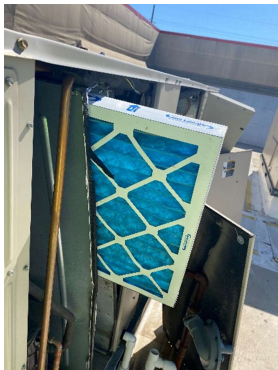
RTU-1 (DINING)
DIRTY EVAPORATOR FILTERS

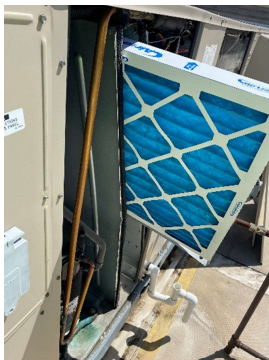
RTU-2 (DINING)
DIRTY EVAPORATOR FILTERS

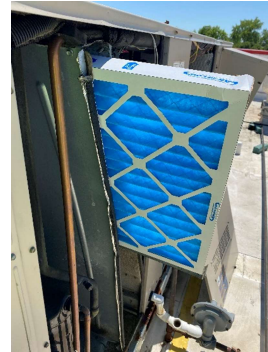
RTU-3 (KITCHEN)
DIRTY EVAPORATOR FILTERS

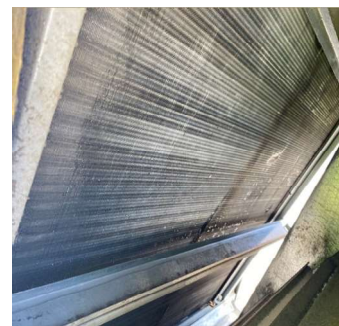
RTU-2 (DINING)
CLEAN EVAPORATOR

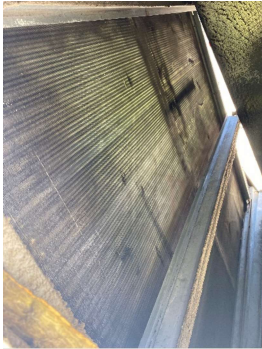
RTU-3 (KITCHEN)
DIRTY EVAPORATOR

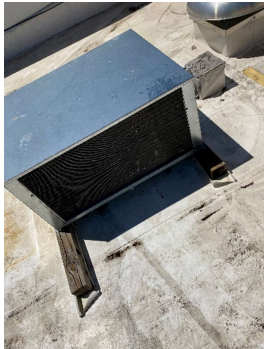
DXC-1 (WALK-IN COOLER)
DIRTY CONDENSER

Food equipment condensers were cleaned. The Walk-In evaporator were cleaned. All equipment is in good health unless stated in the Recommendation List.

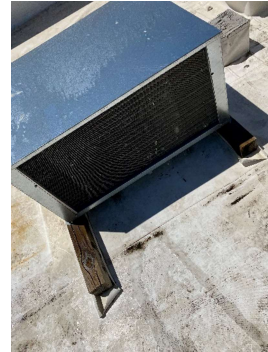
DXC-1 (WALK-IN COOLER)
CLEAN CONDENSER
