Report: TAB Report
Function: Test, Adjust, & Balance
Date: 01/21/2026
Completed By: National TAB

01-12-26 Wawa #7402 Indianapolis, IN

Project: 01-12-26 Wawa #7402 Indianapolis, IN

Section	Page #
Summary	3
Remarks	4
Balance Schdule	10
Checklists	11
AHU/RTU	22
FAN - Exhaust	28
GRD Layout	33

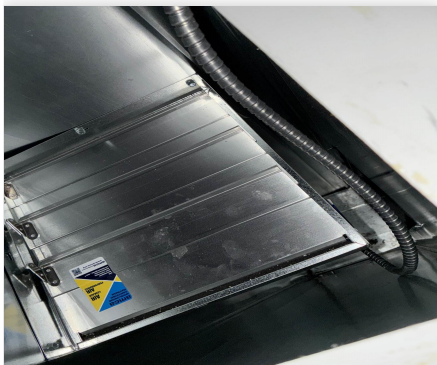
Issue Name : EF-1 BACKDRAFT
Description : EF-1 backdraft damper too small for ductwork. This impedes TAB as it reduces total airflow. Potentially related to over-amp issue.
Created By : National TAB **Assigned To :** National TAB - Noah Stafford
Status : Open
Priority : Urgent **Asset Tag :**
Originated Date : 01/12/2026 - Noah Stafford - National TAB
