**Report: TAB Report**  
**Function: Test, Adjust, & Balance**  
**Date: 01/21/2026**  
**Completed By: National TAB**

**03-30-26 Wawa #7402 Indianapolis, IN**

Project: 03-30-26 Wawa #7402 Indianapolis, IN

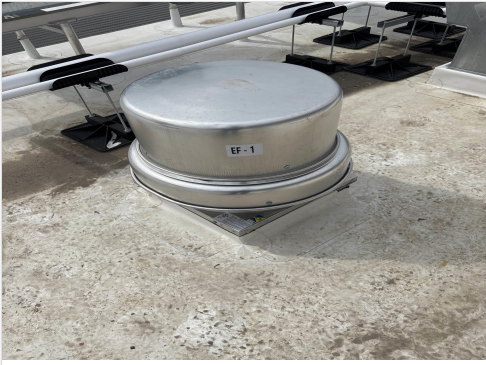
## Unit Data - PHOTO LOG

Asset: EF1

AREA:RESTROOM

Unit Data		
	Design	Actual
MFG	GREENHECK	GREENHECK
Model Num	GB-120-4	GB-098-6
Serial Num	-	25406186
Type	DOWNBLAST	DOWNBLAST
Configuration	VERTICAL	VERTICAL

Test Data		
	Design	Actual
CFM	375	357
Fan Rotation	-	CW
System SetPt	-	5 TURNS OPEN
RL Voltage	-	123
RL Amperage	-	3.7
Total ESP	0.38"	0.30"
Fan Inlet SP	-	-0.30"
Fan Discharge SP	-	ATM
