Report: TAB Report
Function: Test, Adjust, & Balance
Date: 01/21/2026
Completed By: National TAB

03-30-26 Wawa #7402 Indianapolis, IN

Project: 03-30-26 Wawa #7402 Indianapolis, IN

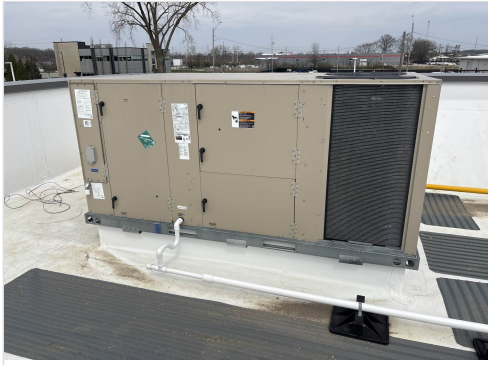
Unit Data - PHOTO LOG

Asset: RTU1

AREA:FOOD SERVICE

Unit Data		
	Design	Actual
MFG	LENNOX	LENNOX
Serial Num	-	5624J00864
Model Num	LCT150H4E	LCT150H4E
Type	RTU	RTU
Configuration	VERTICAL	VERTICAL
Num OA Filters 1	-	2
OA Filter Size 1	-	16"x24"
Num Final Filter 1	-	4
Final Filter Size 1	-	20"x25"x2"

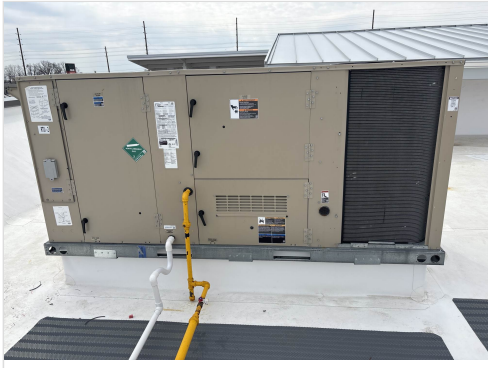
Unit Data - PHOTO LOG

Asset: RTU2

AREA:RETAIL

Unit Data		
	Design	Actual
MFG	LENNOX	LENNOX
Serial Num	-	5624K03720
Model Num	LGT102H4E	LGT102H4E
Type	RTU	RTU
Configuration	VERTICAL	VERTICAL
Num OA Filters 1	-	2
OA Filter Size 1	-	15"x24"
Num Final Filter 1	-	4
Final Filter Size 1	-	20"x25"x2"

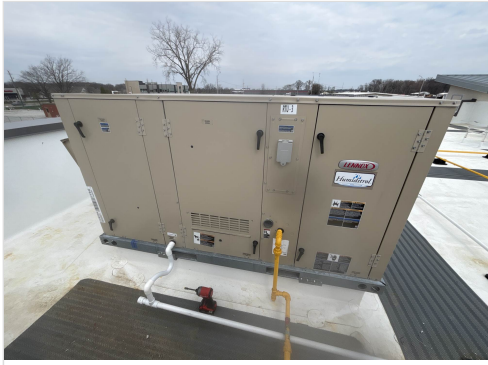
Unit Data - PHOTO LOG

Asset: RTU3

AREA:FOH

Unit Data		
	Design	Actual
MFG	LENNOX	LENNOX
Serial Num	-	5624L02271
Model Num	LGT072H4E	LGT072H4E
Type	RTU	RTU
Configuration	VERTICAL	VERTICAL
Num OA Filters 1	-	1
OA Filter Size 1	-	30"x15"
Num Final Filter 1	-	4
Final Filter Size 1	-	20"x20"x2"

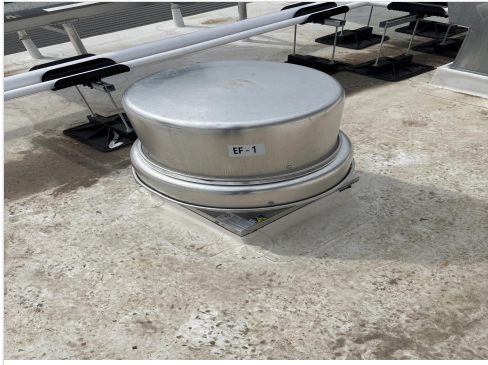
Unit Data - PHOTO LOG

Asset: EF1

AREA:RESTROOM

Unit Data		
	Design	Actual
MFG	GREENHECK	GREENHECK
Model Num	GB-120-4	GB-098-6
Serial Num	-	25406186
Type	DOWNBLAST	DOWNBLAST
Configuration	VERTICAL	VERTICAL

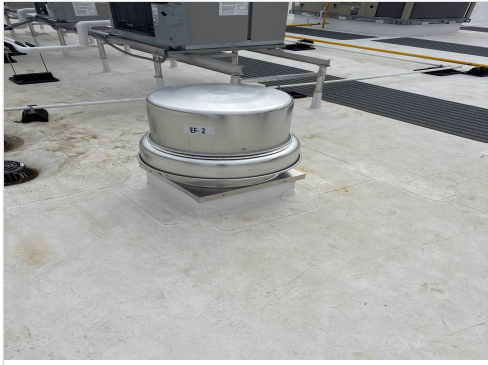
Unit Data - PHOTO LOG

Asset: EF2

AREA:BOH

Unit Data		
	Design	Actual
MFG	GREENHECK	GREENHECK
Model Num	GB-120-4	GB-120-4-VG-1-19-X
Serial Num	-	28572954
Type	DOWNBLAST	DOWNBLAST
Configuration	VERTICAL	VERTICAL
