Report: TAB Report
Function: Test, Adjust, & Balance
Date: 01/21/2026
Completed By: National TAB

03-30-26 Wawa #7402 Indianapolis, IN

Project: 03-30-26 Wawa #7402 Indianapolis, IN

Project: 03-30-26 Wawa #7402 Indianapolis, IN
Function: Test, Adjust, & Balance

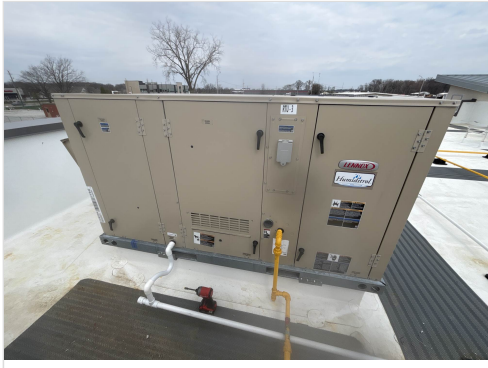
Unit Data - PHOTO LOG

Asset: RTU3

AREA:FOH

Unit Data		
	Design	Actual
MFG	LENNOX	LENNOX
Serial Num	-	5624L02271
Model Num	LGT072H4E	LGT072H4E
Type	RTU	RTU
Configuration	VERTICAL	VERTICAL
Num OA Filters 1	-	1
OA Filter Size 1	-	30"x15"
Num Final Filter 1	-	4
Final Filter Size 1	-	20"x20"x2"

Test Data		
	Design	Actual
SF CFM	2400	2428
RA CFM	1950	2005
OA CFM	450	423
RL Voltage	-	215/215/214V
RL Amperage	-	3.6/3.6/3.5A
SF System SetPt	-	92%
OA Damper Position	-	18%
OA Damper Type	-	ECONOMIZER
