**Report: TAB Report**  
**Function: Test, Adjust, & Balance**  
**Date: 01/21/2026**  
**Completed By: National TAB**

**01-12-26 Wawa #7402 Indianapolis, IN**

Project: 01-12-26 Wawa #7402 Indianapolis, IN

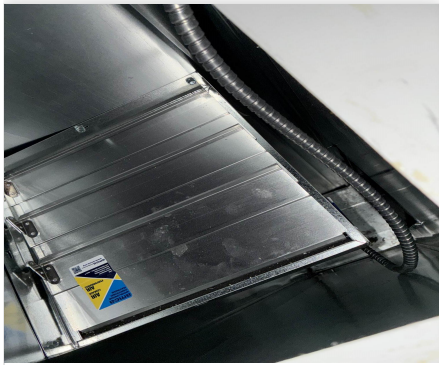
**Issue Name :** EF-1 BACKDRAFT  
**Description :** EF-1 backdraft damper too small for ductwork. This impedes TAB as it reduces total airflow. Potentially related to over-amp issue.  
**Created By :** National TAB                      **Assigned To :** National TAB - Noah Stafford  
**Status :** Open  
**Priority :** Urgent                                      **Asset Tag :**  
**Originated Date :** 01/12/2026 - Noah Stafford - National TAB

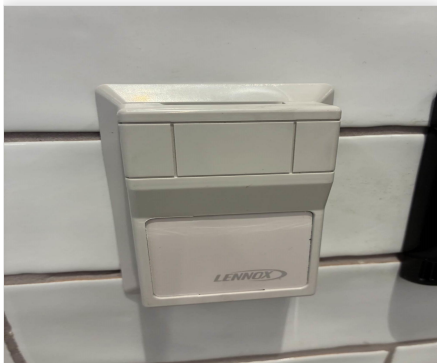
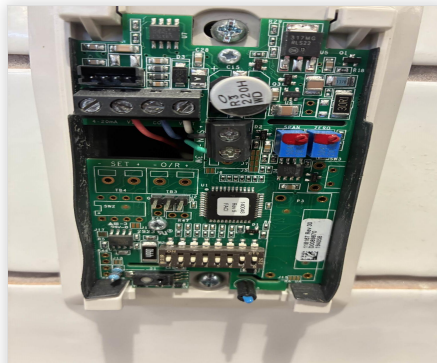
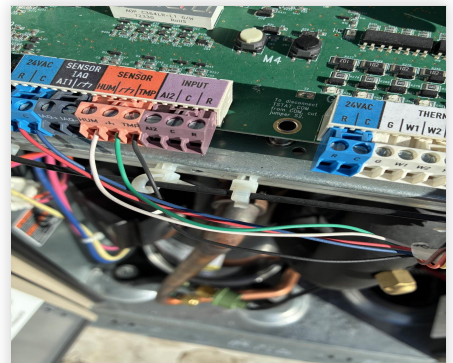
**Issue Name :** RTU SENSOR WIRING  
**Description :** RTUs use only thermostat wiring for the sensors. Design plans call for twisted pair shielded cables containing 18AWG minimum. This issue does not prevent TAB.  
**Created By :** National TAB      **Assigned To :** National TAB - Noah Stafford  
**Status :** Open  
**Priority :** Medium      **Asset Tag :**  
**Originated Date :** 01/12/2026 - Noah Stafford - National TAB

**2 conductor shielded cable has one wire landed to Vin, one to GND, and the shield wire is not connected.** Fail

Different wire type used

Shielded cable not used
