**Report: PRELIM**

**Function: Test, Adjust, & Balance**

**Date: 12/18/2023**

## 12-11-23 FORT LEE RESTAURANT - FORT LEE, NJ

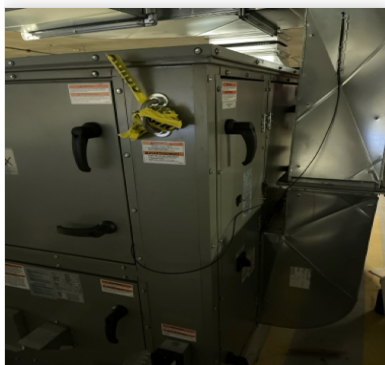
**Dischargesensor  
12/13/2023**

**Issue Name :** DOAS: Discharge air temp sensor  
**Description :** Discharge air temperature sensor is not located in the discharge ductwork.  
**Created By :** National TAB                      **Assigned To :** National TAB - Tyler Youells  
**Status :** Open  
**Priority :**                                              **Asset Tag :**  
**Originated Date :** 12/13/2023 - Tyler Youells - National TAB

- **12/13/2023 National TAB - Tyler Youells**
  - Mechanical installed temp sensor. Wiring needs to be finished installed. Currently wiring routes through control access door

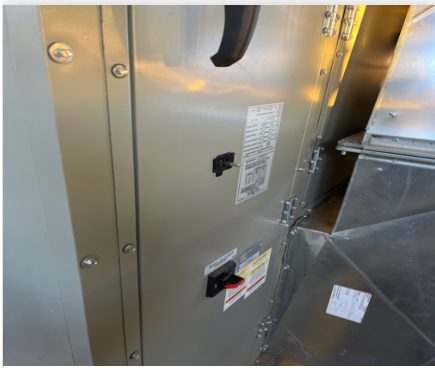
**Missingswitch**  
**12/13/2023**

**Issue Name :** DOAS: Disconnect Switch  
**Description :** Doas is missing the switch on the main disconnect  
**Created By :** National TAB                      **Assigned To :** National TAB - Tyler Youells  
**Status :** Open  
**Priority :**                                              **Asset Tag :**  
**Originated Date :** 12/13/2023 - Tyler Youells - National TAB

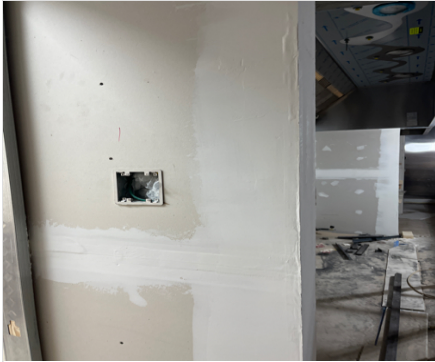
**Hmilocation**  
**12/13/2023**

**Issue Name :** HOOD: HMI touchscreen  
**Description :** Make sure HMI touchscreen is on-site and can be plugged in for TAB and startup Monday.  
**Created By :** National TAB                      **Assigned To :** National TAB - Tyler Youells  
**Status :** Open  
**Priority :**                                              **Asset Tag :**  
**Originated Date :** 12/13/2023 - Tyler Youells - National TAB

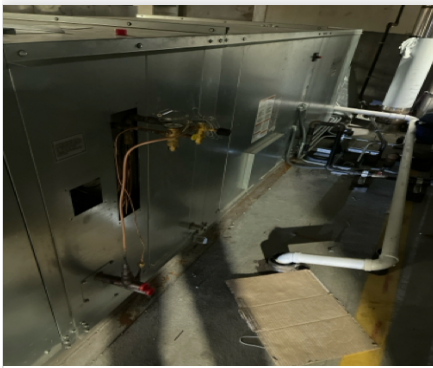
**Coolinglines**  
**12/13/2023**

**Issue Name :** MUA: Cooling  
**Description :** Cooling lines not yet connected.  
**Created By :** National TAB                      **Assigned To :** National TAB - Tyler Youells  
**Status :** Open  
**Priority :**                                              **Asset Tag :**  
**Originated Date :** 12/13/2023 - Tyler Youells - National TAB

- **12/18/2023    National TAB - Tyler Youells**
  - Mechanical installed the refrigerant lines and filled the system. There are still no control wires connecting the condenser to the doas

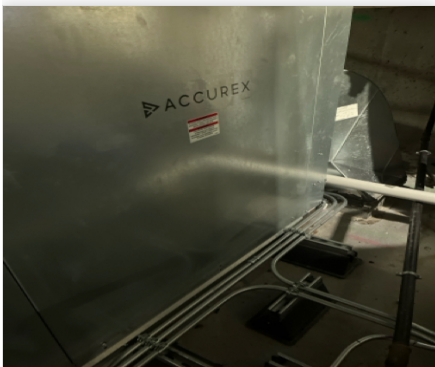
**Doornotaccessible  
12/13/2023**

**Issue Name :** MUA: Motor access door  
**Description :** Motor access door is not able to be removed. Conduit is blocking the door from lifting out. There is a belt in this compartment that will need service eventually. Recommend making door accessible  
**Created By :** National TAB                      **Assigned To :** National TAB - Tyler Youells  
**Status :** Open  
**Priority :**                                              **Asset Tag :**  
**Originated Date :** 12/13/2023 - Tyler Youells - National TAB

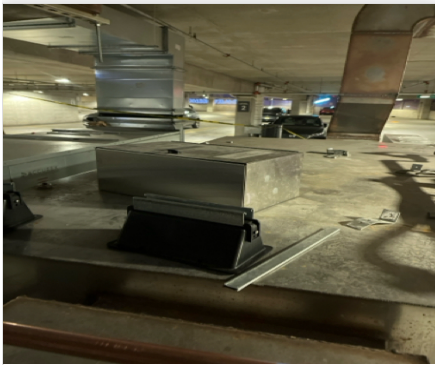
**Controlbox**  
12/13/2023

**Issue Name :** PCU- Wash system not installed  
**Description :** Wash system for static filters has not yet been installed. Control box not landed, piping(not fully) detergent bottle, not yet installed.  
**Created By :** National TAB                      **Assigned To :** National TAB - Tyler Youells  
**Status :** Open  
**Priority :**                                              **Asset Tag :**  
**Originated Date :** 12/13/2023 - Tyler Youells - National TAB
