**Report: TAB Report**  
**Function: Test, Adjust, & Balance**  
**Date: 08/06/2025**  
**Completed By: National TAB**

**PROJECT**  
**08-04-25 CAVA KILDEER, IL**

20413 NORTH RAND ROAD

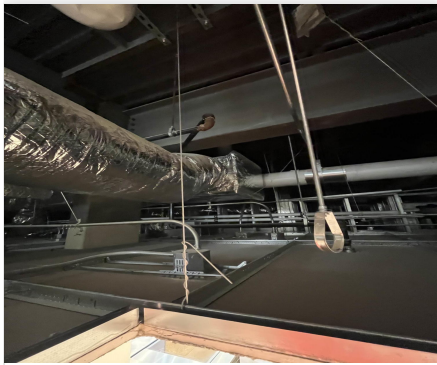
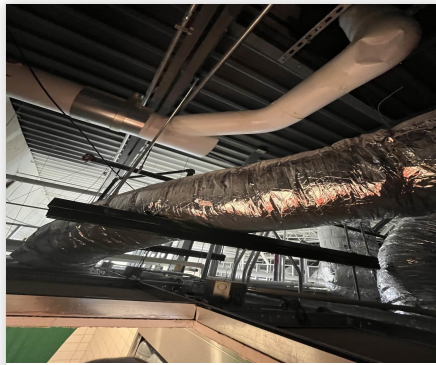
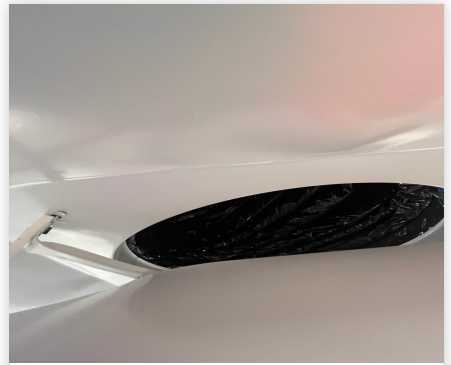
**Issue Name :** Diffuser 1-6 Inaccessible damper  
**Description :** Diffuser 1-6 is high on flow (left of hood control panel) at 534/400CFM. I am unable to reduce the airflow to this diffuser the access panel above hard ceiling is too far away from takeoff where damper is located. The rest of the diffusers on this unit have been balanced to design airflow.  
**Created By :** National TAB                      **Assigned To :** National TAB - Dylan Crisman  
**Status :** Open  
**Priority :** High                                      **Asset Tag :**  
**Originated Date :** 08/05/2025 - Dylan Crisman - National TAB

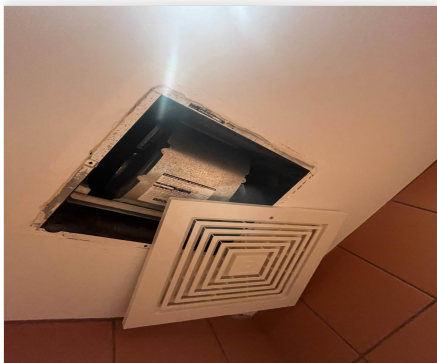
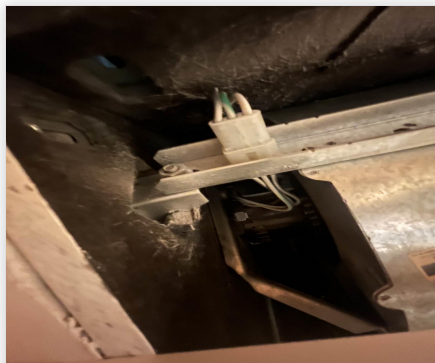
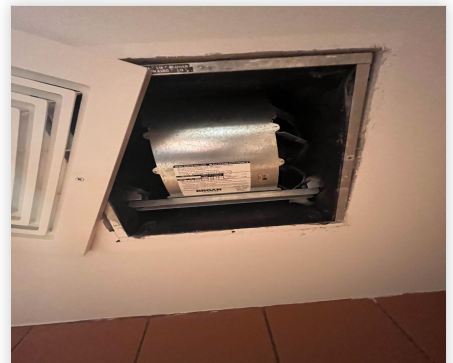
**Issue Name :** EF-2/EF-3 high on flow  
**Description :** EF-2/EF-3 are high on flow @ EF-2 97/75 EF-3 101/75 fans are direct wired without a speed controller installed. Unable to decrease speed of fan to low CFM to design airflow.  
**Created By :** National TAB                      **Assigned To :** National TAB - Dylan Crisman  
**Status :** Open  
**Priority :** High                                      **Asset Tag :**  
**Originated Date :** 08/04/2025 - Dylan Crisman - National TAB

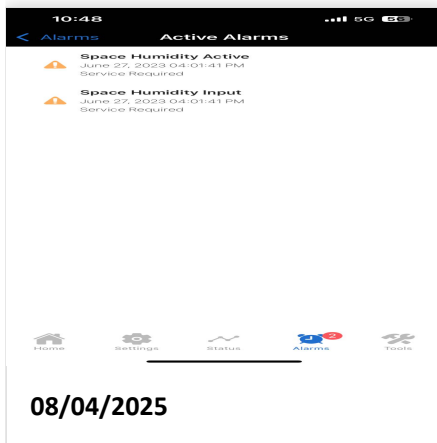
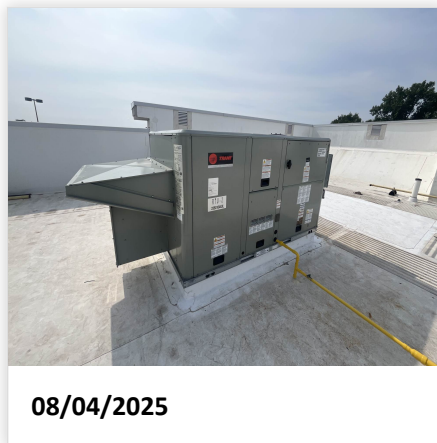
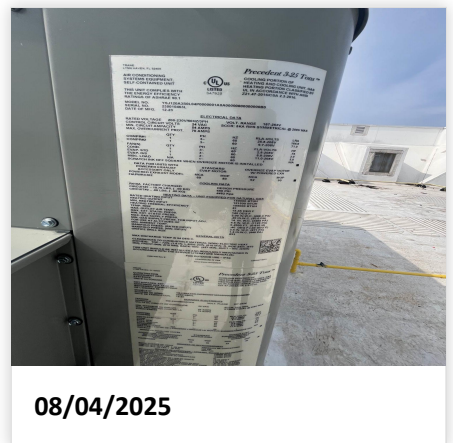
**Issue Name :** RTU-1 alarm  
**Description :** Alarm is present on RTU-1 showing “space humidity active” and “space humidity input” Recommend mechanical checking wiring and landings at RTU as well as space sensor to confirm proper termination.  
**Created By :** National TAB                      **Assigned To :** National TAB - Dylan Crisman  
**Status :** Open  
**Priority :** High                                      **Asset Tag :**  
**Originated Date :** 08/04/2025 - Dylan Crisman - National TAB

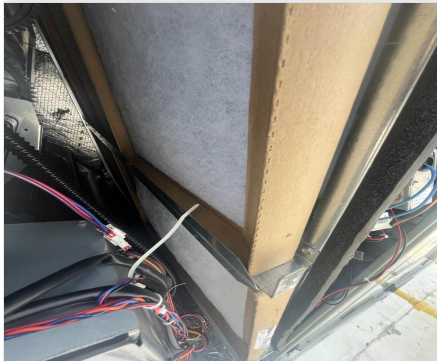
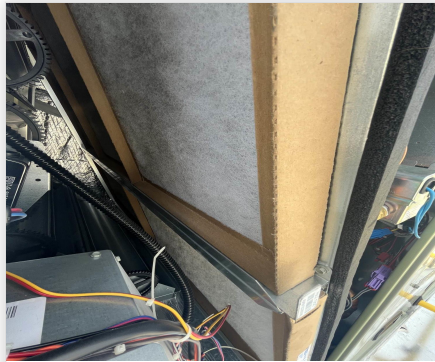
**Issue Name :** RTU-1/RTU-2 final filters  
**Description :** RTU-1/RTU-2 have construction filters installed. Recommend replacing with correct size minimum MERV 8 rated pleated filters.  
**Created By :** National TAB                      **Assigned To :** National TAB - Dylan Crisman  
**Status :** Open  
**Priority :** Low                                      **Asset Tag :**  
**Originated Date :** 08/04/2025 - Dylan Crisman - National TAB

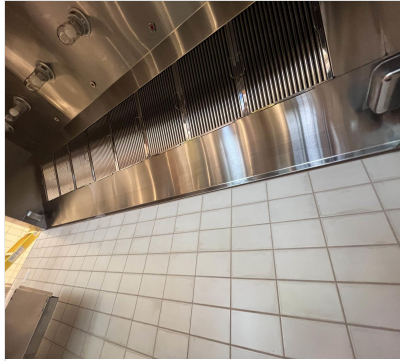
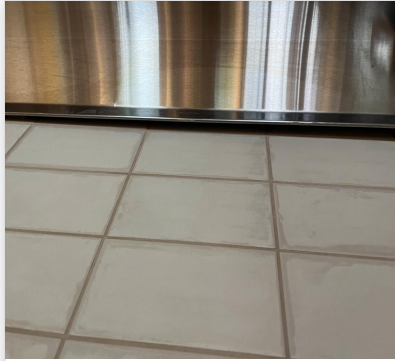
Caulk is applied (less than 1/8" thick) from the hood against all wall surfaces or between connecting side to side hoods to prevent grease accumulation inside any crevice.

Back of hood connection to wall is not caulked.

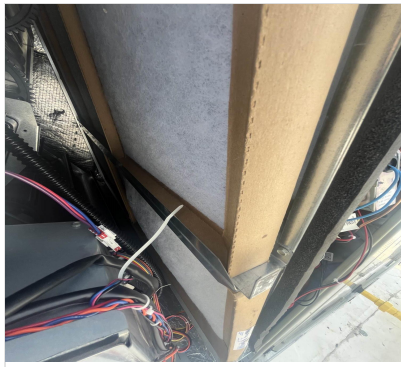
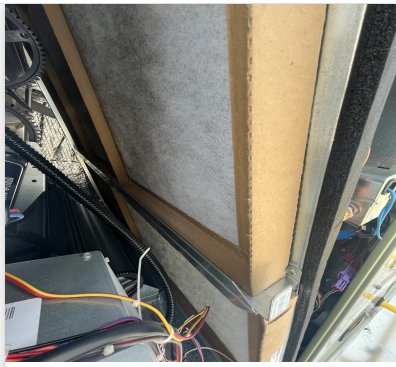
Evaporator coil filters are properly installed with specified MERV rating

Construction filters installed, Issue Created.
