Report: TAB Report
Function: Test, Adjust, & Balance
Date: 6/24/2022

PROJECT
WENDY'S - BROKEN ARROW, OK

Project: WENDY'S - BROKEN ARROW, OK

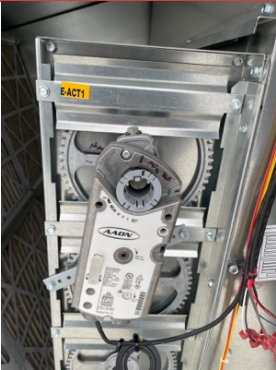
RTU1 MINIMUM DAMPER POSITION

Notes:[1] ECONOMIZER DID NOT RESPOND TO INPUT FROM CONTROL. MANUALLY SET MINIMUM. SEE PICTURE.

Description : Economizers do not function as intended and cannot currently be set at the thermostat. Manually set outside air and physically marked damper position. Once repaired recommend setting to the permanently marked position.

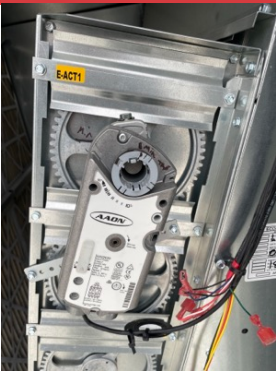
RTU2 MINIMUM DAMPER POSITION

Notes:[1] ECONOMIZER DID NOT RESPOND TO INPUT FROM CONTROL. MANUALLY SET MINIMUM. SEE PICTURE.

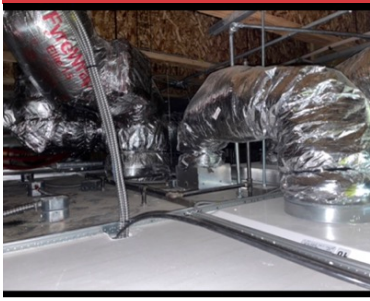
EXTRA EXHAUST FROM HD2 ABOVE CEILING

Notes: CAPTURE JET PRESSURE 0.25" EXHAUST COMING FROM EXTRA DIFFUSER OFF HOOD -50CFM

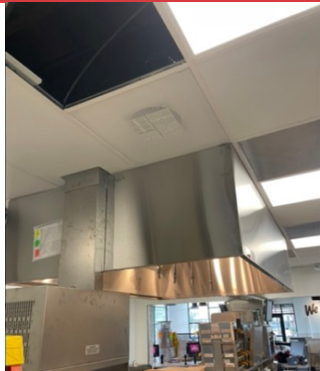
EXTRA EXHAUST FROM HD2 BELOW CEILING
