**Report: FINAL TAB REPORT
Function: Test, Adjust, & Balance
Date: 11/04/2022**

**PROJECT
10-31 SWEETGREEN - SCHAUMBURG, IL**

Project: 10-31 SWEETGREEN - SCHAUMBURG, IL

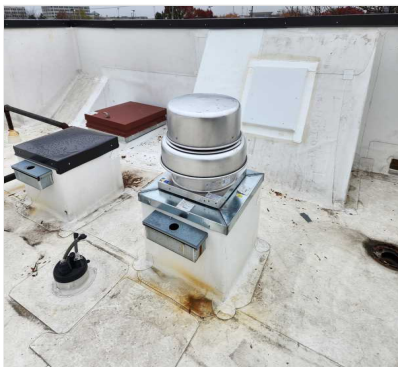
EF-1

Test Data		
	Design	Actual
CFM	1020	525
Fan RPM	-	1050
Fan Rotation	-	CCW
Motor RPM	-	1050
System SetPt	-	6
RL Voltage	-	NA
RL Amperage	-	1.46/1.43
Total ESP	0.8"	0.31"
Fan Inlet SP	-	-0.31"
Fan Discharge SP	-	ATM
