**Report: FINAL TAB REPORT**  
**Function: Test, Adjust, & Balance**  
**Date: 11/04/2022**

**PROJECT**  
**10-31 SWEETGREEN - SCHAUMBURG, IL**

Project: 10-31 SWEETGREEN - SCHAUMBURG, IL

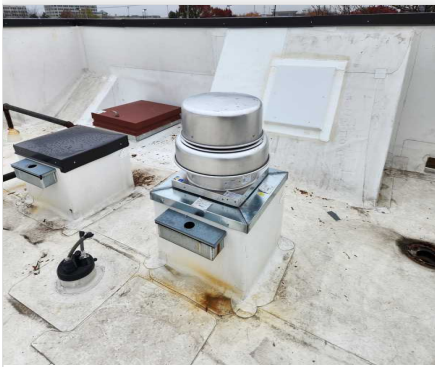
20221031\_143531.jpeg

**Issue Name :** EF-1  
**Description :** EF-1 IS NOT RUNNING. SHOWN ON DRAWINGS AS SERVING A HOOD BUT SERVES GRILLE ABOVE THE OVEN.  
**Created By :** National TAB **Assigned To :** National TAB - Will Turnbough  
**Status :** Open  
**Originated Date :** 10/31/2022 - Zack Eismin - National TAB

- **11/08/2022 National TAB - Will Turnbough**
  - PER GC THE FAN GRINDING HAS BEEN RESOLVED AND THE FAN WAS SET TO MAXIMUM SPEED. AIRFLOW WAS NOT REMEASURED BUT BASED ON A FAN LAW CALCULATION THE AIRFLOW IS 875 CFM (86% OF DESIGN)
- **11/03/2022 National TAB - Zack Eismin**
  - FAN WAS POWERED ON. UNIT HAS A SPEED DIAL INSTALLED BUT CANNOT REACH DESIGN BECAUSE EXHAUST FAN MAKES A LOUD GRINDING NOISE WHEN SET ABOVE 6 ON SPEED DIAL. AIRFLOW IS 525 CFM OUT OF 1020 CFM.

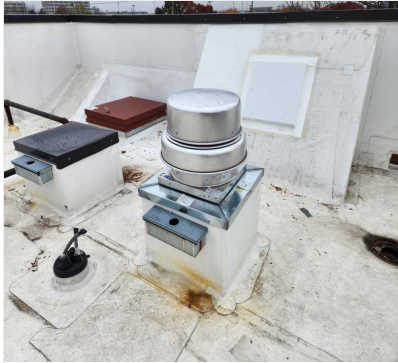
EF-1

Notes: SHOWN ON DRAWING AS A HOOD. BUT A GRILLE ABOVE OVEN IS INSTALLED INSTEAD. FAN SPEED IS MAXIMIZED AND UNABLE TO INCREASE AIRFLOW FURTHER. GC RESPONDED ON 11/7 THAT THE ISSUE WAS RESOLVED. AIRFLOW WAS NOT REMEASURED BUT BASED ON FAN LAW AIRFLOW IS 875 CFM.

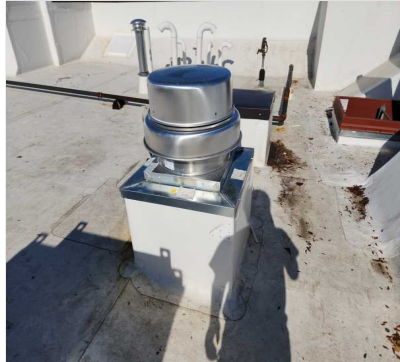
20221101\_121631.jpg

Identify where the exhaust air is discharged and take pictures

Are there any outside air intakes nearby that would be able to re-entrain the exhaust smoke? Take pictures NO

Are there any building entrances or windows near the exhaust discharge where smoke that will cause smoke to enter unwanted spaces? NO
