Report: TAB Report
Function: Test, Adjust, & Balance
Date: 05/22/2025
Completed By: National TAB

PROJECT
05-19-25 CHILI'S FOWLER, FL

Project: 05-19-25 CHILI'S FOWLER, FL

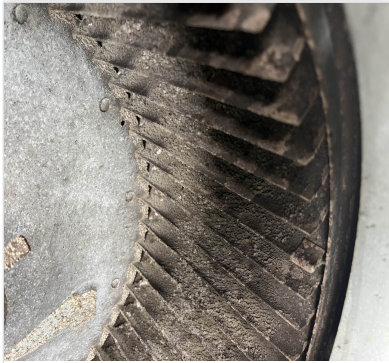
Issue Name : Blower wheels need to be cleaned
Description : There is debris on all blower wheels recommended to scrub it off.
Created By : National TAB **Assigned To :** National TAB - Ian Fuller
Status : Open
Priority : High **Asset Tag :**
Originated Date : 05/22/2025 - Ian Fuller - National TAB

ALL BLOWER WHEELS NEED TO BE CLEANED

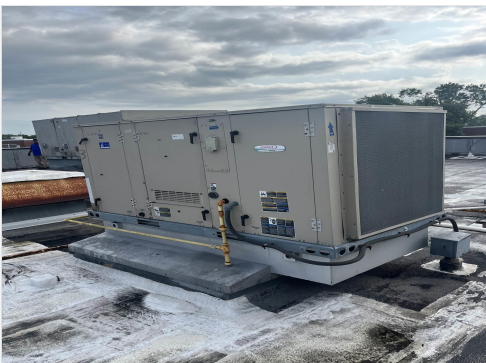
Asset: RTU2

Unit Data		
	Design	Actual
MFG	NA	LENNOX
Serial Num	-	5618E02305
Model Num	NA	LGH156H4BS4Y
Type	-	RTU
Configuration	-	VERTICAL
Num OA Filters 1	-	2
OA Filter Size 1	-	23X14
Num Final Filter 1	-	8
Final Filter Size 1	-	18X24X2

Notes:
HUMIDITROL UNIT NEEDS TO BE HOOKED UP
13 TON UNIT

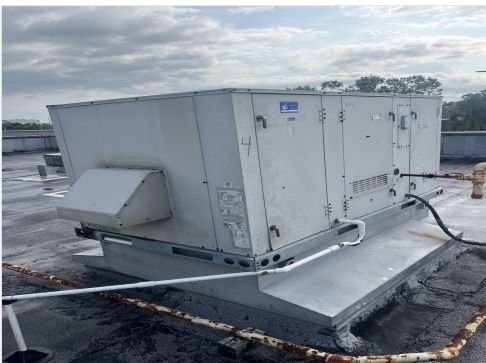
Asset: RTU4

Unit Data		
	Design	Actual
MFG	NA	LENNOX
Serial Num	-	5610F03428
Model Num	NA	LGH060H4ES1Y
Type	-	RTU
Configuration	-	VERTICAL
Num OA Filters 1	-	1
OA Filter Size 1	-	15X9
Num Final Filter 1	-	4
Final Filter Size 1	-	20X20X2

Notes:
5 TON UNIT
MOTORIZED DAMPER FOR OA IS NOT FUNCTIONING
