**Report: TAB Report**  
**Function: Test, Adjust, & Balance**  
**Date: 05/22/2025**  
**Completed By: National TAB**

**PROJECT**  
**05-19-25 CHILI'S FOWLER, FL**

Project: 05-19-25 CHILI'S FOWLER, FL

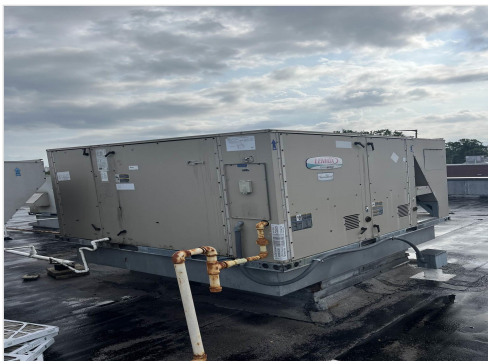
### Unit Data - PHOTO LOG

Unit Data		
	Design	Actual
MFG	NA	LENNOX
Serial Num	-	5610T02865
Model Num	NA	LGH180H4BS1Y
Type	-	RTU
Configuration	-	VERTICAL
Num OA Filters 1	-	3
OA Filter Size 1	-	23X14
Num Final Filter 1	-	6
Final Filter Size 1	-	24X24X2

Notes:  
15 TON UNIT  
CONDENSATE DRAIN NEEDS TO BE CLEANED

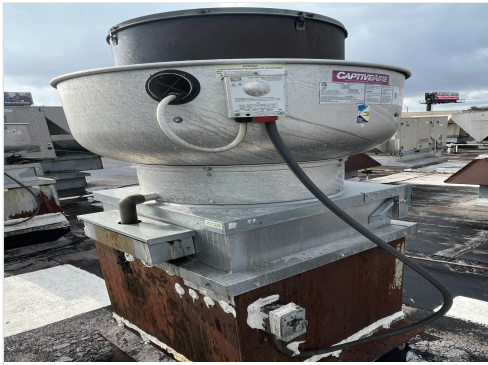
### Unit Data - PHOTO LOG

Test Data		
	Design	Actual
CFM	-	2084
Fan RPM	-	1758
Fan Rotation	-	CCW
Motor RPM	-	58.6 HZ
RL Voltage	-	210/209/207
RL Amperage	-	4.1 VFD

Notes:  
INITIAL READING: 2084 CFM
