**Report: TAB Report**  
**Function: Test, Adjust, & Balance**  
**Date: 05/22/2025**  
**Completed By: National TAB**

**PROJECT**  
**05-19-25 CHILI'S FOWLER, FL**

Project: 05-19-25 CHILI'S FOWLER, FL

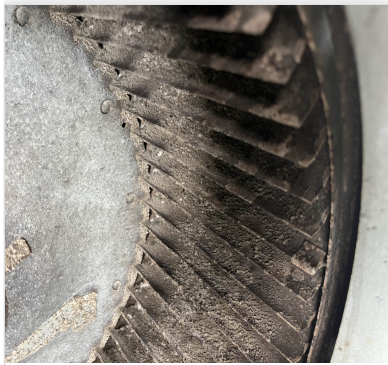
**Issue Name :** Blower wheels need to be cleaned  
**Description :** There is debris on all blower wheels recommended to scrub it off.  
**Created By :** National TAB                      **Assigned To :** National TAB - Ian Fuller  
**Status :** Open  
**Priority :** High                                      **Asset Tag :**  
**Originated Date :** 05/22/2025 - Ian Fuller - National TAB

ALL BLOWER WHEELS NEED TO BE CLEANED

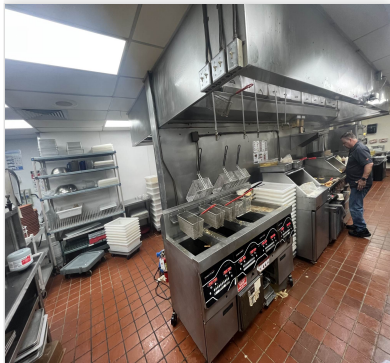
**Issue Name :** Fryer is not completed under hood  
**Description :** Fryer is about 2 feet out of the perimeter of the hood and is throwing smoke into the kitchen. All cooking equipment should be within 1 ft inside of the perimeter of the hood. Fryer is currently emitting smoke into the kitchen.  
**Created By :** National TAB                      **Assigned To :** National TAB - Ian Fuller  
**Status :** Open  
**Priority :** High                                      **Asset Tag :**  
**Originated Date :** 05/22/2025 - Ian Fuller - National TAB

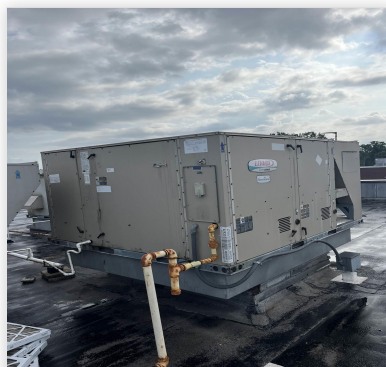
**Issue Name :** Humiditrol unit does not have wires landed at terminal  
**Description :** Recommended to install Hum sensor and land wires at HUM terminal on Prodigy board in order for unit to dehumidify space.  
**Created By :** National TAB                      **Assigned To :** National TAB - Ian Fuller  
**Status :** Open  
**Priority :** Medium                                      **Asset Tag :**  
**Originated Date :** 05/22/2025 - Ian Fuller - National TAB

Notes:  
HUMIDITROL UNIT NEEDS TO BE HOOKED UP  
13 TON UNIT

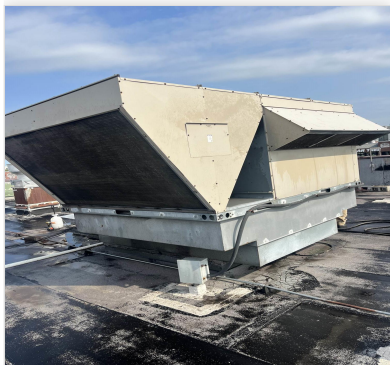
**Issue Name :** M2 Prodigy board communication issue  
**Description :** Board shows alarm that there is a communication issue with the M2 prodigy board. Recommended to service.  
**Created By :** National TAB                      **Assigned To :** National TAB - Ian Fuller  
**Status :** Open  
**Priority :** High                                      **Asset Tag :**  
**Originated Date :** 05/22/2025 - Ian Fuller - National TAB

Notes:  
COMM FAIL M2 not responding

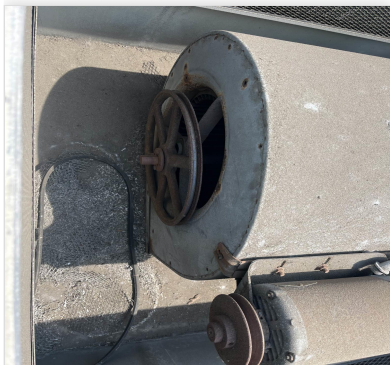
**Issue Name :** MAU bearings have rusted away  
**Description :** Fan blower does not spin because bearings are completely rusted through. Fan has been turned off. Recommended to replace fan sheaves.  
**Created By :** National TAB                      **Assigned To :** National TAB - Ian Fuller  
**Status :** Open  
**Priority :** Urgent                                      **Asset Tag :**  
**Originated Date :** 05/22/2025 - Ian Fuller - National TAB

Bearing on Fan have rusted through need to replace sheaves  
FILTERS: (4) 36.5X14.5

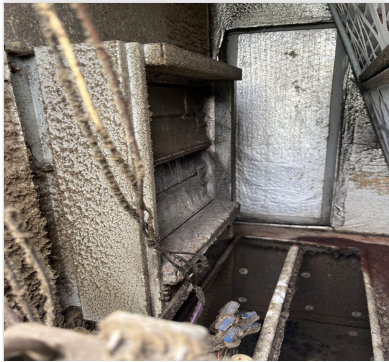
**Issue Name :** RTU#4 Economizer is not functional  
**Description :** Unable to bring OA in design. Recommended to service economizer.  
**Created By :** National TAB                      **Assigned To :** National TAB - Ian Fuller  
**Status :** Open  
**Priority :** Urgent                                      **Asset Tag :**  
**Originated Date :** 05/22/2025 - Ian Fuller - National TAB

UNABLE TO OPEN RTU4 TO DESIGN. MAU1 IS NOT FUNCTIONAL

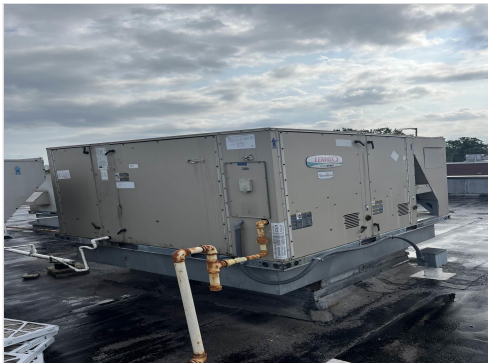
Asset: RTU1

Unit Data		
	Design	Actual
MFG	NA	LENNOX
Serial Num	-	5610T02865
Model Num	NA	LGH180H4BS1Y
Type	-	RTU
Configuration	-	VERTICAL
Num OA Filters 1	-	3
OA Filter Size 1	-	23X14
Num Final Filter 1	-	6
Final Filter Size 1	-	24X24X2

Test Data		
	Design	Actual
OA CFM	-	1301
RL Voltage	-	210/208/209
RL Amperage	-	5.4/5.4/5.4
SF Rotation	-	CCW
SF System SetPt	-	ONE SPEED
RA Damper Position	-	N/A
Min OA Damper Position	-	38%
Min OA Damper Type	-	ECONOMIZER
OA Enthalpy Setpt	-	N/A

Notes:  
15 TON UNIT

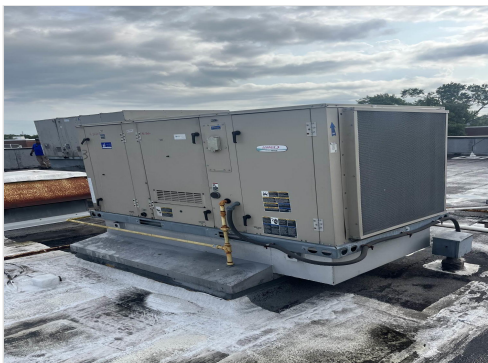
Asset: RTU2

Unit Data		
	Design	Actual
MFG	NA	LENNOX
Serial Num	-	5618E02305
Model Num	NA	LGH156H4BS4Y
Type	-	RTU
Configuration	-	VERTICAL
Num OA Filters 1	-	2
OA Filter Size 1	-	23X14
Num Final Filter 1	-	8
Final Filter Size 1	-	18X24X2

Test Data		
	Design	Actual
OA CFM	-	943
RL Voltage	-	210/209/210
RL Amperage	-	5.5/4.5/4.8
SF Rotation	-	CCW
SF System SetPt	-	ONE SPEED
RA Damper Position	-	N/A
Min OA Damper Position	-	76%
Min OA Damper Type	-	MOTORIZED DAMPER

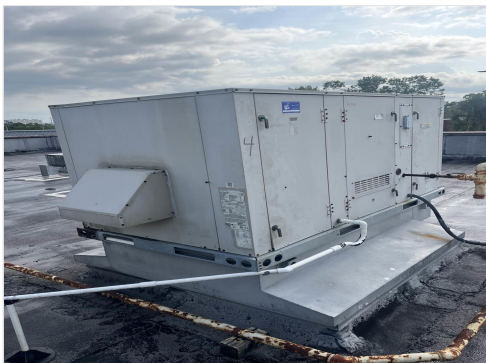
Asset: RTU4

Unit Data		
	Design	Actual
MFG	NA	LENNOX
Serial Num	-	5610F03428
Model Num	NA	LGH060H4ES1Y
Type	-	RTU
Configuration	-	VERTICAL
Num OA Filters 1	-	1
OA Filter Size 1	-	15X9
Num Final Filter 1	-	4
Final Filter Size 1	-	20X20X2

Test Data		
	Design	Actual
OA CFM	-	75
RL Voltage	-	212
RL Amperage	-	3.1
SF Rotation	-	CCW
SF System SetPt	-	58%
RA Damper Position	-	N/A
Min OA Damper Position	-	N/A
Min OA Damper Type	-	MOTORIZED DAMPER
OA Enthalpy Setpt	-	N/A

Notes:  
5 TON UNIT  
MOTORIZED DAMPER FOR OA IS NOT FUNCTIONING

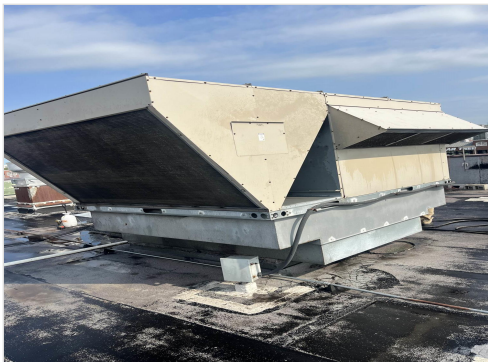
Asset: RTU5

Unit Data		
	Design	Actual
MFG	NA	LENNOX
Serial Num	-	5615C01800
Model Num	NA	LGH180H4BS2Y
Type	-	RTU
Configuration	-	VERTICAL
Num OA Filters 1	-	3
OA Filter Size 1	-	23X13
Num Final Filter 1	-	6
Final Filter Size 1	-	24X24X2

Test Data		
	Design	Actual
OA CFM	-	1329
RL Voltage	-	210/210/209
RL Amperage	-	7.6/7.6/7.1
SF Rotation	-	CCW
SF System SetPt	-	ONE SPEED
RA Damper Position	-	N/A
Min OA Damper Position	-	1.2"
Min OA Damper Type	-	MANUAL DAMPER
OA Enthalpy Setpt	-	5

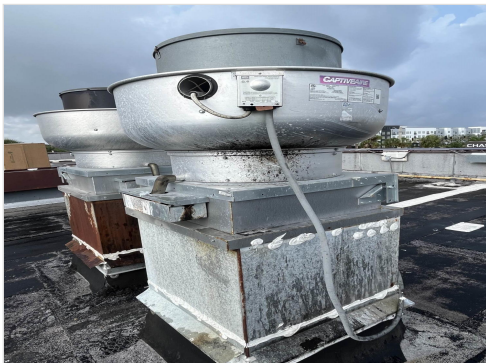
Asset: EF1

Unit Data		
	Design	Actual
MFG	NA	CAPTIVEAIRE
Model Num	NA	DU180HFA
Serial Num	-	5426065
Type	-	UPBLAST
Configuration	-	VERTICAL

Test Data		
	Design	Actual
CFM	-	2832
Fan RPM	-	1800
Fan Rotation	-	CCW
Motor RPM	-	60 HZ
RL Voltage	-	208/210/209
RL Amperage	-	5.0 VFD

Notes:  
INITIAL READING: 2832 CFM

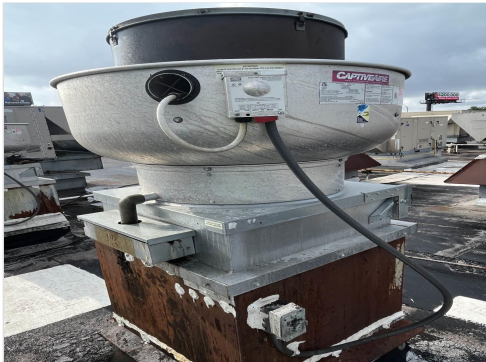
Asset: EF2

Unit Data		
	Design	Actual
MFG	NA	CAPTIVEAIRE
Model Num	NA	DU180HFA
Serial Num	-	6284933
Type	-	UPBLAST
Configuration	-	VERTICAL

Test Data		
	Design	Actual
CFM	-	2084
Fan RPM	-	1758
Fan Rotation	-	CCW
Motor RPM	-	58.6 HZ
RL Voltage	-	210/209/207
RL Amperage	-	4.1 VFD

Notes:  
INITIAL READING: 2084 CFM

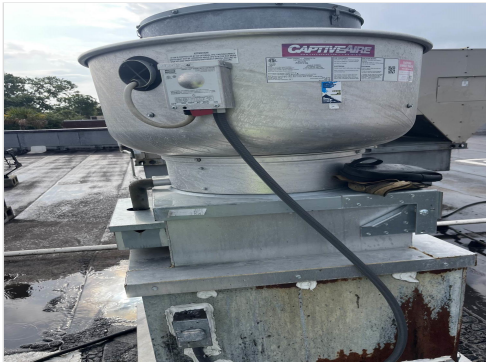
Asset: EF3

Unit Data		
	Design	Actual
MFG	NA	CAPTIVEAIRE
Model Num	NA	DU85HFA
Serial Num	-	6284916
Type	-	UPBLAST
Configuration	-	VERTICAL

Test Data		
	Design	Actual
CFM	-	1832
Fan RPM	-	1437
Fan Rotation	-	CCW
Motor RPM	-	50.0 HZ
RL Voltage	-	210/212/211
RL Amperage	-	2.6 VFD

Notes:  
INITIAL READING: 0 CFM

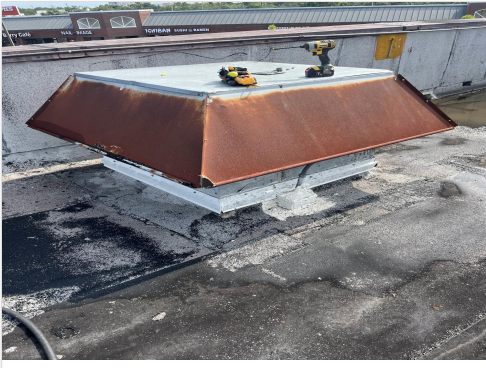
Asset: SF1

Unit Data		
	Design	Actual
MFG	NA	N/A
Model Num	NA	N/A
Serial Num	-	N/A
Type	-	MAU
Configuration	-	VERTICAL

Test Data		
	Design	Actual
CFM	-	0

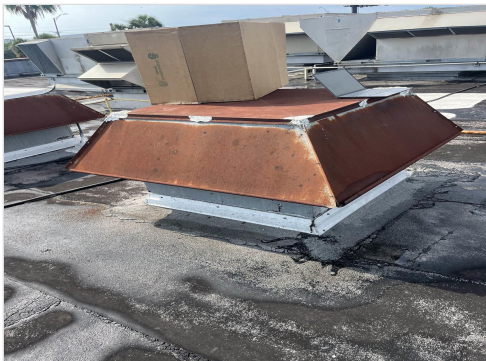
Asset: SF2

Unit Data		
	Design	Actual
MFG	NA	N/A
Model Num	NA	N/A
Serial Num	-	N/A
Type	-	MUA
Configuration	-	VERTICAL

Test Data		
	Design	Actual
CFM	-	1661

UNABLE TO ACCESS MOTOR COMPARTMENT TO GET DATA  
INITIAL READING: 0 CFM TURNED OFF AT DISCONNECT

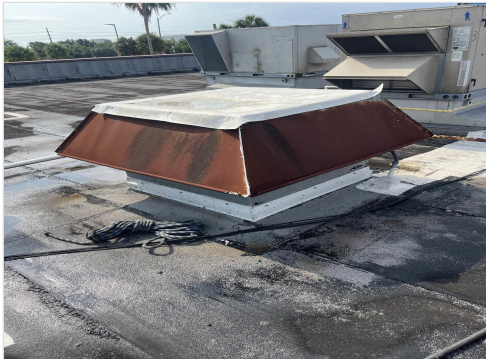
Asset: SF3

Unit Data		
	Design	Actual
MFG	NA	N/A
Model Num	NA	N/A
Serial Num	-	N/A
Type	-	MUA
Configuration	-	VERTICAL

Test Data		
	Design	Actual
CFM	-	1445

INITIAL READING: 1445 CFM

UNABLE TO ACCESS MOTOR COMPARTMENT TO GET DATA

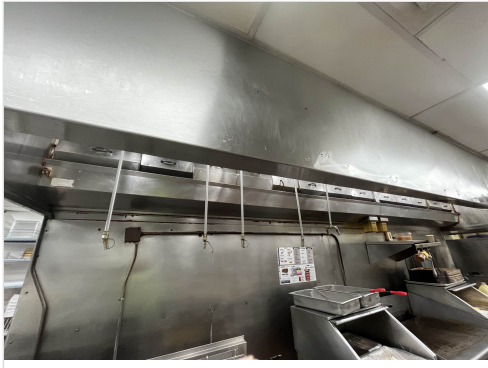
Asset: HD1

Unit Data		
	Design	Actual
MFG	NA	N/A
Model Num	NA	N/A
Job / Serial Num	-	N/A
Type	-	TYPE 1 LOW PROXIMITY
Hood length	-	136"
Hood Width	-	55"
Supply Plenum Type	-	BACK RETURN

Test Data Exhaust		
	Design	Actual
Filter Qty 1	-	8
Filter Total AK Area	-	6.13
Filter1 FPM	-	367
Filter2 FPM	-	334
Filter3 FPM	-	298
Filter4 FPM	-	354
Filter5 FPM	-	337
Filter6 FPM	-	338
Filter7 FPM	-	308
Filter8 FPM	-	387
Filter Ave FPM(corr)	-	340
CFM	-	2084

Cooking Equipment	
	Actual
Item 1	FRYER

Notes:  
 HOOD FILTER OPENING: 6.5X136  
 AK: 6.13
