**National TAB
1329 E Kemper Rd, Ste 4210
Cincinnati, OH 45246**

**Report: Renew
Date: 4/6/2022**

**FREDDY'S HCI - DURHAM, NC (3201) - RENEW 2FCB
(3)**

The purpose of the visit is to perform preventative maintenance for the store. We change belts and filters, clean evaporators and condenser, and check refrigeration and heating cycle where possible. We also, check and set exhaust, outside air, and make up air coming in out of the build to the engineer's design and/or to make the space as comfortable and healthy as possible. All of this ensures a healthy and comfortable space, extends service life of units, and reduces the number of future repairs by prevention.

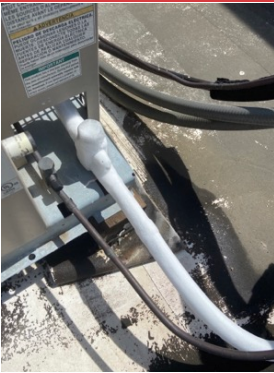
FROZEN LIN ON WALK IN COOLER

RECOMMENDATION (CLEAN/REPAIR/REPLACE/INFO)	
REPLACE	MAU filters need to be replaced. They are being ordered with the new hood filters from TriMark
REPLACE	Hood filters need to be replaced. Micah is ordering them from TriMark.
REPAIR	Walk-In Cooler evaporator is frosted over and fans are not running. A service provider needs to resolve this issue.
REPAIR	RTU-2 CONDENSATE DRAIN this drain is properly made but has been snapped. Contact your service provider to replace this item so that it drains properly.

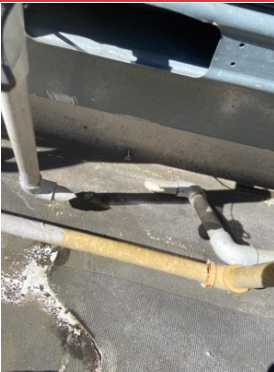
RTU-2 CONDENSATE DRAINE
Snapped drain

(1) WHILE THE SIZING IS CORRECT RTU-2 HAS A SNAPPED CONDENSATE DRAIN. A NEW ONE NEEDS TO BE INSTALLED. CONTACT YOUR SERVICE PROVIDER TO REPAIR OR REPLACE THIS PART, OR CONTACT GREG FOR ASSESTMENT AND HAVE NTAB TECH REPLACE AT NEXT SCHEDULED RENEW VISIT.

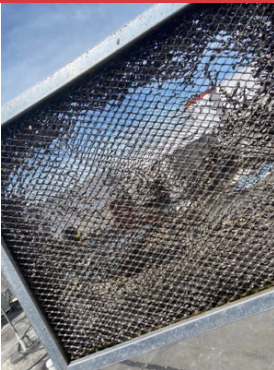
MAU OA FILTERS NEED TO BE REPLACED

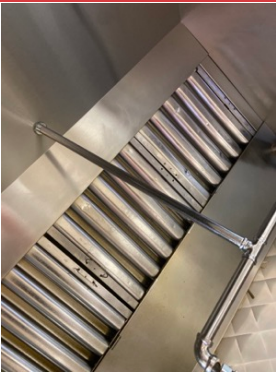
FRYER HOOD HANDLES MISSING

Crew is t cleaning them because they are hard to remove and install when closing up.

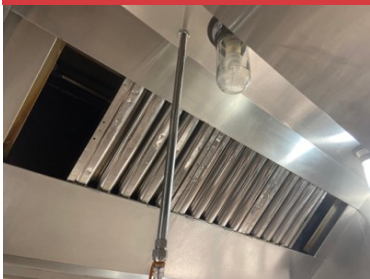
HOOD NEEDS REPLACEMENT FILTERS

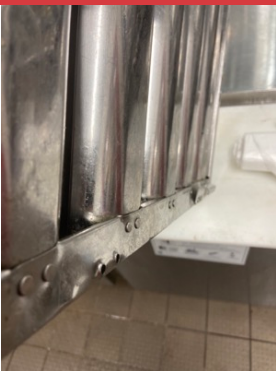
CLIPS MISSING ON FILTERS

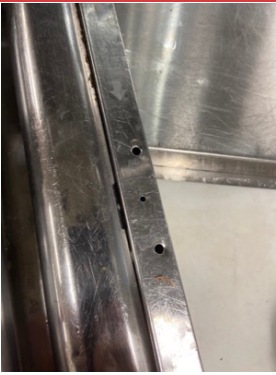
HANDLES MISSING

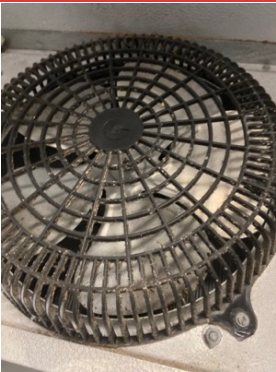
FANS NOT RUNNING WALK IN COOLER

Notes: FANS NOT RUNNING. EVAP COIL HAS ICE BUILD UP ON COILS. i CLEANED THEM OFF AND IN 15 MINUTES THEY HAD BEEN COVERED AGAIN IN FROST AND ICE.

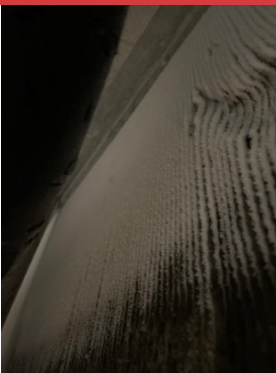
ICE ON COILS WALK IN COOLER

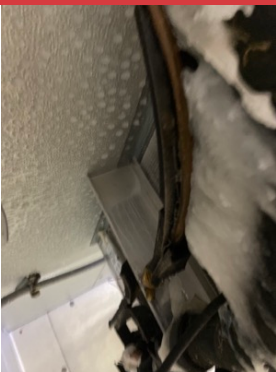
ICE BUILD UP ON PEN PIPE

Notes: ICE BUILD UP ON PEN PIPE SEE ISSUES AND SITE PICTURES

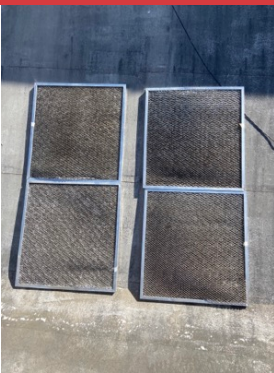
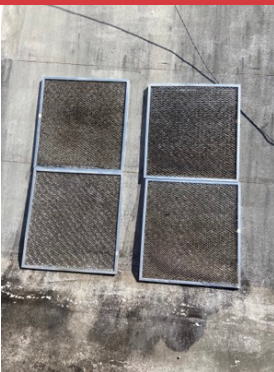
RTU-1 OA DIRTY

RTU-1 OA CLEAN

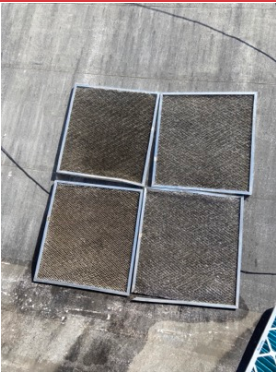
RTU-2 OA DIRTY

RTU-2 OA CLEAN

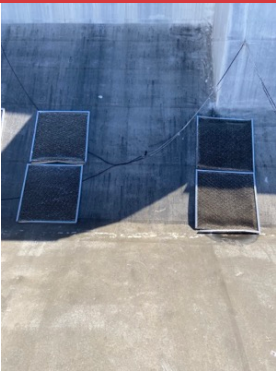
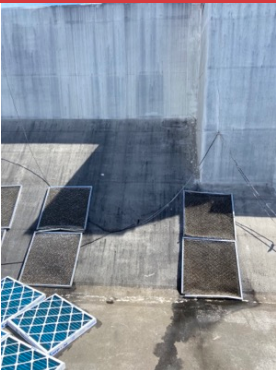
RTU-3 OA DIRTY

RTU-3 OA CLEAN

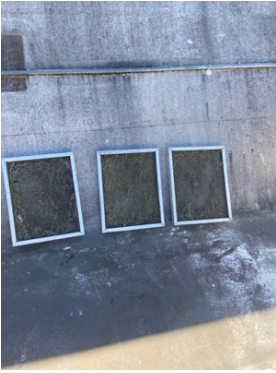
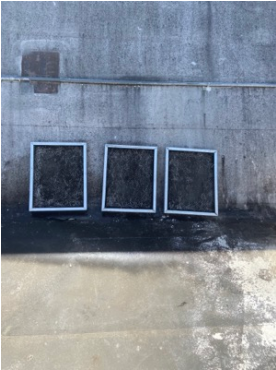
MUA OA DIRTY

MAU OA CLEAN

MAU: The intake filters had slight dirt accumulation. They were washed.

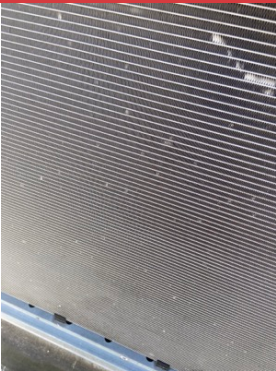
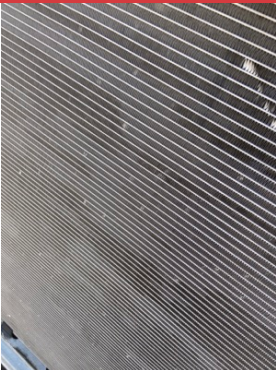
RTU-1 CONDENSER DIRTY

RTU-1 CONDENSER CLEAN

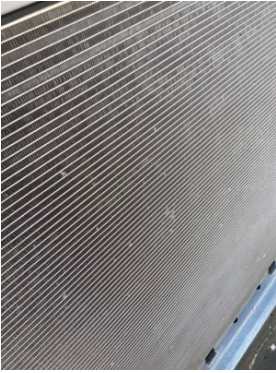
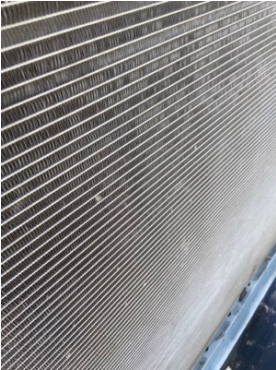
RTU-2 CONDENSER DIRTY

RTU-2 CONDENSER CLEAN

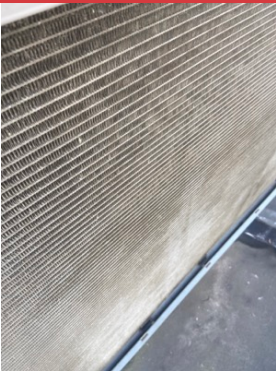
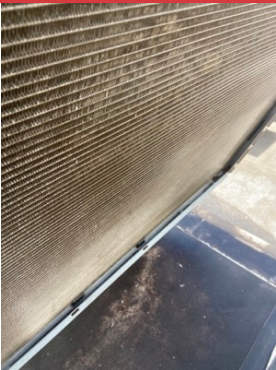
RTU-3 CONDENSER DIRTY

RTU-3 CONDENSER CLEAN

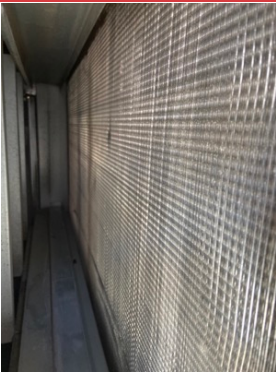
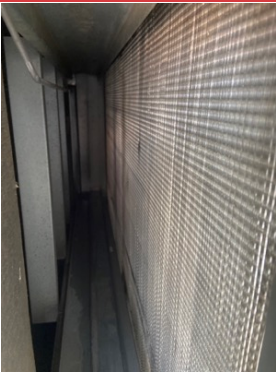
RTU-1 EVAP COIL DIRTY

RTU-1 EVAP COIL CLEAN

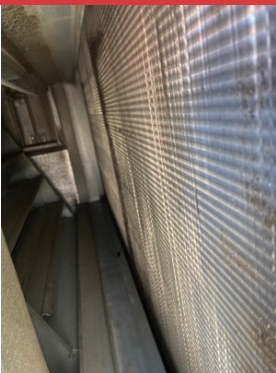
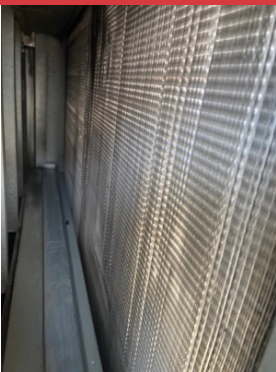
RTU-2 EVAP COIL DIRTY

RTU-2 EVAP COIL CLEAN

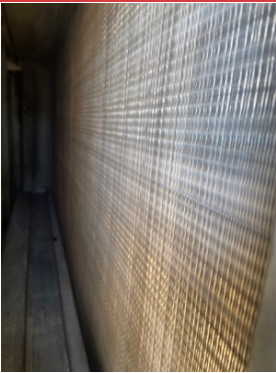
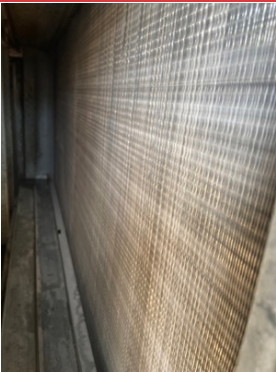
RTU-3 EVAP COIL DIRTY

RTU-3 EVAP COIL CLEAN

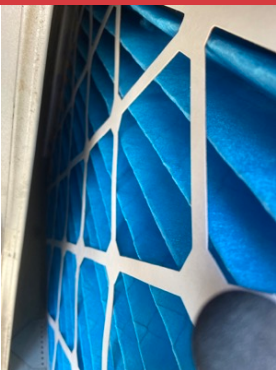
RTU-1 EVAP FILTER DIRTY

RTU-1 EVAP FILTER CLEAN

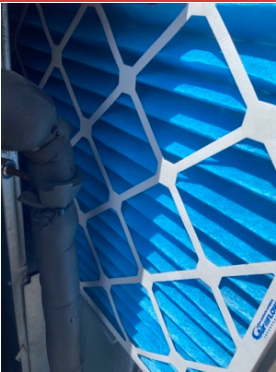
RTU-2 EVAP FILTER DIRTY

RTU-1 EVAP FILTER CLEAN

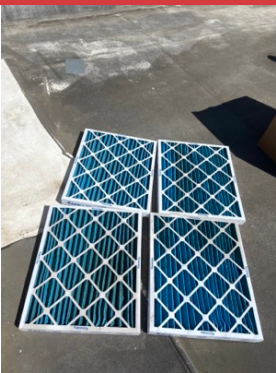
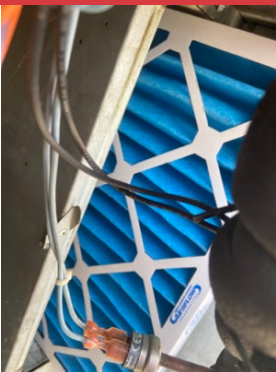
RTU-3 EVAP FILTER DIRTY

RTU-3 EVAP FILTER CLEAN
