**Report: TAB Report**  
**Function: Test, Adjust, & Balance**  
**Date: 01/21/2026**  
**Completed By: National TAB**

## 01-12-26 QT #1125 SPARTANSBURG, SC

QUIKTRIP  
4705 SOUTH 129TH EAST AVENUE  
TULSA, OK 74134

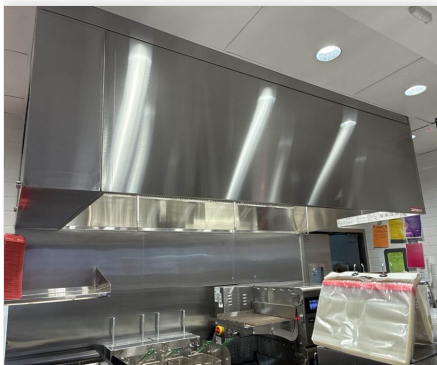
**01/15/2026**

**Issue Name :** Hood End Panels Not Installed  
**Description :** There are no hood end panels installed as per the Hood Schedule.  
**Created By :** National TAB **Assigned To :** National TAB - Dan Hertenstein  
**Status :** Open  
**Priority :** Low **Asset Tag :** HD1  
**Originated Date :** 01/15/2026 - Alex Bauer - National TAB

**End panels are installed per prototype?** Fail

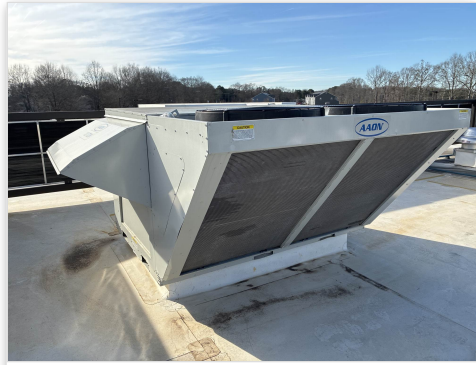
Unit Data	
	Actual
MFG	AAON
Serial Num	202403-ANEK30408
Model Num	RN-013-8-0-HA0A-152
Num OA Filters 1	1
OA Filter Size 1	22.5X44.5
Num Final Filter 1	2
Final Filter Size 1	19.5X46.5

Test Data		
	Design	Actual
SF CFM	4200	4347
SF RPM	-	1355
OA CFM (Hoods On)	800	779
OA CFM (Hoods Off)	350	431
RL Voltage	-	159 VFD
RL Amperage	-	7.65 VFD
VFD Max SetPt	-	46.2 Hz
OA Damper Position (Hoods On)	-	46%
OA Damper Position (Hoods Off)	-	CLOSED

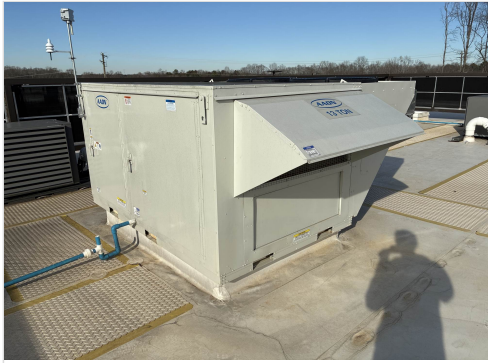
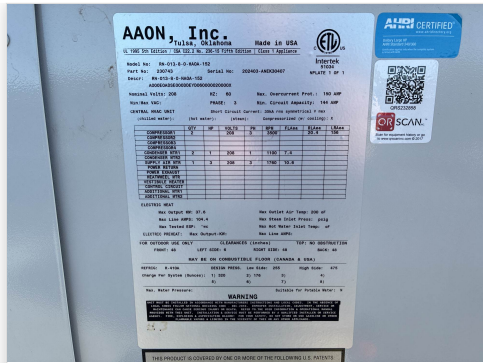
Unit Data	
	Actual
MFG	AAON
Serial Num	202403-ANEK30407
Model Num	RN-013-8-0-HA0A-152
Num OA Filters 1	1
OA Filter Size 1	22.5X44.5
Num Final Filter 1	2
Final Filter Size 1	19.5X46.5

Test Data		
	Design	Actual
SF CFM	4200	4086
SF RPM	-	1619
OA CFM (Hoods On)	800	807
OA CFM (Hoods Off)	350	417
RL Voltage	-	214 VFD
RL Amperage	-	10.4 VFD
VFD Max SetPt	-	55 Hz
OA Damper Position (Hoods On)	-	46%
OA Damper Position (Hoods Off)	-	CLOSED
