Report: TAB Report
Function: Test, Adjust, & Balance
Date: 01/21/2026
Completed By: National TAB

01-12-26 QT #1125 SPARTANSBURG, SC

QUIKTRIP
4705 SOUTH 129TH EAST AVENUE
TULSA, OK 74134

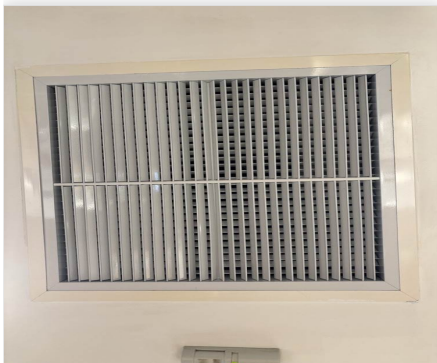
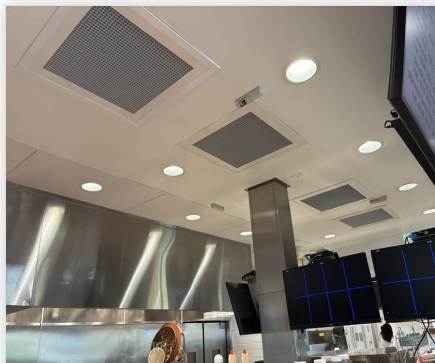
Issue Name : Incorrect Kitchen Diffusers
Description : The kitchen diffusers 3-1 through 3-4 are the incorrect type. They need to be the Titus S1 diffuser with the installed dampers to control the airflow.
Created By : National TAB **Assigned To :** National TAB - Dan Hertenstein
Status : Open
Priority : Low **Asset Tag :** RT-3
Originated Date : 01/13/2026 - Alex Bauer - National TAB

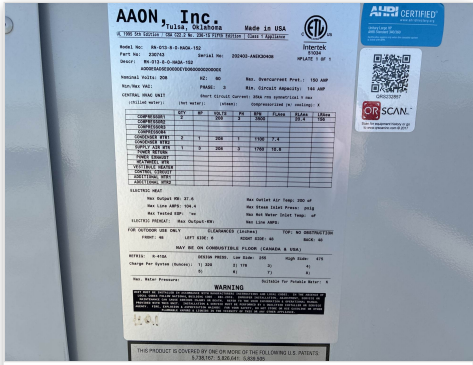
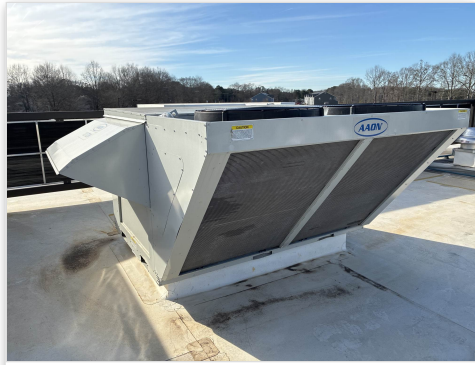
Unit Data - PHOTO LOG

Unit Data	
	Actual
MFG	AAON
Serial Num	202403-ANEK30408
Model Num	RN-013-8-0-HA0A-152
Num OA Filters 1	1
OA Filter Size 1	22.5X44.5
Num Final Filter 1	2
Final Filter Size 1	19.5X46.5

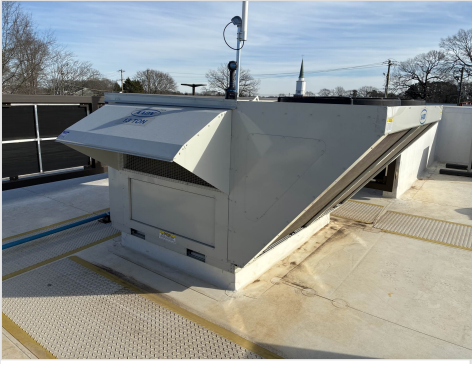
Unit Data - PHOTO LOG

Unit Data	
	Actual
MFG	AAON
Serial Num	202403-ANEK30409
Model Num	RN-013-8-0-HA0A-152
Num OA Filters 1	1
OA Filter Size 1	22.5X44.5
Num Final Filter 1	2
Final Filter Size 1	19.5X46.5

Notes:
Diffuser 2-1 could not be adjusted.

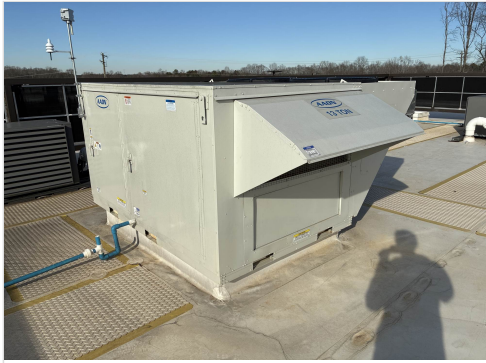
Unit Data - PHOTO LOG

Unit Data	
	Actual
MFG	AAON
Serial Num	202403-ANEK30407
Model Num	RN-013-8-0-HA0A-152
Num OA Filters 1	1
OA Filter Size 1	22.5X44.5
Num Final Filter 1	2
Final Filter Size 1	19.5X46.5

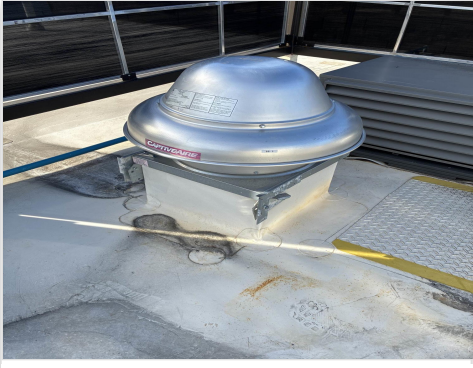
Unit Data - PHOTO LOG

Unit Data	
	Actual
MFG	CAPTIVEAIRE
Model Num	DR50HFA
Serial Num	6712325
Type	DOWNBLAST
Configuration	VERTICAL

Notes:
No damper for EF1-4.

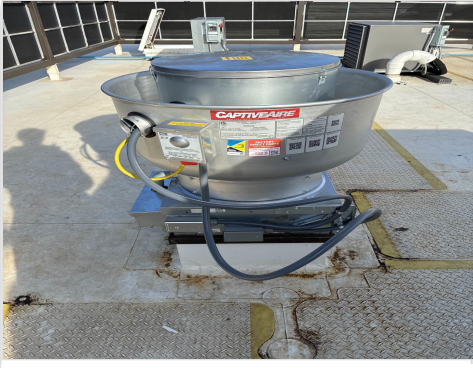
Unit Data - PHOTO LOG

Unit Data	
	Actual
MFG	CAPTIVEAIRE
Model Num	DU50HFA
Serial Num	8189416
Type	UPBLAST
Configuration	VERTICAL

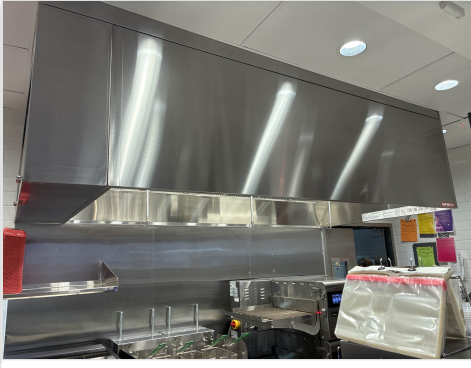
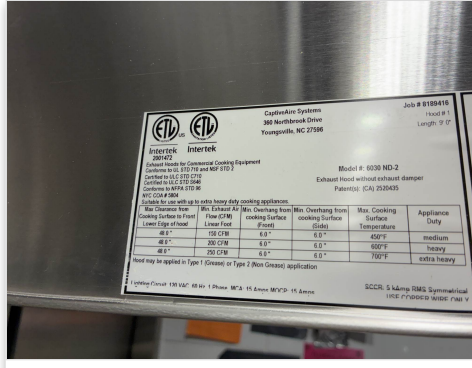
Unit Data - PHOTO LOG

Unit Data		
	Design	Actual
MFG	CAPTIVEAIRE	CAPTIVEAIRE
Model Num	6030ND-2-F	6030ND-2
Job / Serial Num	-	8189416
Type	-	TYPE I CANOPY
Hood length	-	120"
Hood Width	-	60"

Test Data Exhaust		
	Design	Actual
Filter Type	-	BAFFLE FILTERS
Filter Size 1	-	16X20
Filter Qty 1	-	6
Filter AK factor size 1	-	2.08
Filter Total AK Area	-	12.48
Filter1 FPM	-	110
Filter2 FPM	-	144
Filter3 FPM	-	96
Filter4 FPM	-	139
Filter5 FPM	-	72
Filter6 FPM	-	90
Filter Ave FPM(corr)	-	108
CFM	1350	1348
