5571 TAB PUNCH LIST

Prepared by Ben Searles

May 8, 2025

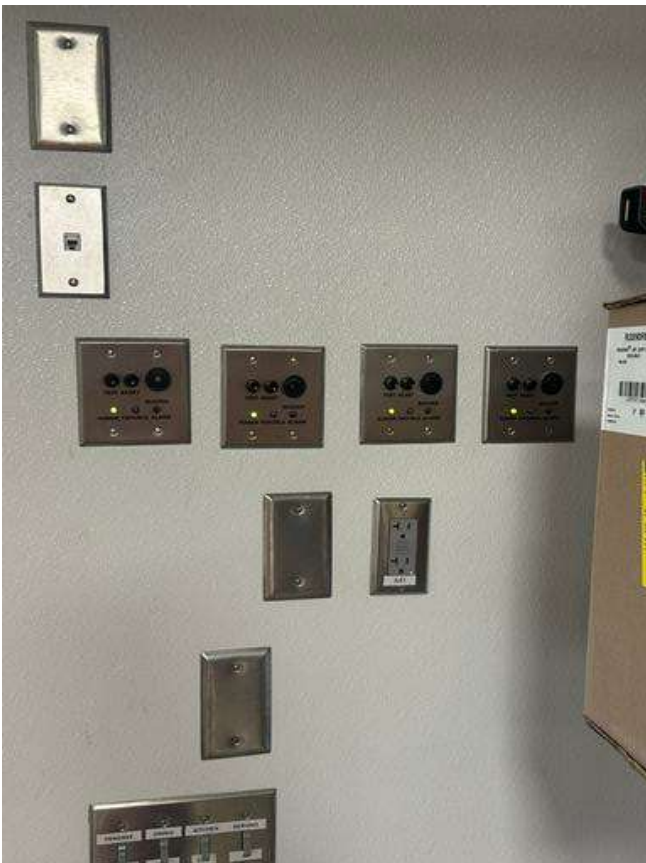
IMG_1030

#177 [CNTL 508] [NEW] Controls labeling.

Label all smoke
annunciators for which piece
of equipment they serve.

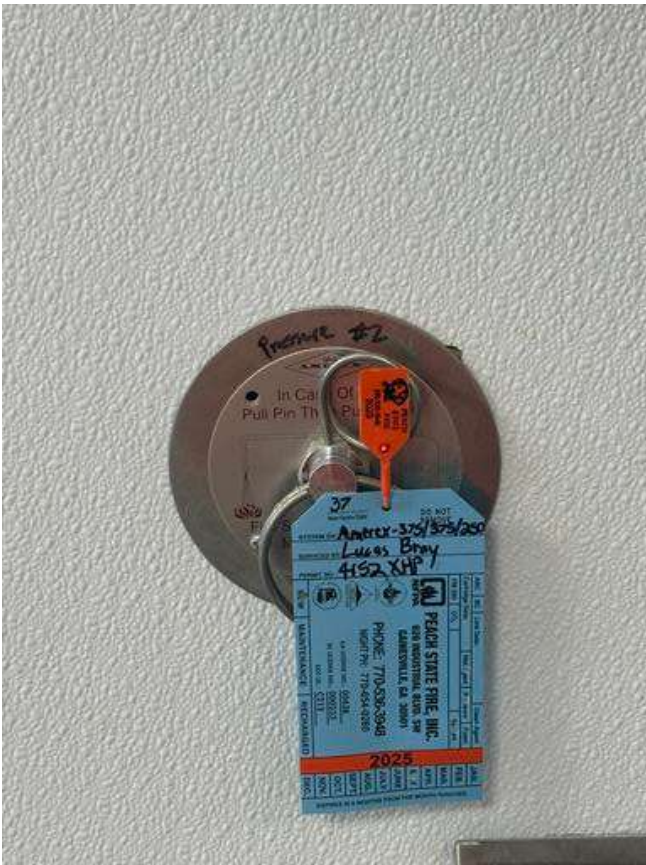
IMG_1031

#176 [CNTL 509] [NEW] Ansul pull labeling.

Label ansul pull station 1 for which hood it serves. The other two pull stations are labeled properly.

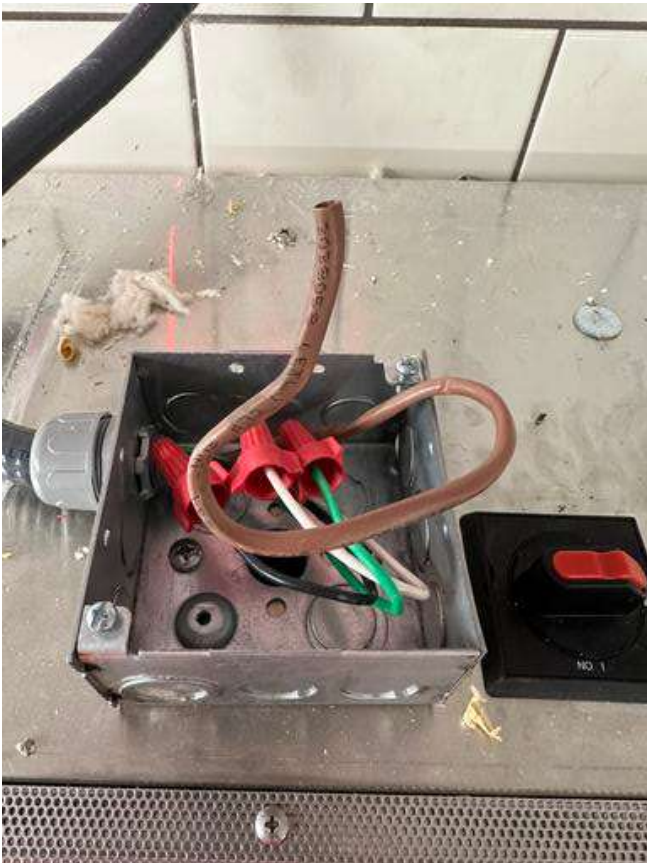
IMG_1043

#175 [CURT 501] [NEW] Air curtain power.

Air door 2 power does not appear to be wired at time of TAB inspection.

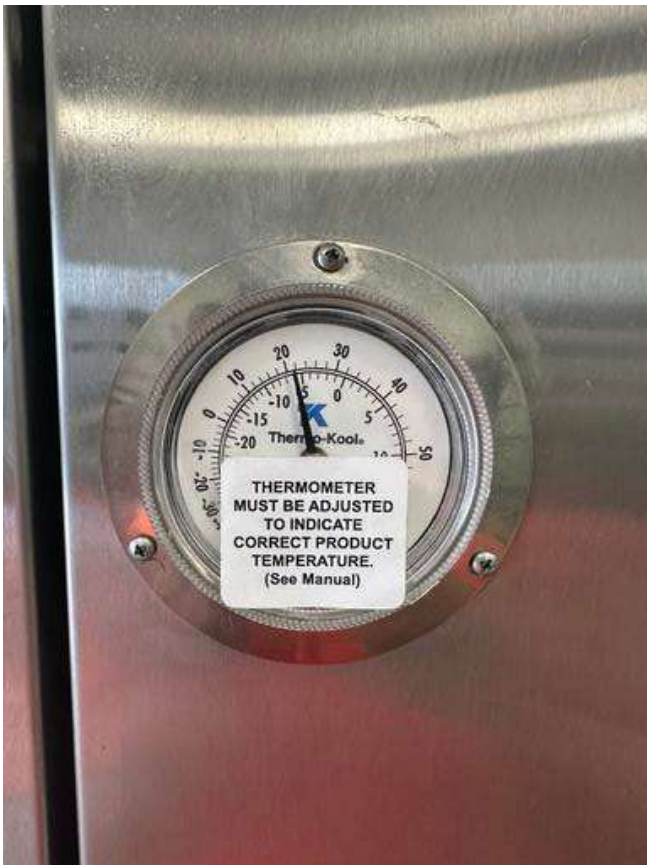
IMG_1036

#172 [REFG 500] [NEW] WIC/WIF temperatures.

WIF boxe is not holding specified temperature. At the time of inspection, the WIF was holding at around 20 degrees.

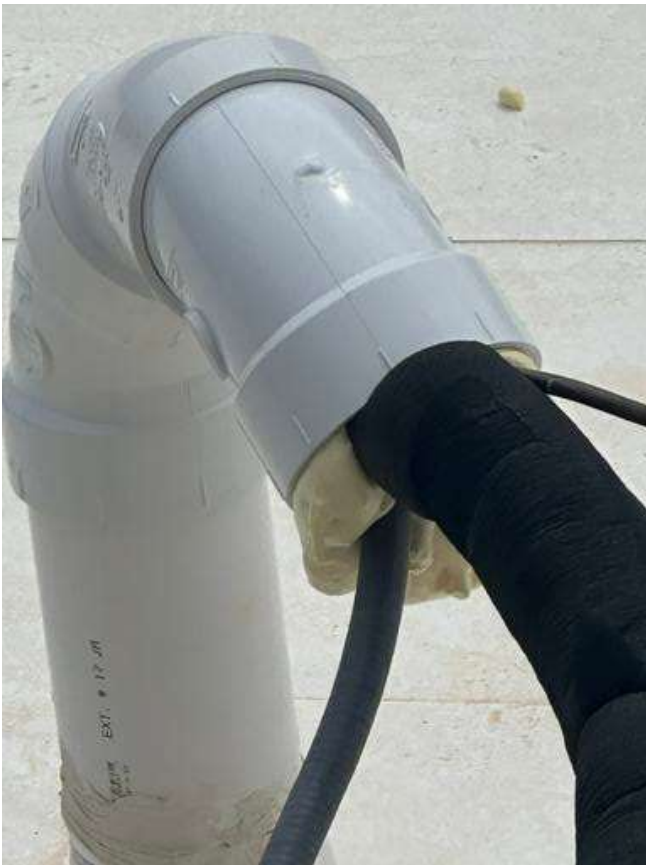
IMG_1046

#171 [REFG 511] [NEW] PVC pipe chase (gooseneck) installation.

PVC pipe chase risers are sealed with spray foam, but are not cut flush with a layer of silicone over the top.

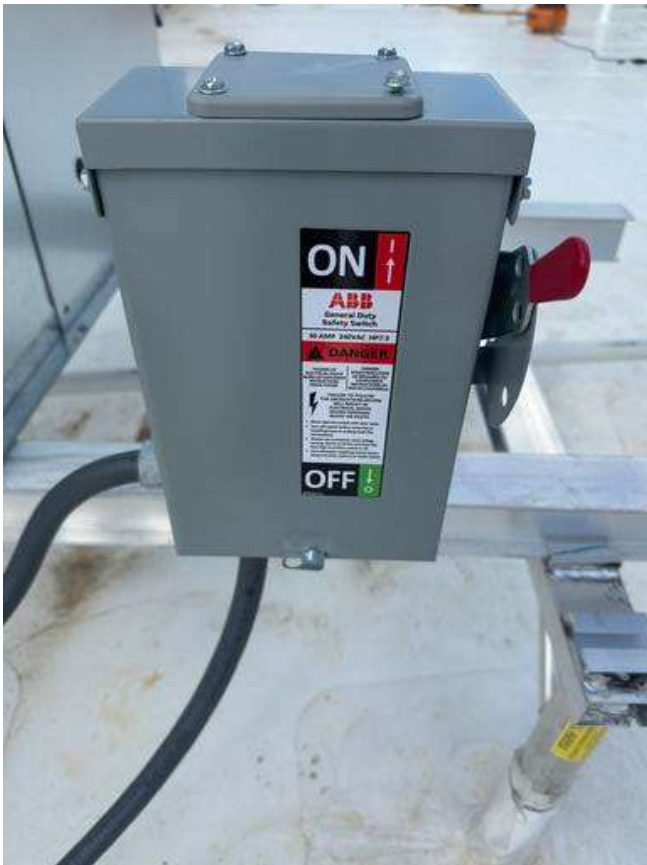
IMG_1034

#170 [REFG 516] [NEW] Condenser electrical disconnects.

Electrical disconnects are not properly labeled.

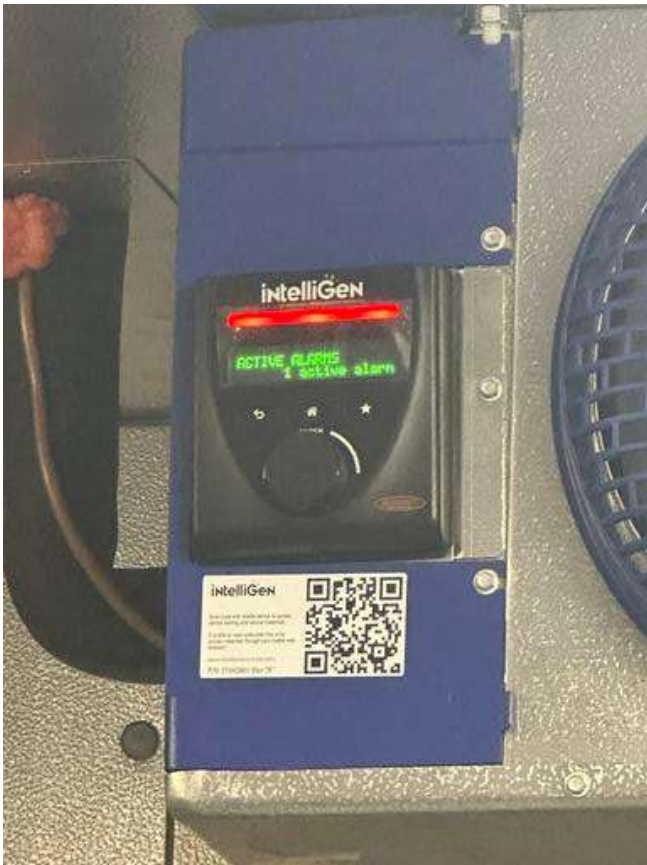
IMG_1035
Ben Searles
May 8, 2025 2:43 PM

#169 [REFG 999] [NEW] WIF alarm.

Status Open	Start Date May 8, 2025
Type Planned Work	Created May 8, 2025 2:40 PM bens@nationaltab.com
Description The WIF is experiencing an active alarm.	Last Updated May 8, 2025 2:43 PM
