Report: TAB

Function: Test, Adjust, & Balance

Date: 07/16/2025

07-14-25 FREDDY'S DENTON, TX

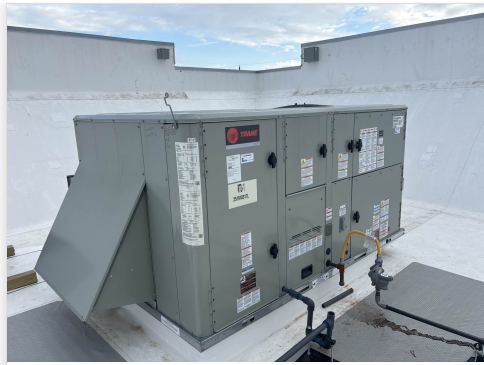
Asset: RTU1

Unit Data		
	Design	Actual
MFG	TRANE	TRANE
Serial Num	-	251910317L
Model Num	YSJ150	YSK150A3S0H0AC2C0A201A0A2
Type	RTU	RTU
Configuration	VERTICAL	VERTICAL
Num OA Filters 1	-	1
OA Filter Size 1	-	35.75x15.5
Num Final Filter 1	-	3
Final Filter Size 1	-	18x24x2
Num Final Filter 2	-	3
Final Filter Size 2	-	18x18x2

Test Data		
	Design	Actual
SF CFM	5000	4992
SF RPM	-	1242.08
RA CFM	4019	4000
OA CFM	981	992
RL Voltage	-	204/205/204
RL Amperage	-	3.68/3.6/3.72
SF Rotation	-	CCW
SF System SetPt	-	64
RA Damper Position	-	65.1
Min OA Damper Position	-	34.9
Min OA Damper Type	-	MOTORIZED
OA Enthalpy Setpt	-	60

Diffuser 1-14 is high, and face damper is closed as far as it can go.

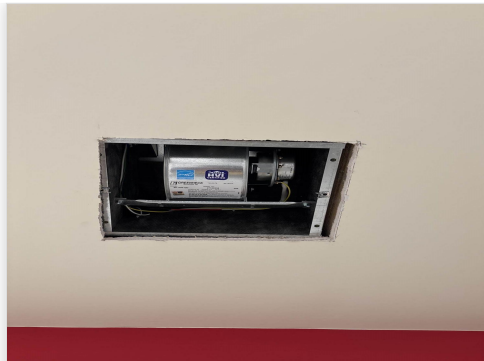
Asset: EF2

Unit Data		
	Design	Actual
MFG	GREENHECK	GREENHECK
Model Num	SP-A00-390	SP-A90-QD
Serial Num	-	27102235
Type	CEILING	CEILING
Configuration	VERTICAL	VERTICAL

Test Data		
	Design	Actual
CFM	75	74
Fan RPM	900	NA
Fan Rotation	-	CCW
Motor RPM	-	NA
System SetPt	-	N/A
RL Voltage	-	119
RL Amperage	-	0.13/0.10
Total ESP	.250"	NA
Fan Inlet SP	-	NA
Fan Discharge SP	-	NA

Notes:
Static pressure was not accessible due to cemented ceiling.

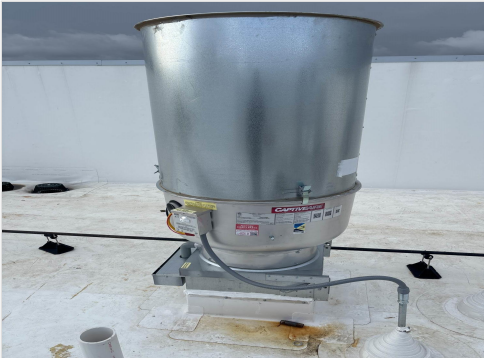
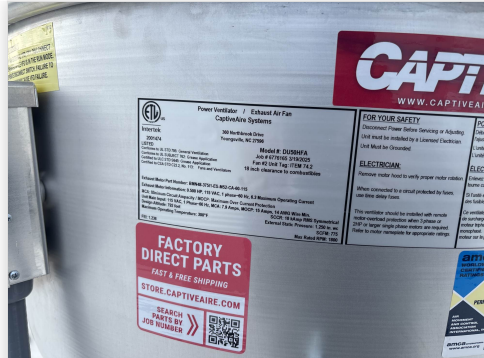
Asset: KEF2

Unit Data		
	Design	Actual
MFG	CAPTIVEAIRE	CAPTIVEAIRE
Model Num	DU50HFA	DU50HFA
Serial Num	-	6776165
Type	UPBLAST	UPBLAST
Configuration	VERTICAL	VERTICAL

Test Data		
	Design	Actual
CFM	775	801
Fan RPM	1532	846
Fan Rotation	-	CCW
Motor RPM	-	846
System SetPt	-	47%
RL Voltage	-	118
RL Amperage	-	1.39/1.42
Total ESP	1.250"	-0.288
Fan Inlet SP	-	-0.2885
Fan Discharge SP	-	ATM

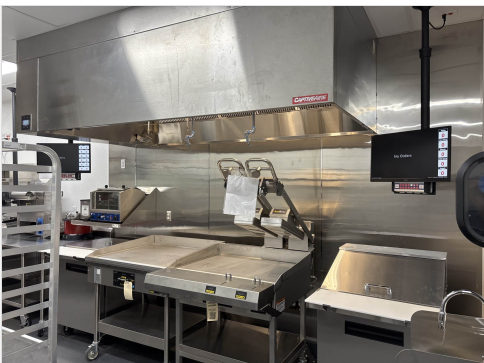
Asset: HD1

Unit Data		
	Design	Actual
MFG	CAPTIVEAIRE	CAPTIVEAIRE
Model Num	5424-ND-2	5424-ND-2
Job / Serial Num	-	6776165
Type	TYPE I - CANOPY	TYPE I CANOPY
Hood length	96"	96"
Hood Width	54"	54"

Test Data Exhaust		
	Design	Actual
Filter Type	CAPTRATE SOLO FILTER	CAPTRATE SOLO FILTER
Filter Size 1	16X16	16X16
Filter Qty 1	5	5
Filter AK factor size 1	1.62	1.62
Filter Total AK Area	8.10	8.10
Filter1 FPM	-	206
Filter2 FPM	-	213
Filter3 FPM	-	203
Filter4 FPM	-	208
Filter5 FPM	-	198
Filter Ave FPM(corr)	-	205
CFM	1600	1676
