Report: TAB

Function: Test, Adjust, & Balance

07-14-25 FREDDY'S DENTON, TX

Project: 07-14-25 FREDDY'S DENTON, TX

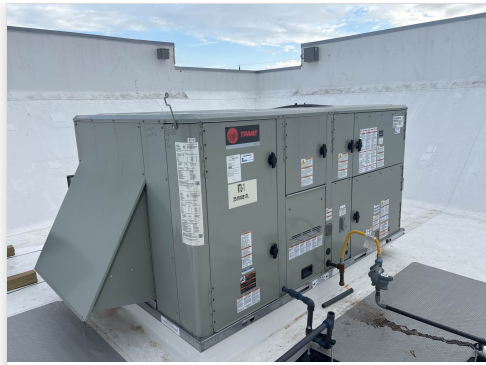
Asset: RTU1

Diffuser 1-14 is high, and face damper is closed as far as it can go.

Diffuser 1-7 is unable to output air due to design of ductwork or internal problem.

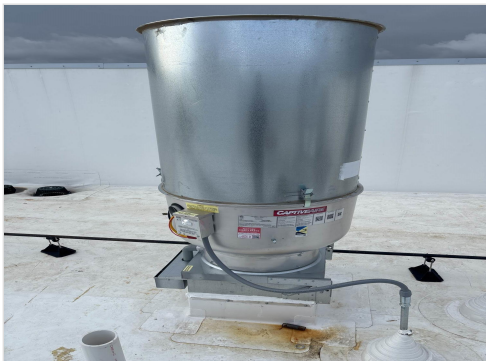
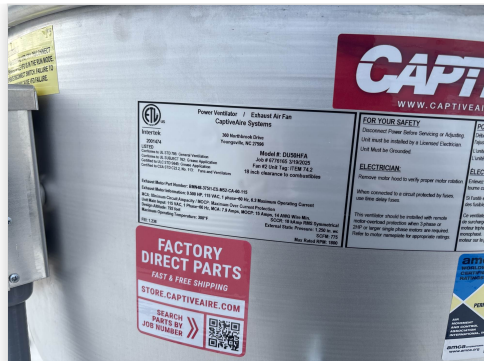
Motor Data		
	Design	Actual
Motor MFG	-	NEMA 48
Frame	-	N/A
Horsepower	.500	0.5
Motor Rpm	-	1800
Phase	1	1
Voltage (rated)	115	115
Amperage (rated)	-	6.3
Service Factor	-	N/A

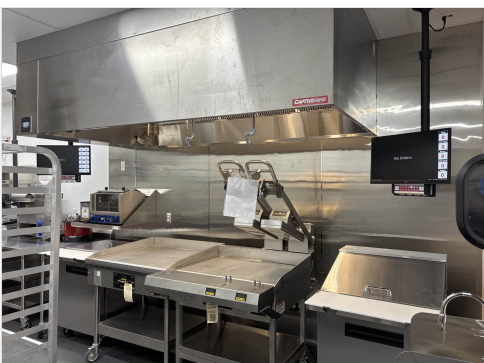
07/14/2025

Cooking Equipment	
	Actual
Item 1	Griddle
Item 2	Griddle
