Report: Prelim Report

Function: Test, Adjust, & Balance

08-11-25 WAWA #6612 DUMFRIES, VA

Project: 08-11-25 WAWA #6612 DUMFRIES, VA

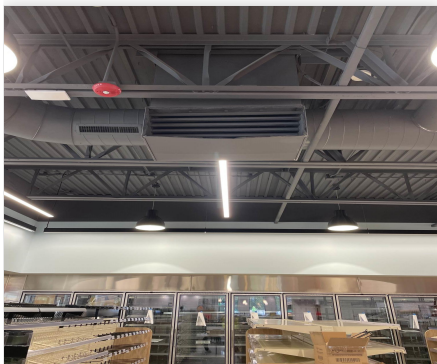
Issue Name : RTU-2 Return
Description : RTU-2 return is not covered with a bird screen / egg crate and is wide open. Return should be covered.
Created By : National TAB **Assigned To :** National TAB - Jordan Best
Status : Open
Priority : High **Asset Tag :**
Originated Date : 08/13/2025 - Jordan Best - National TAB
