Report: TAB

Function: Test, Adjust, & Balance

**05-05-25 SWEETGREEN SANTA CLARA, CA
(TAB, IAQ)**

Project: 05-05-25 SWEETGREEN SANTA CLARA, CA (TAB, IAQ)

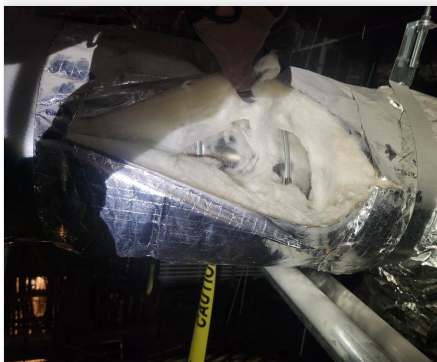
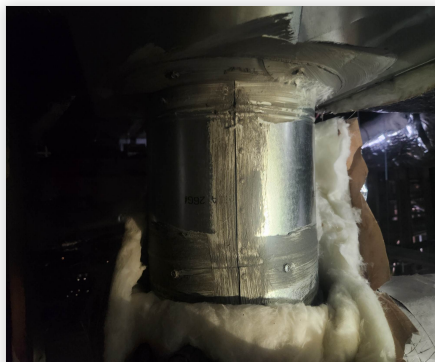
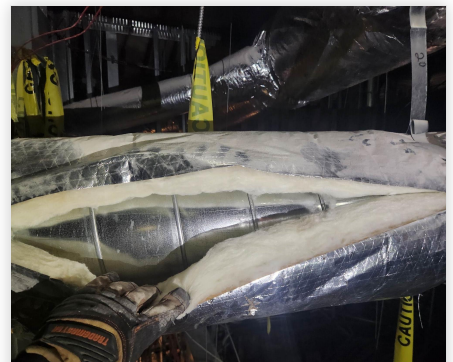
Issue Name : EXISTING DUCT WORK DOES NOT HAVE DAMPERS FOR BALANCING
Description : Existing ductwork do not have dampers installed for balancing diffusers or for balancing outside air. Recommend to have dampers installed for proper balancing.
Created By : National TAB **Assigned To :** National TAB - Will Turnbough
Status : Open
Priority : Urgent **Asset Tag :**
Originated Date : 05/06/2025 - Zack Eismin - National TAB

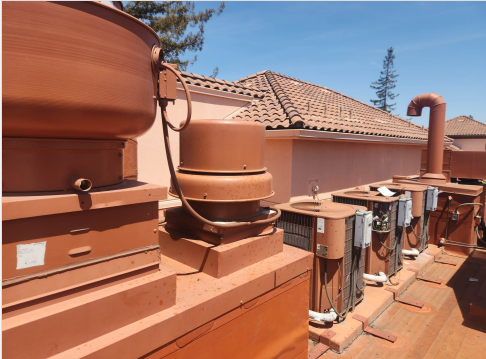
Unit Data - PHOTO LOG

Test Data		
	Design	Actual
CFM	300	289
Fan RPM	-	1378
Fan Rotation	-	CCW
Motor RPM	-	1773
System SetPt	-	1 TURN OPEN
RL Voltage	-	NA
RL Amperage	-	NA
Total ESP	1.00"	0.69"
Fan Inlet SP	-	-0.69"
Fan Discharge SP	-	ATM
