**Report: TAB**

**Function: Test, Adjust, & Balance**

**Date: 05/06/2025**

**05-05-25 SWEETGREEN SANTA CLARA, CA  
(TAB, IAQ)**

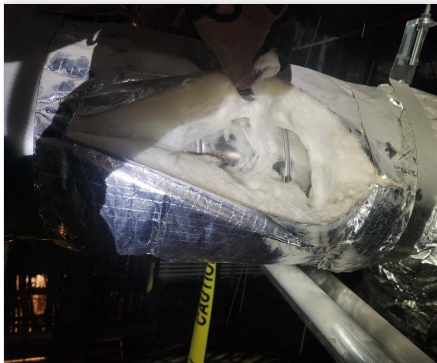
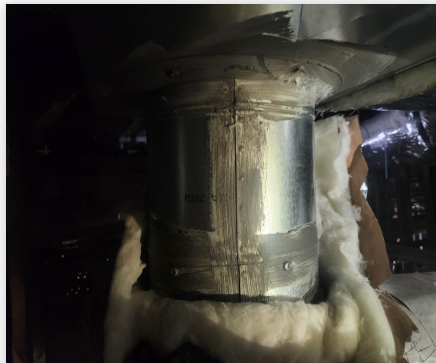
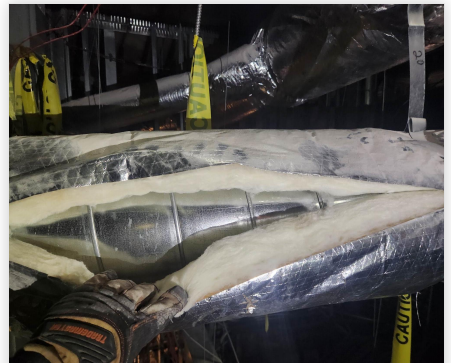
**Issue Name :** EXISTING DUCT WORK DOES NOT HAVE DAMPERS FOR BALANCING  
**Description :** Existing ductwork do not have dampers installed for balancing diffusers or for balancing outside air. Recommend to have dampers installed for proper balancing.

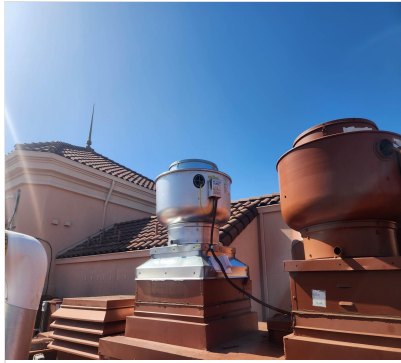
**Identify where the exhaust air is discharged and take pictures**

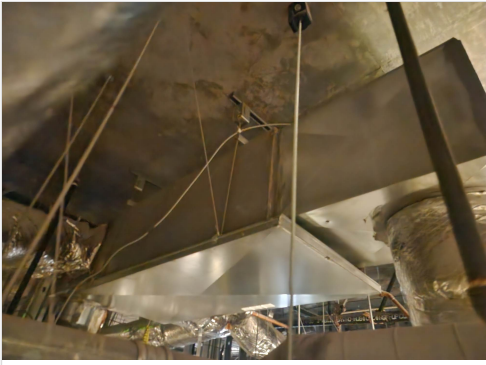
Asset: AHU1

Notes:  
 UNIT IS UNABLE TO MEET DESIGN CURRENTLY 1415 / 2000 CFM  
 EXISTING DUCTWORK DOES NOT HAVE DAMPERS UNABLE TO BALANCE DIFFUSERS PROPORTIONALLY OR SET OA.

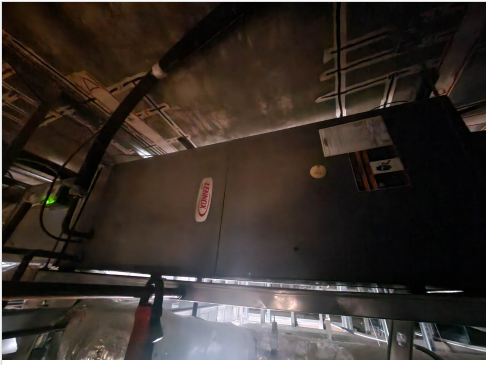
Asset: AHU2

Notes:  
 UNIT IS UNABLE TO MEET DESIGN 1444/2000  
 OA DUCT DOES NOT HAVE DAMPERS TO ADJUST AIRFLOW

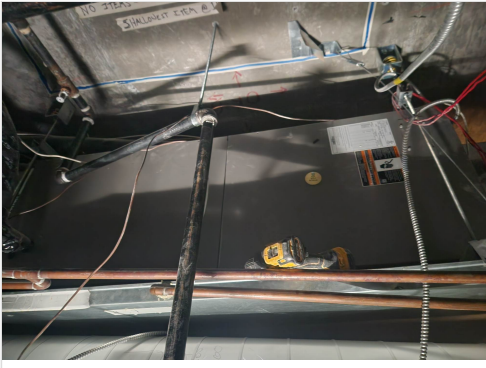
Asset: AHU3

UNIT IS UNABLE TO MEET DESIGN 1468 /2000 CFM.

EXISTING DUCTWORK DOES NOT HAVE DAMPERS DIFFUSERS CANNOT BE SET PRORTIONALLY AND OA CANNOT BE SET.

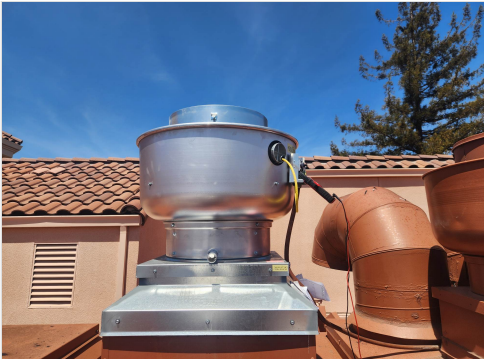
Asset: EF1

Test Data		
	Design	Actual
CFM	1350	1352
Fan RPM	-	NA
Fan Rotation	-	CCW
Motor RPM	-	NA
System SetPt	-	LOW
RL Voltage	-	117
RL Amperage	-	5.2
Total ESP	1.00"	1.02"
Fan Inlet SP	-	-1.02
Fan Discharge SP	-	ATM
