Report: TAB

Function: Test, Adjust, & Balance

Date: 10/28/2024

**10-28-24 KROGER #024-721 - LEXINGTON,
KY (WIW)**

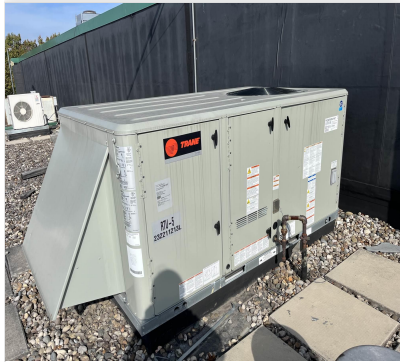
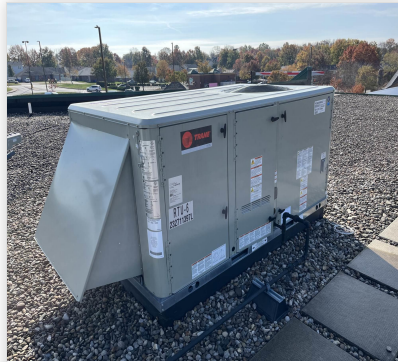
Rtu 5 duct leakage at drop down. Rtu 5 economizer controller potentiometers do not actuate economizer but economizer closes when fan off. Rtu-6 oa high above design even when economizer is fully closed.
