Report: TAB REPORT
Function: Test, Adjust, & Balance
Date: 09/11/2023

PROJECT
09-11-2023 WENDY'S - PLOVER, WI

Issue List

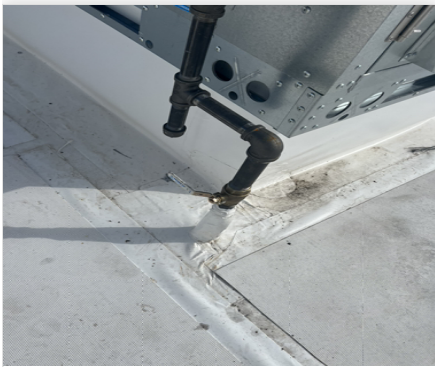
ValveOff
09/12/2023

Issue Name : DOAS Gas Not Yet Started Up
Description : DOAS gas valves are in the off position. Per GC, gas startup has not been completed on the units. Recommend gas startup is completed, and gas valves turned on.
Created By : National TAB **Assigned To :** National TAB - Michael McDonnell
Status : Open
Originated Date : 09/12/2023 - Michael McDonnell - National TAB

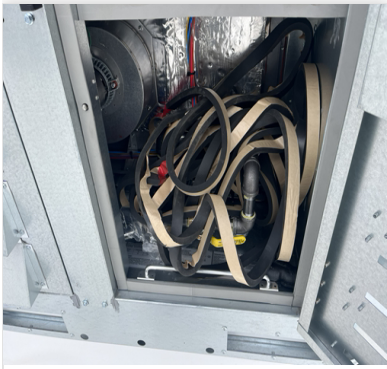
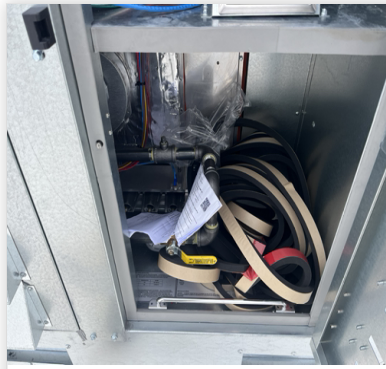
RTU-1
09/12/2023

- **09/12/2023 National TAB - Michael McDonnell**
 - Door padding / Weather Stripping is stored in the gas manifold compartment. Recommend removal and installation.

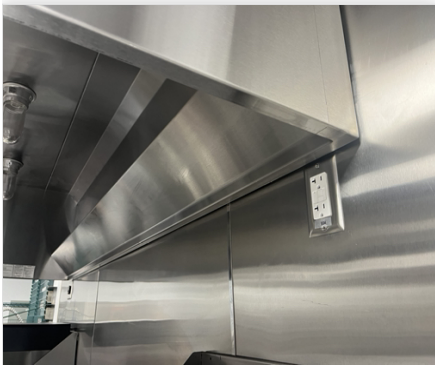
HD
09/12/2023

Issue Name : Hoods Not Flush With Wall
Description : Exhaust hoods are not flush with the back wall. Recommend crack is sealed to prevent accumulation of grease and dirt.
Created By : National TAB **Assigned To :** National TAB - Michael McDonnell
Status : Open
Originated Date : 09/12/2023 - Michael McDonnell - National TAB

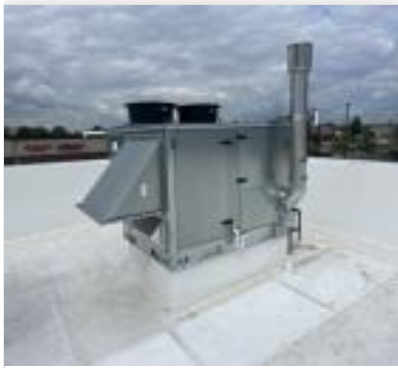
RTU-2-Dining
09/11/2023

Dining RTU causing some general ventilation noise. Not anticipated to cause any issue and should be drowned out by store operation and music.
