Report: prelim

Function: Test, Adjust, & Balance

09-11-2023 WENDY'S - PLOVER, WI

Project: 09-11-2023 WENDY'S - PLOVER, WI

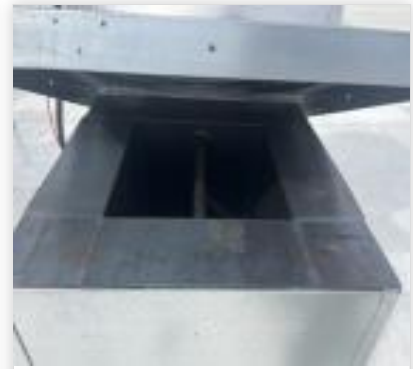
Greaseduct
09/11/2023

Lean fan back. Is grease duct installation adequate and is duct ran all the way to the base of the fan?

Yes
