Report: TAB Report
Function: Test, Adjust, & Balance
Date: 11/20/2025
Completed By: National TAB

PROJECT
09-29-25 WHATABURGER #1545 MARIETTA,
GA

Project: 09-29-25 WHATABURGER #1545 MARIETTA, GA

Project Summary

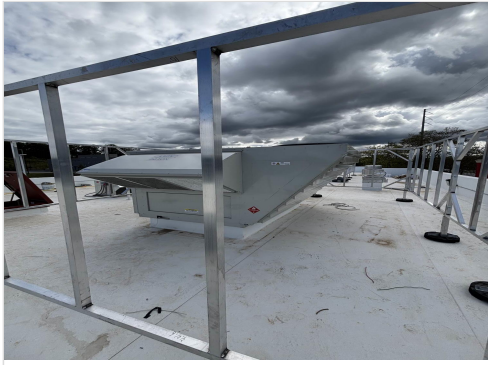
Unit Data - PHOTO LOG

Asset: RTU1

Unit Data		
	Design	Actual
MFG	AAON	AAON
Serial Num	-	202507-BNGP124112
Model Num	RN-020-8-0-GB04-349	RN-020-3-0-FABY-S0-21-000-A
Type	RTU	RTU
Configuration	VERTICAL	VERTICAL
Num OA Filters 1	-	3
OA Filter Size 1	-	23X18
Num Final Filter 1	-	6
Final Filter Size 1	-	20X25X2

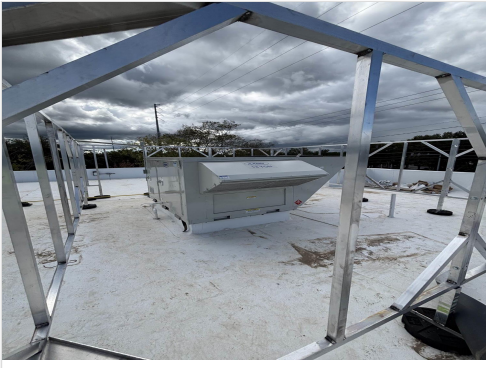
Unit Data - PHOTO LOG

Asset: RTU2

Unit Data		
	Design	Actual
MFG	AAON	AAON
Serial Num	-	202507-ANGK124048
Model Num	RN-013-8-0-GB04-3F9	RN-013-3-0-FABY-S0-21-000-A
Type	DINING	DINING
Configuration	VERTICAL	VERTICAL
Num OA Filters 1	-	2
OA Filter Size 1	-	23X18
Num Final Filter 1	-	4
Final Filter Size 1	-	20X25X2

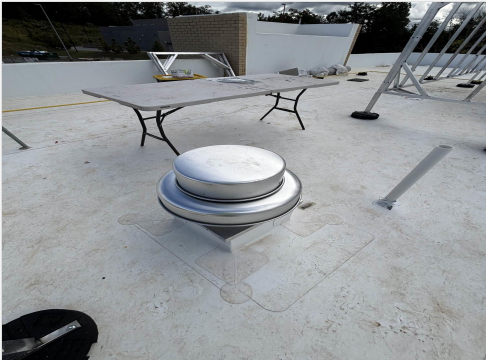
Unit Data - PHOTO LOG

Asset: EF1

Unit Data		
	Design	Actual
MFG	GREENHECK	GREENHECK
Model Num	G-095-D	G-095-D
Serial Num	-	27169131
Type	CEILING	DOWNBLAST
Configuration	VERTICAL	VERTICAL

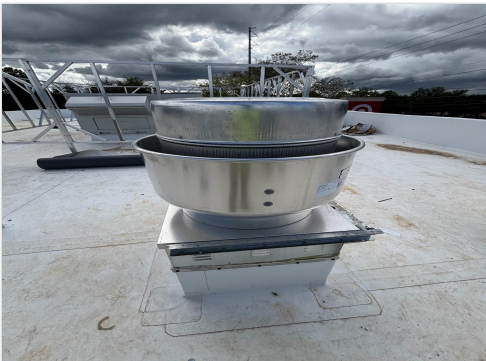
Unit Data - PHOTO LOG

Asset: KEF1

Unit Data		
	Design	Actual
MFG	GREENHECK	GREENHECK
Model Num	CUE-140-10-VG	CUE-140-VG
Serial Num	-	27181721
Type	UPBLAST	UPBLAST
Configuration	VERTICAL	VERTICAL

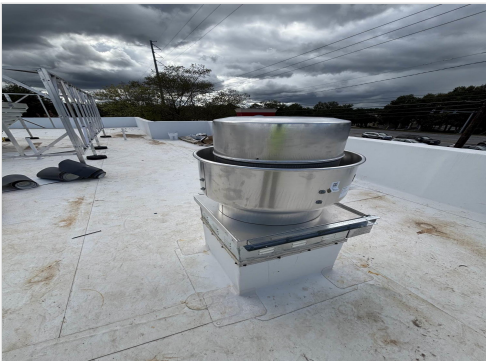
Unit Data - PHOTO LOG

Asset: KEF2

Unit Data		
	Design	Actual
MFG	GREENHECK	GREENHECK
Model Num	CUE-120-VG	CUE-120-VG
Serial Num	-	27181762
Type	UPBLAST	UPBLAST
Configuration	VERTICAL	VERTICAL

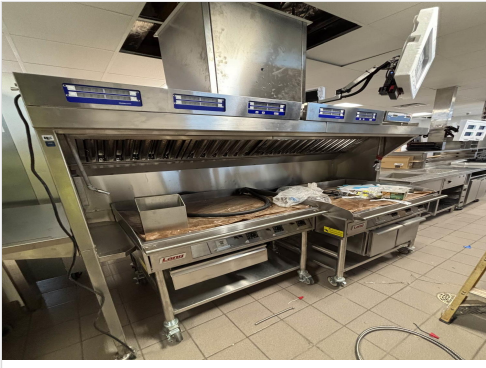
Unit Data - PHOTO LOG

Asset: HD1

Unit Data		
	Design	Actual
MFG	H&K DALLAS	H&K DALLAS
Model Num	HKD023	HKD027
Job / Serial Num	-	8157759-001
Type	TYPE 1 CANOPY	TYPE 1 CANOPY
Hood length	86.78"	87"
Hood Width	55.63"	56"

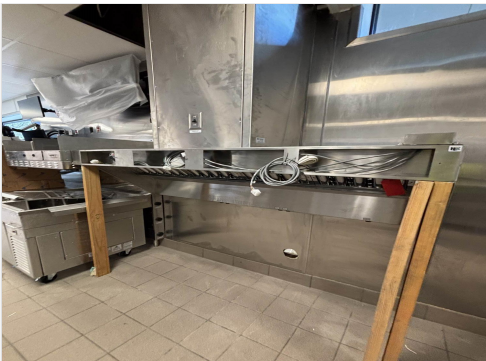
Unit Data - PHOTO LOG

Asset: HD2

Unit Data		
	Design	Actual
MFG	H&K DALLAS	H&K DALLAS
Model Num	HKD023	HKD023
Job / Serial Num	-	8170840-001
Type	TYPE 1 CANOPY	TYPE 1 CANOPY
Hood length	73"	73"
Hood Width	22.19"	26"
