Report: TAB REPORT
Function: Test, Adjust, & Balance
Date: 01/30/2026
Completed By: National TAB

PROJECT
01-26-26 WAWA #7219 LIMA, OH

Project: 01-26-26 WAWA #7219 LIMA, OH

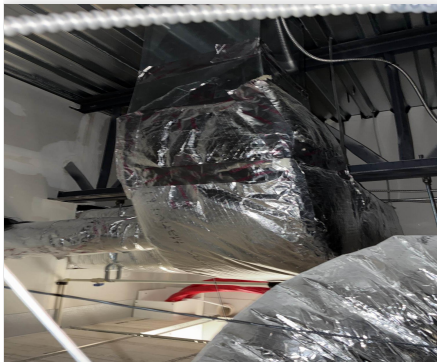
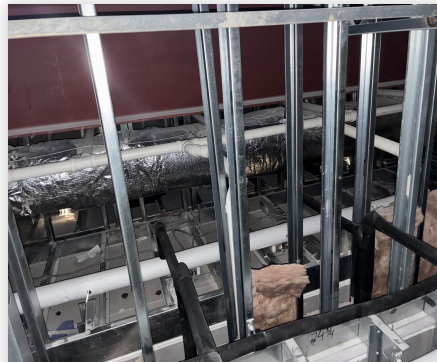
Issue Name : EF-1 DIFFUSERS LOW FLOW
Description : EF-1 diffusers read a total of 937cfm out of 1500cfm required by design. Motor sheave is fully tightened; motor is operating at maximum amperage. No duct leakage detected. Exhaust fan ductwork pictured. Issue is also present at the Richmond, IN store of the same model.
Created By : National TAB **Assigned To :** National TAB - Noah Stafford
Status : Open
Priority : High **Asset Tag :**
Originated Date : 01/28/2026 - Noah Stafford - National TAB

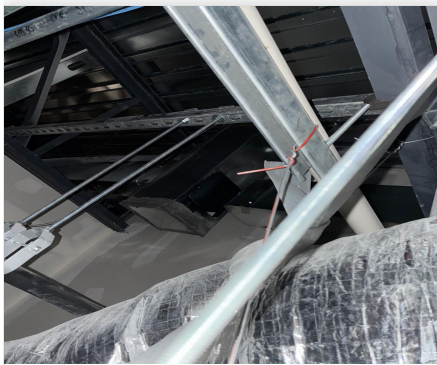
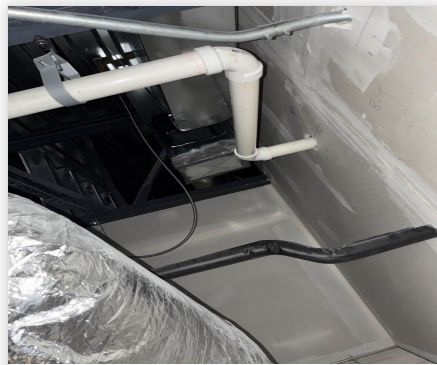
Issue Name : EF-2 LOW FLOW
Description : EF-2 is exhausting 120cfm out of 400cfm required by design. Low exhaust grille readings likely due to detached ductwork pictured.
Created By : National TAB **Assigned To :** National TAB - Noah Stafford
Status : Closed
Priority : High **Asset Tag :**
Originated Date : 01/29/2026 - Noah Stafford - National TAB

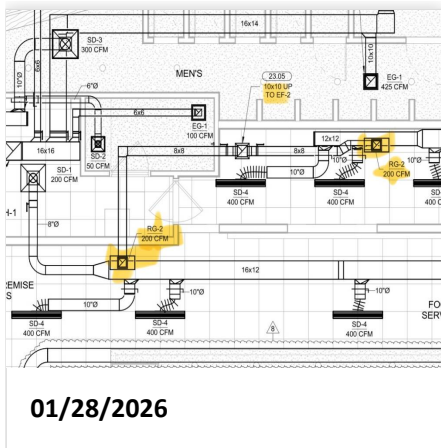
Issue Name : EF-2 MISSING GRILLES
Description : EF-2 is missing both grilles. TAB cannot be completed until resolved.
Created By : National TAB **Assigned To :** National TAB - Noah Stafford
Status : Closed
Priority : **Urgent** **Asset Tag :**
Originated Date : 01/27/2026 - Noah Stafford - National TAB

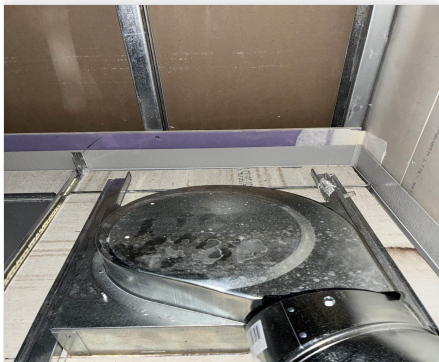
Issue Name : EF-3 POWER
Description : EF-3 is not wired. TAB cannot be completed until resolved.
Created By : National TAB **Assigned To :** National TAB - Noah Stafford
Status : Closed
Priority : Urgent **Asset Tag :**
Originated Date : 01/27/2026 - Noah Stafford - National TAB

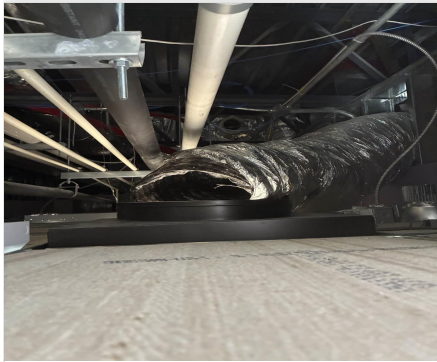
Issue Name : RTU-1 RETURN DUCTWORK
Description : Return grill 1-3 disconnected. Return grill 1-2 not ducted. TAB cannot be completed until resolved.
Created By : National TAB **Assigned To :** National TAB - Noah Stafford
Status : Closed
Priority : Urgent **Asset Tag :**
Originated Date : 01/27/2026 - Noah Stafford - National TAB

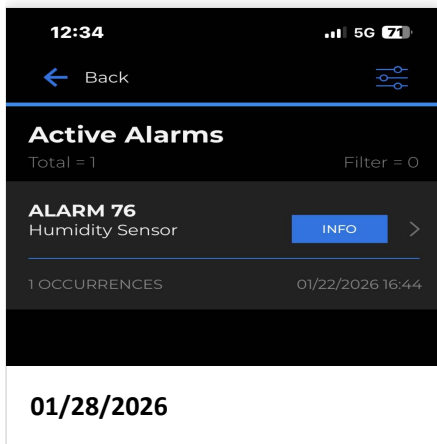
Issue Name : RTU-2 ALARM
Description : RTU-2 has error code 76: humidity sensor. Issue does not prevent TAB.
Created By : National TAB **Assigned To :** National TAB - Noah Stafford
Status : Open
Priority : InfoOnly **Asset Tag :**
Originated Date : 01/28/2026 - Noah Stafford - National TAB

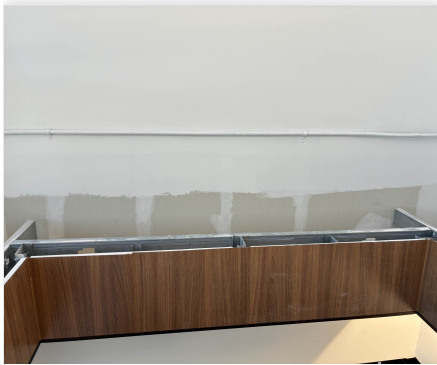
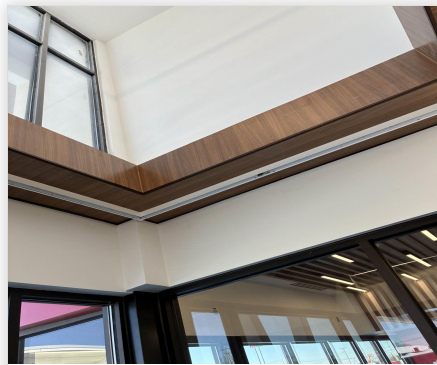
Issue Name : RTU-3 MISSING DIFFUSER
Description : RTU-3 is missing diffuser 3-1 at the main entrance vestibule. TAB cannot be completed until installed.
Created By : National TAB **Assigned To :** National TAB - Noah Stafford
Status : Closed
Priority : Urgent **Asset Tag :**
Originated Date : 01/28/2026 - Noah Stafford - National TAB

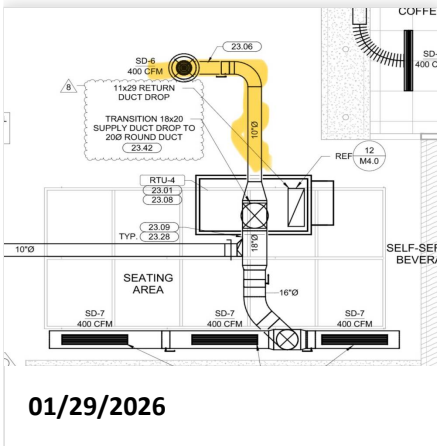
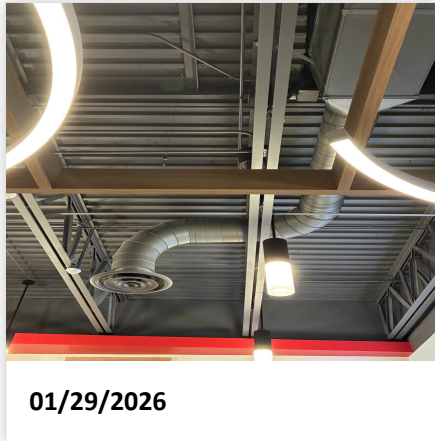
Issue Name : RTU-4 MISSING DAMPER
Description : RTU-4 missing damper on pictured round diffuser. TAB cannot be completed until resolved.
Created By : National TAB **Assigned To :** National TAB - Noah Stafford
Status : Closed
Priority : High **Asset Tag :**
Originated Date : 01/29/2026 - Noah Stafford - National TAB
