Report By:

National TAB
1329 E. KEMPER ROAD
SUITE 4210
CINCINNATI, OH 45246

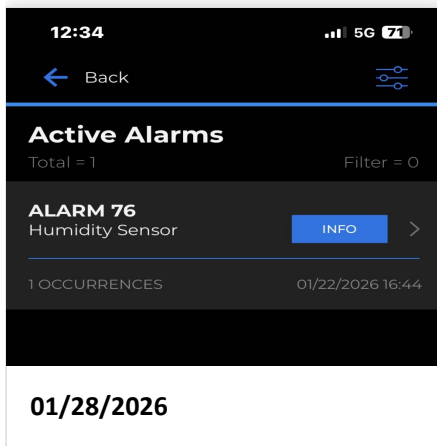
Project Issue Response Details

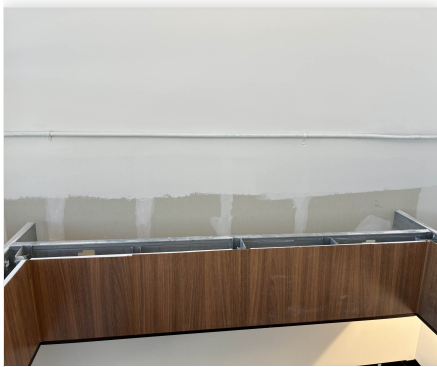
Project Issue File Details

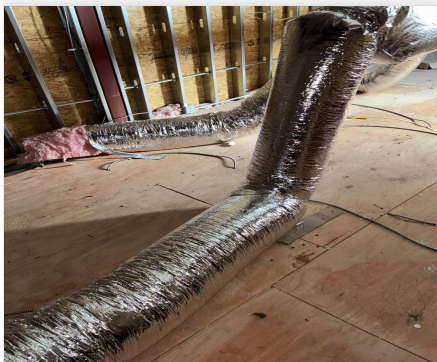
Project Issue File Details
