Report By:

National TAB
1329 E. KEMPER ROAD
SUITE 4210
CINCINNATI, OH 45246

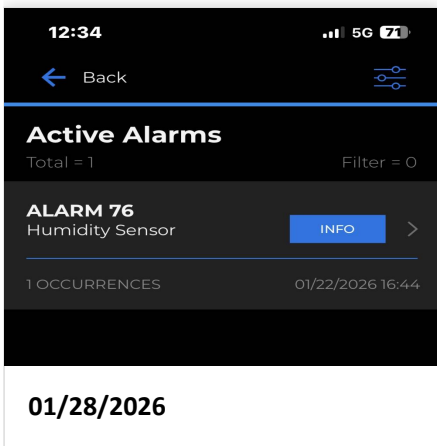
Project Issue File Details
