Report By:

National TAB
1329 E. KEMPER ROAD
SUITE 4210
CINCINNATI, OH 45246

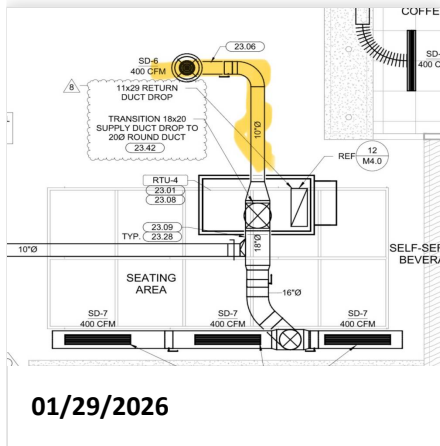
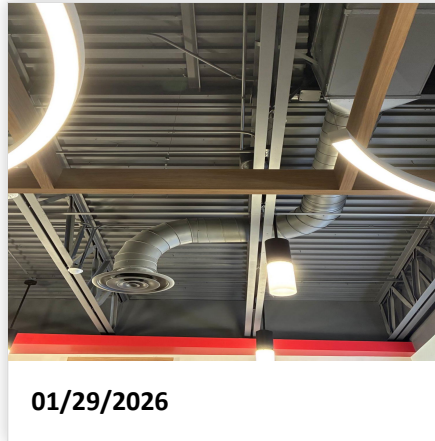
AIR BALANCE SCHEDULE
