Report: FINAL TAB REPORT
Function: Test, Adjust, & Balance
Date: 11/14/2022

11-14 CHIPOTLE - SPANISH FORK #43-4049 (SPANISH FORK, UT)

841 E Highway 6

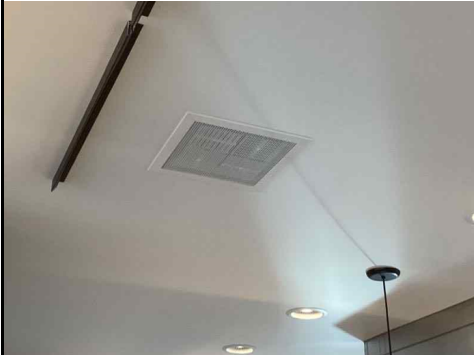
Name:	Deflectors not removed per schedule.jpg				
Captured:	11/9/2022 1:37 PM

Issue ID:	0001	Status:	Corrected	Issue Priority:	
Equipment:	RTU-01/S-05				Created Date: 09-Nov-22
Area:	Service Line				Completed Date: 09-Nov-22
Issue Description:					
Deflectors not removed per schedule.					
Issue Type:	Installation				
Role Assignment:	Mechanical Contractor				
Comments / Signature:					
Issue Photos:

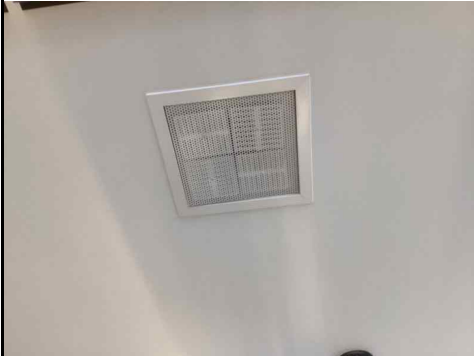
Name:	Deflectors not removed per schedule.jpg				
Captured:	11/9/2022 1:37 PM

Issue ID:	0002	Status:	Corrected	Issue Priority:	
Equipment:	RTU-01/S-06				Created Date: 09-Nov-22
Area:	Service Line				Completed Date: 09-Nov-22
Issue Description:					
Deflectors not removed per schedule.					
Issue Type:	Installation				
Role Assignment:	Mechanical Contractor				
Comments / Signature:					
Issue Photos:

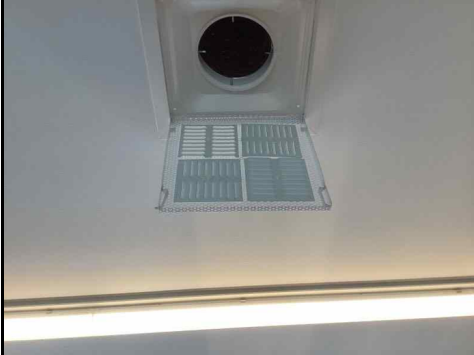
Name:	Deflectors not removed per schedule..jpg				
Captured:	11/9/2022 1:38 PM

Issue ID:	0003	Status:	Corrected	Issue Priority:	
Equipment:	RTU-01/S-07				Created Date: 09-Nov-22
Area:	Service Line				Completed Date: 09-Nov-22
Issue Description:					
Deflectors not removed per schedule.					
Issue Type:	Installation				
Role Assignment:	Mechanical Contractor				
Comments / Signature:					
Issue Photos:

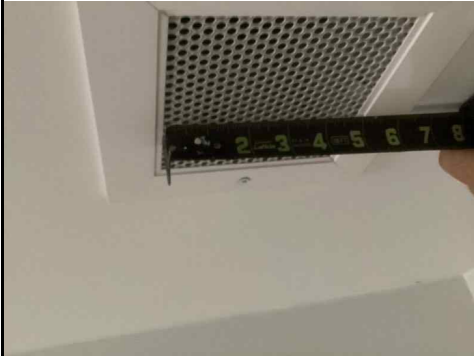
Name:	Drawings show inlet to be a 6x6 grille. 5x5 is ins.jpg				
Captured:	11/9/2022 1:51 PM

Issue ID:	0005	Status:	Accepted as is	Issue Priority:	
Equipment:	EF-02/E-01				Created Date: 09-Nov-22
Area:	RESTROOM				Completed Date: 10-Nov-22
Issue Description:					
No OBD installed.					
Issue Type:	Installation				
Role Assignment:	Mechanical Contractor				
Comments / Signature:					
Issue Photos:

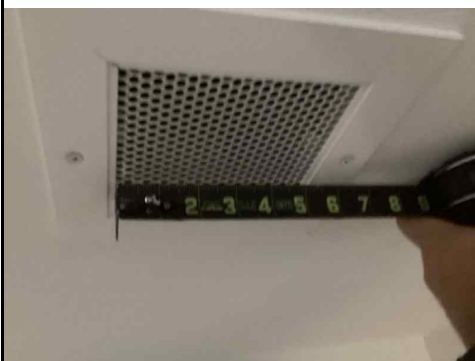
Name:	Drawings show inlet to be a 6x6 grille. 5x5 is ins.jpg				
Captured:	11/9/2022 1:53 PM

Issue ID:	0006	Status:	Accepted as is	Issue Priority:	
Equipment:	EF-02/E-02				Created Date: 09-Nov-22
Area:	RESTROOM				Completed Date: 10-Nov-22
Issue Description:					
No OBD installed.					
Issue Type:	Installation				
Role Assignment:	Mechanical Contractor				
Comments / Signature:					
Issue Photos:

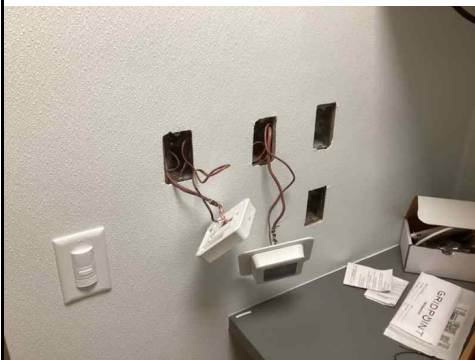
Name:	T-stats not installed in wall. Gridpoint not yet i.jpg				
Captured:	11/9/2022 2:43 PM

Issue ID:	0007	Status:	Open	Issue Priority:	
Equipment:					Created Date: 09-Nov-22
Issue Description:					
T-stats not installed in wall. Gridpoint not yet installed.					
Issue Type:	Installation				
Role Assignment:	Mechanical Contractor				
Comments / Signature:					
Issue Photos:

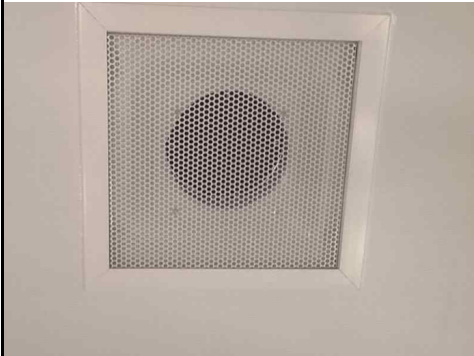
Name:	Integral OBD outlined in schedule not installed. U.jpg				
Captured:	11/9/2022 3:04 PM

Issue ID:	0010	Status:	Open	Issue Priority:	
Equipment:	RTU-01/S-05				Created Date: 09-Nov-22
Area:	Service Line				
Issue Description:					
No OBD installed. Unable to verify if there is a damper at the tap.					
Issue Type:	Installation				
Role Assignment:	Mechanical Contractor				
Comments / Signature:					
Issue Photos:

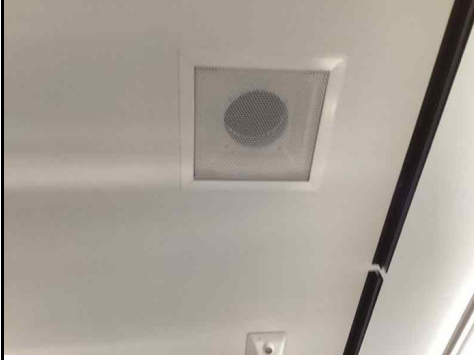
Name:	Integral OBD outlined in schedule not installed. U.jpg				
Captured:	11/9/2022 3:04 PM

Issue ID:	0011	Status:	Open	Issue Priority:	
Equipment:	RTU-01/S-06				Created Date: 09-Nov-22
Area:	Service Line				
Issue Description:					
No OBD installed. Unable to verify if there is a damper at the tap.					
Issue Type:	Installation				
Role Assignment:	Mechanical Contractor				
Comments / Signature:					
Issue Photos:

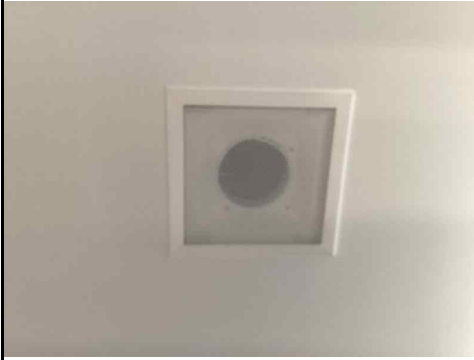
Name:	Integral OBD outlined in schedule not installed. U.jpg				
Captured:	11/9/2022 3:04 PM

Issue ID:	0012	Status:	Open	Issue Priority:	
Equipment:	RTU-01/S-07				Created Date: 09-Nov-22
Area:	Service Line				
Issue Description:					
No OBD installed. Unable to verify if there is a damper at the tap.					
Issue Type:	Installation				
Role Assignment:	Mechanical Contractor				
Comments / Signature:					
Issue Photos:

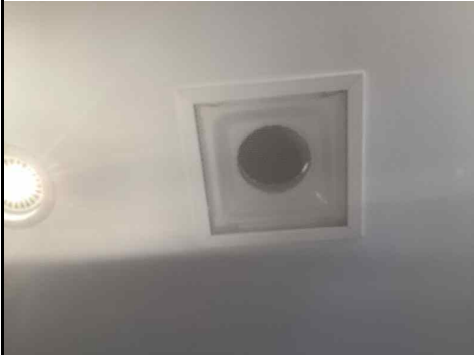
Name:	Integral OBD outlined in schedule not installed. U.jpg				
Captured:	11/9/2022 3:05 PM

Issue ID:	0013	Status:	Open	Issue Priority:	
Equipment:	RTU-01/S-08				Created Date: 09-Nov-22
Area:	Service Line				
Issue Description: No OBD installed. Unable to verify if there is a damper at the tap.					
Issue Type:	Installation				
Role Assignment:	Mechanical Contractor				
Comments / Signature:					
Issue Photos:

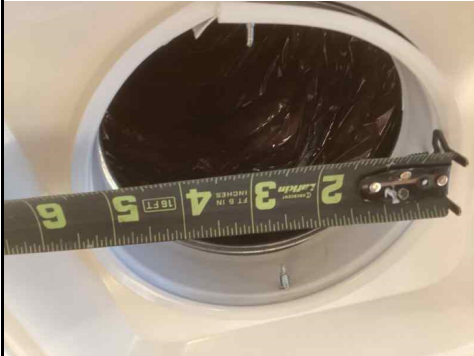
Name:	Drawings show design of 8" outlets. 6" outlets are.jpg				
Captured:	11/9/2022 3:19 PM

Issue ID:	0014	Status:	Open	Issue Priority:	
Equipment:	RTU-01/S-05				Created Date: 09-Nov-22
Area:	Service Line				
Issue Description: Duct is installed as a 6 inch and not an 8 inch, restricting the airflow.					
Issue Type:	Installation				
Role Assignment:	Mechanical Contractor				
Comments / Signature:					
Issue Photos:

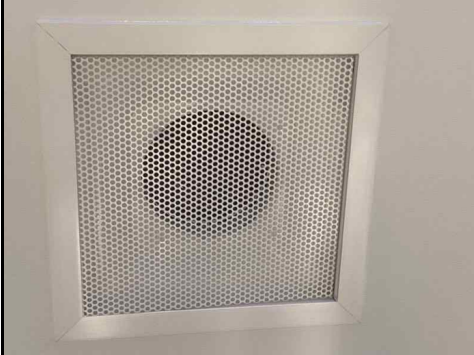
Name:	Drawings show design of 8" outlets. 6" outlet is i.jpg				
Captured:	11/9/2022 3:23 PM

Issue ID:	0015	Status:	Open	Issue Priority:	
Equipment:	RTU-01/S-06				Created Date: 09-Nov-22
Area:	Service Line				
Issue Description: Duct is installed as a 6 inch and not an 8 inch, restricting the airflow.					
Issue Type:	Installation				
Role Assignment:	Mechanical Contractor				
Comments / Signature:					
Issue Photos:

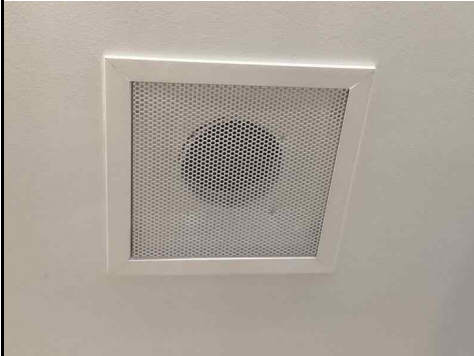
Name:	Drawings show design of 8" outlets. 6" outlet is i.jpg				
Captured:	11/9/2022 3:23 PM

Issue ID:	0016	Status:	Open	Issue Priority:	
Equipment:	RTU-01/S-07				Created Date: 09-Nov-22
Area:	Service Line				
Issue Description: Duct is installed as a 6 inch and not an 8 inch, restricting the airflow.					
Issue Type:	Installation				
Role Assignment:	Mechanical Contractor				
Comments / Signature:					
Issue Photos:

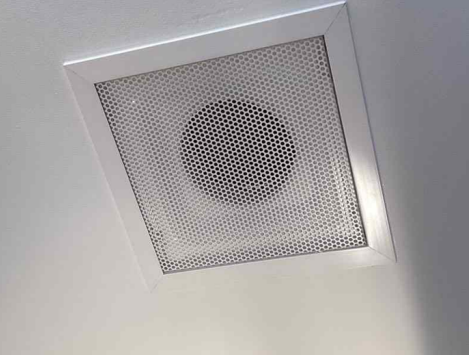
Name:	Drawings show design of 8" outlets. 6" outlet is i.jpg				
Captured:	11/9/2022 3:24 PM

Issue ID:	0017	Status:	Open	Issue Priority:	
Equipment:	RTU-01/S-08	Created Date: 09-Nov-22			
Area:	Service Line				
Issue Description: Duct is installed as a 6 inch and not an 8 inch, restricting the airflow.					
Issue Type:	Installation				
Role Assignment:	Mechanical Contractor				
Comments / Signature:					
Issue Photos:

RTU-01/S-08	11/9/2022	Clayton Nelson	Duct is installed as a 6 inch and not an 8 inch, restricting the airflow.

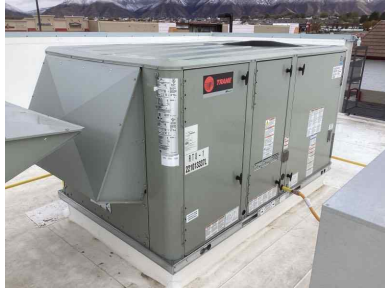
SYSTEM/UNIT: RTU-01

Design Airflow (CFM)		Final Airflow (CFM)	
Design Total	3400	Actual Total CFM	3057
Design Grille Total	3100	Actual Grille Total CFM	3057
Design Return	2900	Actual Return Air CFM	2519
Design Min O/A	500	Actual Min O/A CFM	538
Unit Design Data		Unit Data	
Submittal Make	Trane	Make (tag)	Trane
Submittal Model #	YHC102	Model # (tag)	YHC102F3RLA26K7C1A2A
Submittal Airflow	Not Provided	Serial # (tag)	221013337L
Sched./Sub. Volts	208	Location	Roof
Sched./Sub. Phase	3	Unit Discharge	Downblast
Sched./Sub. HP	Not Listed	Cooling Coil Location	Unit / Drawthru
Submittal BHP	Not Provided	Coil Area (sq ft)	13.9
Filter MERV Rating (Sched/Sub)	Not Listed	Clg Coil Vel (FPM)	220
Design Static Pressures (in wg)		Fan Design Data	
Design Ext SP	0.8	Submittal Motor RPM	Not Provided
Submittal Total SP	Not Provided	Submittal Fan RPM	-
Submittal Clg Coil Δ SP	-	Fan Data	
Filter Data		Actual Fan RPM/Speed	45%
Condition	Partially Loaded	Actual Motor RPM	Not Accessible

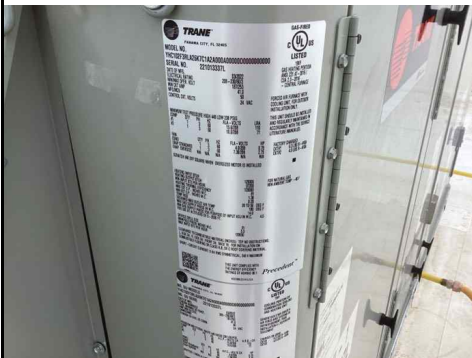
Make (tag) Photo:

Name: Make (tag).jpg
 Captured: 11/9/2022 1:31 PM
 Caption:

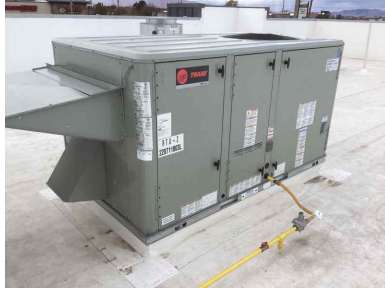
SYSTEM/UNIT: RTU-02

Design Airflow (CFM)		Final Airflow (CFM)	
Design Total	3400	Actual Total CFM	3206
Design Grille Total	3400	Actual Grille Total CFM	3206
Design Return	2400	Actual Return Air CFM	2183
Design Min O/A	1000	Actual Min O/A CFM	1023
Unit Design Data		Unit Data	
Submittal Make	Trane	Make (tag)	Trane
Submittal Model #	YHC102	Model # (tag)	YHC102F3RHA26K7C1A2A
Submittal Airflow	Not Provided	Serial # (tag)	220711803L
Sched./Sub. Volts	208	Location	Roof
Sched./Sub. Phase	3	Unit Discharge	Downblast
Sched./Sub. HP	Not Listed	Cooling Coil Location	Unit / Drawthru
Submittal BHP	Not Provided	Coil Area (sq ft)	13.9
Filter MERV Rating (Sched/Sub)	Not Listed	Clg Coil Vel (FPM)	231
Design Static Pressures (in wg)		Fan Design Data	
Design Ext SP	0.8	Submittal Motor RPM	Not Provided
Submittal Total SP	Not Provided	Submittal Fan RPM	-
Submittal Clg Coil Δ SP	-	Fan Data	
Filter Data		Actual Fan RPM/Speed	30%
Condition	Partially Loaded	Actual Motor RPM	Not Accessible

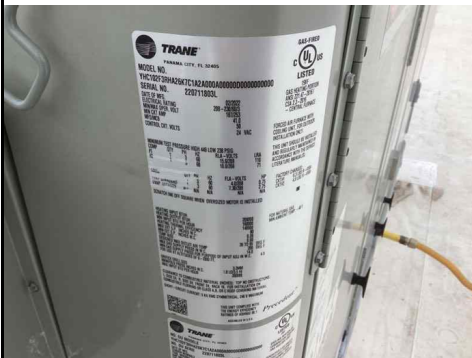
Make (tag) Photo:

Name: Make (tag).jpg
Captured: 11/9/2022 1:30 PM
Caption:

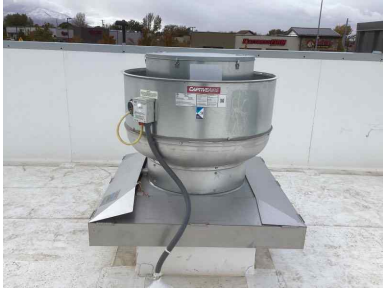
SYSTEM/UNIT: EF-01

Design Airflow (CFM)		Final Airflow (CFM)		
Design Airflow	3200	Actual Airflow	3250	
Design Grille Airflow	Not Applicable	Actual Grille Airflow	Not Applicable	
<th>Unit Design Data</th> <td>Fan CFM Test Method</td> <td>See Kitchen Hood Sheet</td>		Unit Design Data	Fan CFM Test Method	See Kitchen Hood Sheet
Submittal Make	CAPTIVEAIRE	Test Method Ak (sq ft)	-	
Submittal Model #	NCA24HPFA	<th>Unit Data</th>		Unit Data
Submittal Airflow	Not Provided	Make (tag)	Captive Aire	
Sched./Sub. Volts	208	Model # (tag)	DU240HFA	
Sched./Sub. Phase	3	Serial # (tag)	5024088	
Sched./Sub. HP	2	Unit Location	Roof	
Submittal BHP	Not Provided	Unit Discharge	Upblast	
<th>Design Static Pressures (in wg)</th> <td>Fan Service</td> <td>Exhaust</td>		Design Static Pressures (in wg)	Fan Service	Exhaust
Design External SP	1.20	Fan Type	Centrifugal (BI)	
Submittal Total SP	Not Provided	Fan Discharge	Upblast	
<th>Motor Nameplate Data</th> <td>Fan Arrangement</td> <td>SWSI</td>		Motor Nameplate Data	Fan Arrangement	SWSI

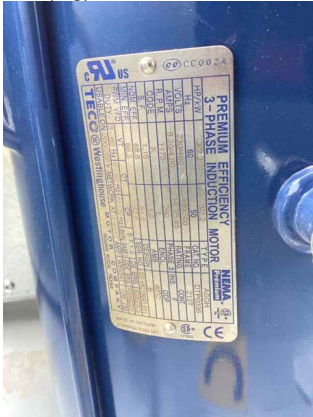
Motor Make (tag) Photo:

Name: Motor Make (tag).jpg
Captured: 11/9/2022 1:28 PM
Caption:

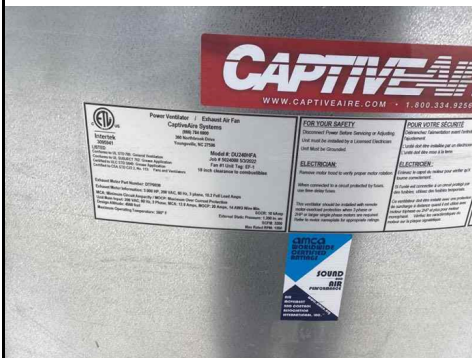
Make (tag) Photo:

Name: Make (tag).jpg
Captured: 11/9/2022 1:28 PM
Caption:

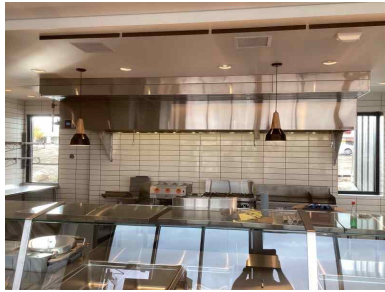
SYSTEM/UNIT: EF-01/HD-01

Design Airflow (CFM)		Final Airflow (CFM)	
Design Exhaust CFM	3200	Actual Exhaust CFM	3250

Test Section		Supplemental Data	
Smoke Generation Type	Smoke Emitter	Space Offset Temp Riser 1	15
Cooking Equip Heat On	No	Space Offset Temp Riser 2	15
Hood Capture %	100	Riser Temp F (idle) Riser 1	66.5
End Panels Installed (Y/N)	Y	Riser Temp F (idle) Riser 2	60.9
		Ambient Room Temp	66.7
		100% override functional	N

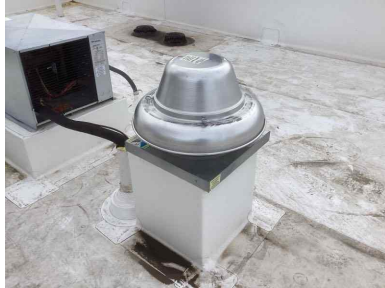
SYSTEM/UNIT: EF-02

Design Airflow (CFM)		Final Airflow (CFM)	
Design Airflow	150	Actual Airflow	162
Design Grille Airflow	150	Actual Grille Airflow	162
		Fan CFM Test Method	Inlet Total
		Test Method Ak (sq ft)	Not Applicable
Unit Design Data		Unit Data	
Submittal Make	CAPTIVEAIRE	Make (tag)	Captive Aire
Submittal Model #	DR12HFA	Model # (tag)	DR12HFA
Submittal Airflow	Not Provided	Serial # (tag)	5024388
Sched./Sub. Volts	120	Unit Location	Roof
Sched./Sub. Phase	1	Unit Discharge	Upblast
Sched./Sub. HP	0.18	Fan Service	Exhaust
Submittal BHP	Not Provided	Fan Type	Centrifugal (BI)
		Fan Discharge	Upblast
		Fan Arrangement	SWSI
Design Static Pressures (in wg)		Fan Design Data	
Design External SP	.60	Submittal Motor RPM	Not Provided
Submittal Total SP	Not Provided	Submittal Fan RPM	-
Motor Nameplate Data		Fan Data	
Motor Make (tag)	NEMA	Actual Fan RPM/Speed	859
Motor Frame (tag)	-	Actual Motor RPM	Not Accessible
Motor HP (tag)	1/4	Speed Cont. Position	48%

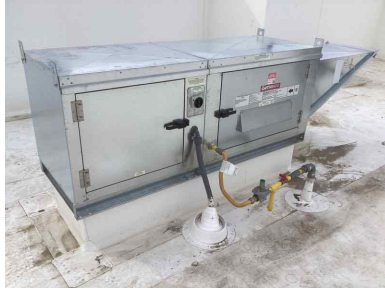
SYSTEM/UNIT: MAU-01

Design Airflow (CFM)		Final Airflow (CFM)	
Design Airflow	1950	Actual Airflow	1951
Design Grille Airflow	Not Applicable	Actual Grille Airflow	Not Applicable
		Fan CFM Test Method	See Kitchen Hood Sheet
		Test Method Ak (sq ft)	-
Unit Design Data		Unit Data	
Submittal Make	CAPTIVEAIRE	Make (tag)	Captive Aire
Submittal Model #	A1-D.250-G10	Model # (tag)	A1-D.250-15D
Submittal Airflow	Not Provided	Serial # (tag)	5024088
Sched./Sub. Volts	208	Unit Location	Roof
Sched./Sub. Phase	3	Unit Discharge	Downblast
Sched./Sub. HP	2	Fan Service	Make-Up Air
Submittal BHP	Not Provided	Fan Type	Centrifugal (FC)
		Fan Discharge	Downblast
		Fan Arrangement	DWDI
Design Static Pressures (in wg)		Fan Design Data	
Design External SP	.80	Submittal Motor RPM	Not Provided
Submittal Total SP	Not Provided	Submittal Fan RPM	-
Motor Nameplate Data		Fan Data	
Motor Make (tag)	TECO	Actual Fan RPM/Speed	Single Speed
Motor Frame (tag)	145T	Actual Motor RPM	Not Accessible

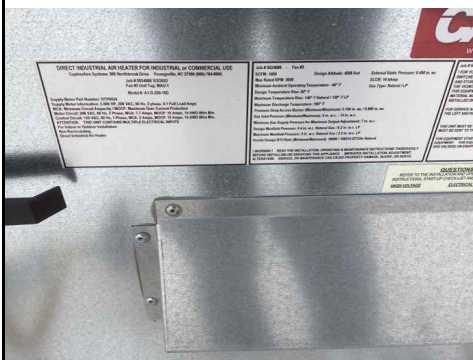
Make (tag) Photo:

Name: Make (tag).jpg
Captured: 11/9/2022 1:27 PM
Caption:
