**Report: TAB Report**  
**Function: Test, Adjust, & Balance**  
**Date: 02/26/2025**  
**Completed By: National TAB**

**PROJECT**  
**02-24-25 WAWA #6309 POOLER, GA**

Project: 02-24-25 WAWA #6309 POOLER, GA

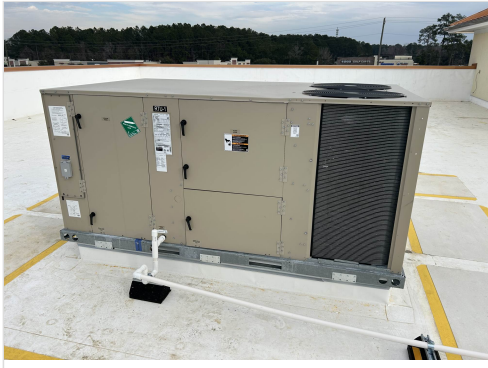
## Unit Data - PHOTO LOG

Asset: RTU1

Unit Data		
	Design	Actual
MFG	LENNOX	LENNOX
Serial Num	-	5624L02327
Model Num	LCT102H4E	LCT102H4EG2Y
Type	RTU	RTU
Configuration	VERTICAL	VERTICAL
Num OA Filters 1	-	1
OA Filter Size 1	-	23x14
Num Final Filter 1	-	4
Final Filter Size 1	-	20x25x2

Test Data		
	Design	Actual
SF CFM	3400	3386
SF RPM	-	1193
MOTOR RPM	-	1193
RA CFM	2900	2863
OA CFM	500	523
RL Voltage	-	214/214/213
RL Amperage	-	2.9/2.9/3.0
SF System SetPt	-	67%
OA Damper Position	-	45%
OA Damper Type	-	SINGLE BLADE

Performance Data		
	Design	Actual
MA Plenum SP	-	-0.26"
Fan Suction SP	-	-0.74"
Fan Discharge SP	-	0.57"
Total ESP	0.51"	0.83"
Fan Total SP	-	1.31"

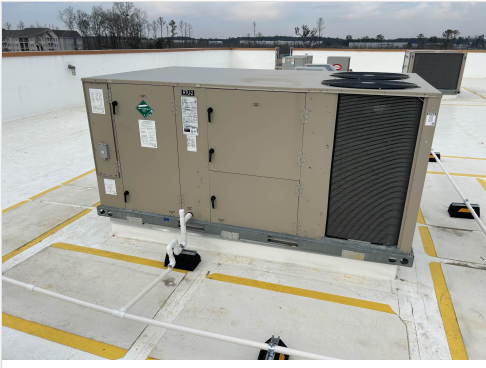
## Unit Data - PHOTO LOG

Asset: RTU2

Unit Data		
	Design	Actual
MFG	LENNOX	LENNOX
Serial Num	-	5624L02328
Model Num	LCT150H4E	LCT150H4EN2Y
Type	RTU	RTU
Configuration	VERTICAL	VERTICAL
Num OA Filters 1	-	1
OA Filter Size 1	-	23x14
Num Final Filter 1	-	4
Final Filter Size 1	-	20x25x2

Test Data		
	Design	Actual
SF CFM	5000	5085
SF RPM	-	1513
MOTOR RPM	-	1513
RA CFM	4500	4580
OA CFM	500	505
RL Voltage	-	214/214/214
RL Amperage	-	5.2/5.3/5.3
SF System SetPt	-	85%
OA Damper Position	-	37%
OA Damper Type	-	SINGLE BLADE

Performance Data		
	Design	Actual
MA Plenum SP	-	-0.57"
Fan Suction SP	-	-1.22"
Fan Discharge SP	-	0.60"
Total ESP	0.5"	1.17"
Fan Total SP	-	1.82"

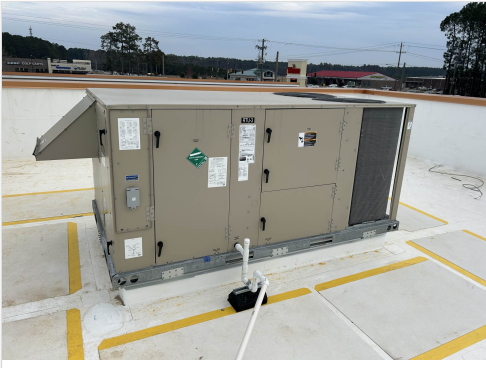
## Unit Data - PHOTO LOG

Asset: RTU3

Unit Data		
	Design	Actual
MFG	LENNOX	LENNOX
Serial Num	-	5624L02329
Model Num	LCT092H4E	LCT092H4EG2Y
Type	RTU	RTU
Configuration	VERTICAL	VERTICAL
Num OA Filters 1	-	1
OA Filter Size 1	-	23x14
Num Final Filter 1	-	4
Final Filter Size 1	-	20x25x2

Test Data		
	Design	Actual
SF CFM	3000	3013
SF RPM	-	1068
MOTOR RPM	-	1068
RA CFM	2700	2698
OA CFM	300	315
RL Voltage	-	215/215/214
RL Amperage	-	2.3/2.3/2.3
SF System SetPt	-	60%
OA Damper Position	-	27%
OA Damper Type	-	SINGLE BLADE

Performance Data		
	Design	Actual
MA Plenum SP	-	-0.27"
Fan Suction SP	-	-0.62"
Fan Discharge SP	-	0.30"
Total ESP	0.5"	0.57"
Fan Total SP	-	0.92"

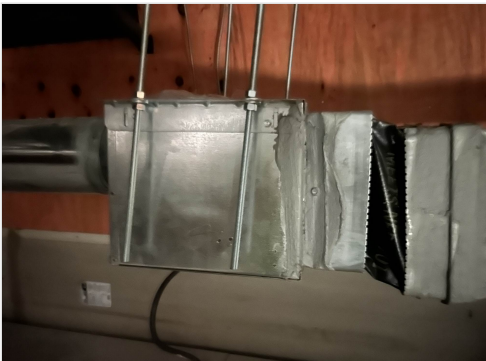
### Unit Data - PHOTO LOG

Asset: EF2

Unit Data		
	Design	Actual
MFG	GREENHECK	GREENHECK
Model Num	CSP-B110	CSP-A110
Serial Num	-	25478695
Type	INLINE	INLINE
Configuration	HORIZONTAL	HORIZONTAL

Test Data		
	Design	Actual
CFM	60	57
Fan RPM	584	950
Fan Rotation	-	CORRECT
Motor RPM	-	950
System SetPt	-	SINGLE SPEED
RL Voltage	-	123
RL Amperage	-	0.19
Total ESP	0.125"	0.042"
Fan Inlet SP	-	-0.042"
Fan Discharge SP	-	ATM
