**Report: TAB Report**  
**Function: Test, Adjust, & Balance**  
**Date: 07/18/2025**  
**Completed By: National TAB**

**PROJECT**  
**07-07-25 WAWA #5453 OCALA, FL**

Project: 07-07-25 WAWA #5453 OCALA, FL

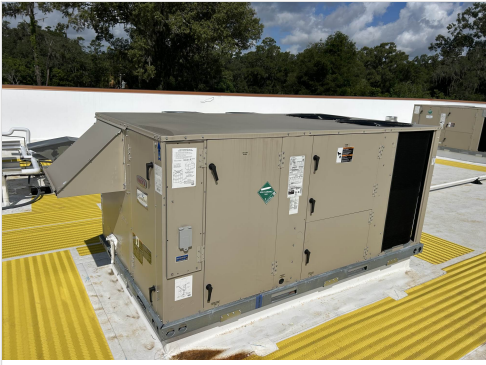
## Unit Data - PHOTO LOG

Asset: RTU1

Test Data		
	Design	Actual
SF CFM	3400	3409
SF RPM	-	1342
MOTOR RPM	-	1342
RA CFM	2900	2904
OA CFM	500	505
RL Voltage	-	212/213/213
RL Amperage	-	2.7/2.7/2.6
SF System SetPt	-	61%
OA Damper Position	-	42%
OA Damper Type	-	SINGLE BLADE

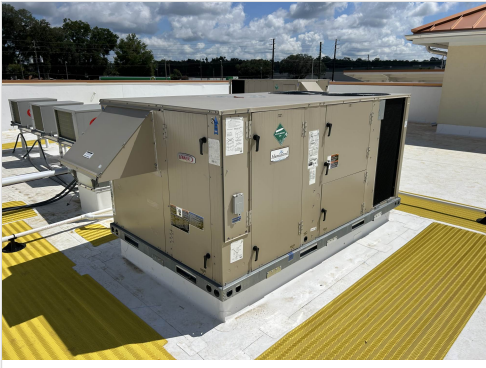
## Unit Data - PHOTO LOG

Asset: RTU2

Test Data		
	Design	Actual
SF CFM	5000	4997
SF RPM	-	1958
MOTOR RPM	-	1958
RA CFM	4500	4501
OA CFM	500	496
RL Voltage	-	213/212/213
RL Amperage	-	6.6/6.5/6.5
SF System SetPt	-	89%
OA Damper Position	-	37%
OA Damper Type	-	SINGLE BLADE

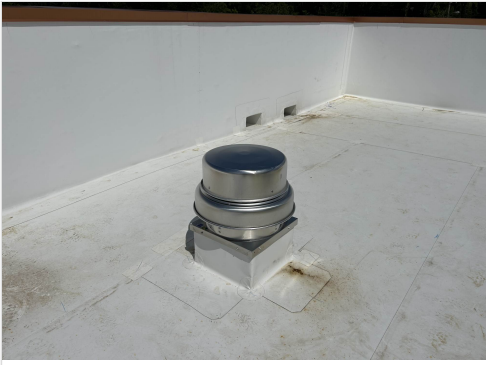
**Unit Data - PHOTO LOG**

Asset: EF1

Test Data		
	Design	Actual
CFM	800	913
Fan RPM	863	DD
Fan Rotation	-	CW
Motor RPM	-	DD
System SetPt	-	SPEED CONTROLLER (MARKED)
RL Voltage	-	112
RL Amperage	-	2.1
Total ESP	.250"	0.33"
Fan Inlet SP	-	-0.33"
Fan Discharge SP	-	ATM

Fan cannot be slowed further without overramping motor.

**Issue Name :** EF-1 - High Flow  
**Description :** EF-1 is currently running at 913 CFM (114% design). Slowing the fan further causes the motor to overamp, except at extremely low speeds. All exhaust grilles are balanced proportionally to the high total. No further action required.  
**Created By :** National TAB                      **Assigned To :** National TAB - Dan Hertenstein  
**Status :** Open  
**Priority :** InfoOnly                                      **Asset Tag :**  
**Originated Date :** 07/13/2025 - Mark Johnson - National TAB

- **02/19/2026 National TAB - Jackson Gunnels**
  - Re-evaluated motor. Voltage and amperage were both recorded to increase as speed controller is decreased. Fan left at maximum speed to keep amp draw below FLA.
