Report: TAB Report
Function: Test, Adjust, & Balance
Date: 07/18/2025
Completed By: National TAB

PROJECT
07-07-25 WAWA #5453 OCALA, FL

Project: 07-07-25 WAWA #5453 OCALA, FL

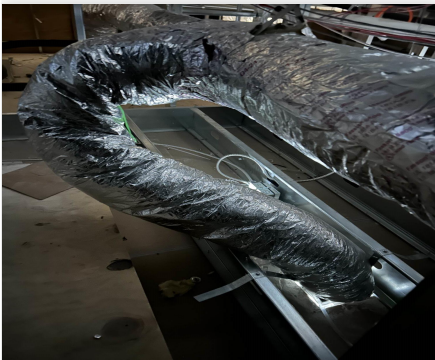
Issue Name : Diffusers 1-14, 1-15 - Low Flow
Description : Supply diffusers 1-14 and 1-15 (rear vestibule, men’s restroom) are at 75% and 85% of design, respectively. Dampers are fully open. Flex was adjusted and shortened by MC to improve airflow slightly. Further balancing would be a detriment to overall unit performance. No further action required as long as there are no comfort complaints.
Created By : National TAB **Assigned To :** National TAB - Dan Hertenstein
Status : Open
Priority : InfoOnly **Asset Tag :**
Originated Date : 07/13/2025 - Mark Johnson - National TAB
