Report: TAB Report
Function: Test, Adjust, & Balance
Date: 07/18/2025
Completed By: National TAB

07-07-25 WAWA #5453 OCALA, FL

Project: 07-07-25 WAWA #5453 OCALA, FL

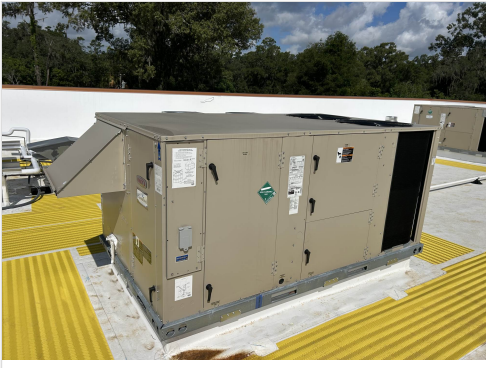
Unit Data - PHOTO LOG

Unit Data		
	Design	Actual
MFG	LENNOX ENLIGHT	LENNOX ENLIGHT
Serial Num	-	5624J04435
Model Num	LCT102H4E	LCT102H4EG1Y
Type	RTU	RTU
Configuration	VERTICAL	VERTICAL
Num OA Filters 1	-	1
OA Filter Size 1	-	23x14
Num Final Filter 1	-	4
Final Filter Size 1	-	20x25x2

Test Data		
	Design	Actual
SF CFM	3400	3409
SF RPM	-	1342
MOTOR RPM	-	1342
RA CFM	2900	2904
OA CFM	500	505
RL Voltage	-	212/213/213
RL Amperage	-	2.7/2.7/2.6
SF System SetPt	-	61%
OA Damper Position	-	42%
OA Damper Type	-	SINGLE BLADE
