Report: TAB Report
Function: Test, Adjust, & Balance
Date: 07/18/2025
Completed By: National TAB

PROJECT
07-07-25 WAWA #5453 OCALA, FL

Project: 07-07-25 WAWA #5453 OCALA, FL

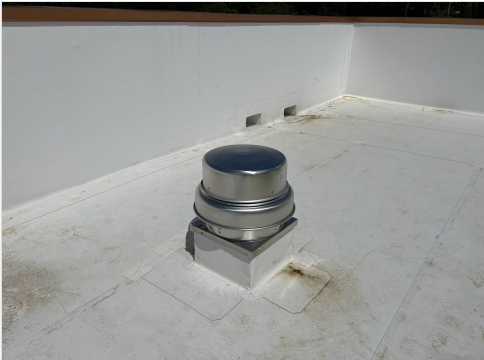
Unit Data - PHOTO LOG

Unit Data		
	Design	Actual
MFG	GREENHECK	GREENHECK
Model Num	G-120	G-120-B-6-1-19-X
Serial Num	-	27049718
Type	DOWNBLAST	DOWNBLAST
Configuration	VERTICAL	VERTICAL

Test Data		
	Design	Actual
CFM	800	913
Fan RPM	863	DD
Fan Rotation	-	CW
Motor RPM	-	DD
System SetPt	-	SPEED CONTROLLER (MARKED)
RL Voltage	-	112
RL Amperage	-	2.1
Total ESP	.250"	0.33"
Fan Inlet SP	-	-0.33"
Fan Discharge SP	-	ATM

Notes:
Fan cannot be slowed further without overramping motor.

Issue Name : EF-1 - High Flow
Description : EF-1 is currently running at 913 CFM (114% design). Slowing the fan further causes the motor to overamp, except at extremely low speeds. All exhaust grilles are balanced proportionally to the high total. Recommend motor inspection and monitoring for comfort issues around the space.
Created By : National TAB **Assigned To :** National TAB - Dan Hertenstein
Status : Open
Priority : Medium **Asset Tag :**
Originated Date : 07/13/2025 - Mark Johnson - National TAB
