Report: TAB Report
Function: Test, Adjust, & Balance
Date: 07/18/2025
Completed By: National TAB

PROJECT
07-07-25 WAWA #5453 OCALA, FL

Project: 07-07-25 WAWA #5453 OCALA, FL

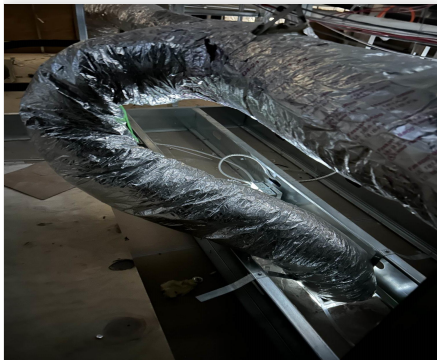
Issue Name : Diffusers 1-14, 1-15 - Low Flow
Description : Supply diffusers 1-14 and 1-15 (rear vestibule, men’s restroom) are at 75% and 85% of design, respectively. Dampers are fully open. Flex was adjusted and shortened by MC to improve airflow slightly. Further balancing would be a detriment to overall unit performance. No further action required as long as there are no comfort complaints.
Created By : National TAB **Assigned To :** National TAB - Dan Hertenstein
Status : Open
Priority : InfoOnly **Asset Tag :**
Originated Date : 07/13/2025 - Mark Johnson - National TAB

- **02/26/2026 National TAB - Stephen Tassinaro**
 - NTi technicians as well as the Wawa managers noted that these diffusers are not causing any comfort issues in the space.

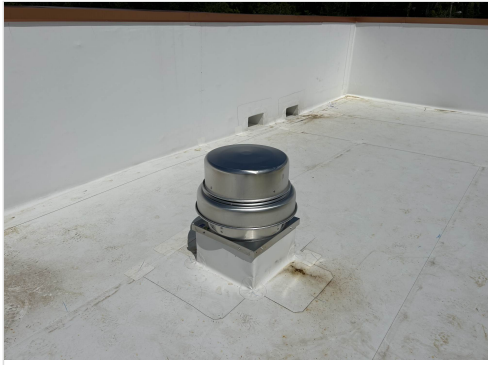
Unit Data - PHOTO LOG

Unit Data		
	Design	Actual
MFG	GREENHECK	GREENHECK
Model Num	G-120	G-120-B-6-1-19-X
Serial Num	-	27049718
Type	DOWNBLAST	DOWNBLAST
Configuration	VERTICAL	VERTICAL

Test Data		
	Design	Actual
CFM	800	913
Fan RPM	863	DD
Fan Rotation	-	CW
Motor RPM	-	DD
System SetPt	-	SPEED CONTROLLER (MARKED)
RL Voltage	-	112
RL Amperage	-	2.1
Total ESP	.250"	0.33"
Fan Inlet SP	-	-0.33"
Fan Discharge SP	-	ATM

Fan cannot be slowed further without overramping motor.

- **02/26/2026 National TAB - Stephen Tassinaro**
 - This is a known and re-occurring issue with this fan. It is not expected to cause any issue in the space operating at 114% design.

- **02/19/2026 National TAB - Jackson Gunnels**
 - Re-evaluated motor. Voltage and amperage were both recorded to increase as speed controller is decreased. Fan left at maximum speed to keep amp draw below FLA.
